# Uniform Mitigation Verification Inspection Form

**RE: Palmetto Dunes Condominium**  
**21811 Palmetto Dunes Drive**  
**Estero, FL 33928**  
**Roofing Restoration**  
KEG File #20RN-0085  
**Wind Mitigation**  
**Permit # 1722052-0**

DATE	April 14, 2020	JOB NO.	20RN-0085
Palmetto Dunes CAI – Roofing Project			
LOCATION	Palmetto Dunes Drive		
CONTRACTOR	EnviroStruct, LLC	Palmetto Dunes CAI	
WEATHER	Sunny	TEMP.	Time
		88° F	1:00PM
PRESENT AT SITE	Rahmin Bahar, EnviroStruct (ES) Teresita Nazario-Acosta, Karins Engineering Group (KEG)

REPORT: FR # 26

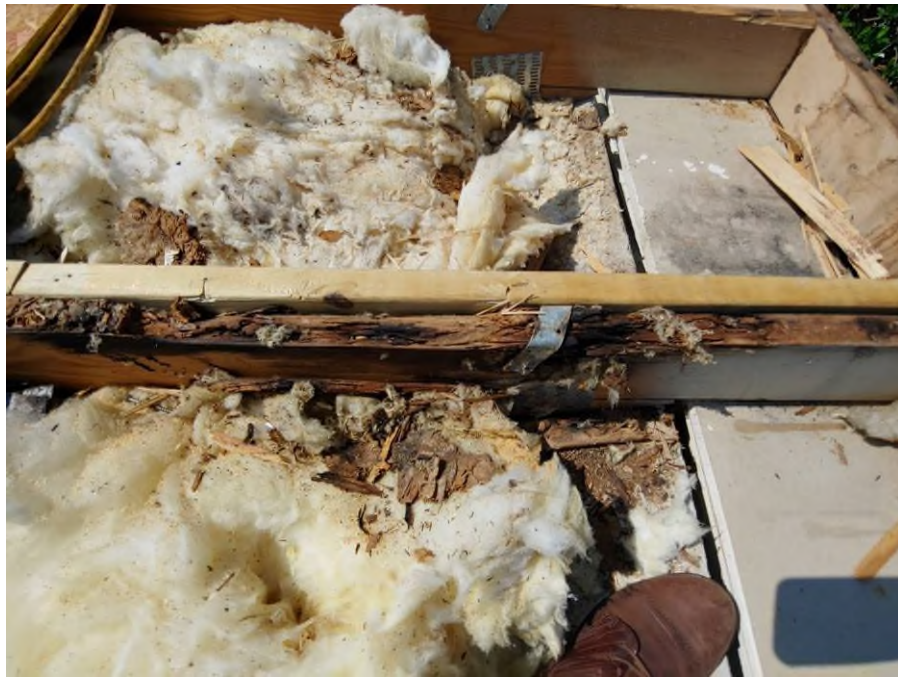
**Photograph #15: Rotten fascia, trusses and plywood sheathing were observed on building 21811.**

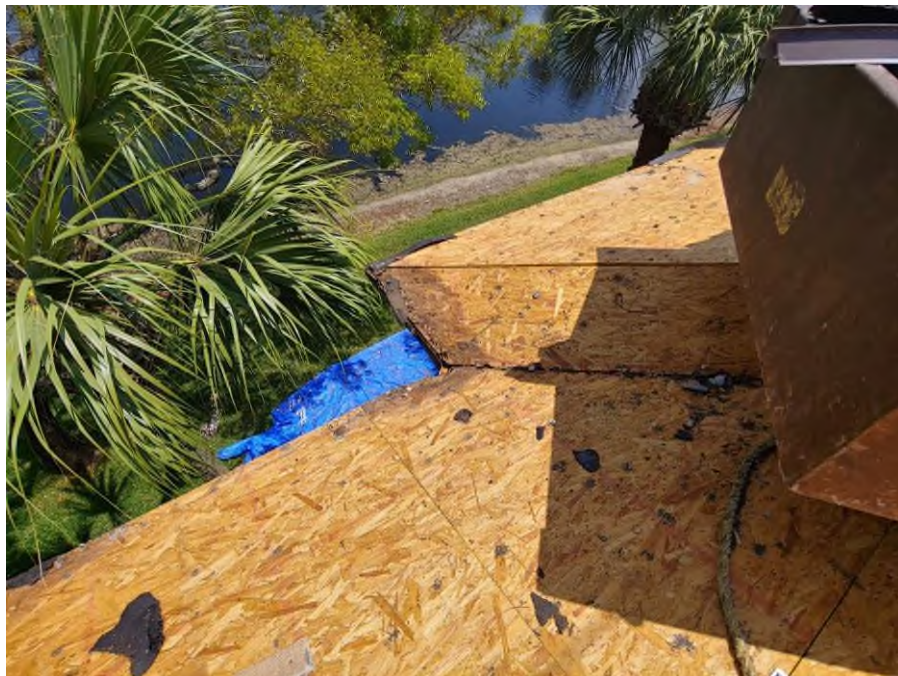
**Photograph #16: Rotten fascia, trusses and plywood sheathing were observed on building 21811.**
