Uniform Mitigation Verification Inspection Form

Inspection Date: 6-2-2020		
Owner Information		
Owner Name: Palmetto Dunes Pelican Sound Condominium Association Inc.		Contact Person:
Address: 21741 Palmetto Dunes Drive, Units 101,102,201,202		Home Phone:
City: Estero	Zip: 33928	Work Phone:
County: Lee		Cell Phone:
Insurance Company:		Policy #:
Year of Home: 2001	# of Stories: 2	Email:

RE: Palmetto Dunes Condominium
21741 Palmetto Dunes Drive
Estero, FL 33928
Roofing Restoration
KEG File #20RN-0085
Wind Mitigation
Permit # 1721364-0

REPORT: FR # 27

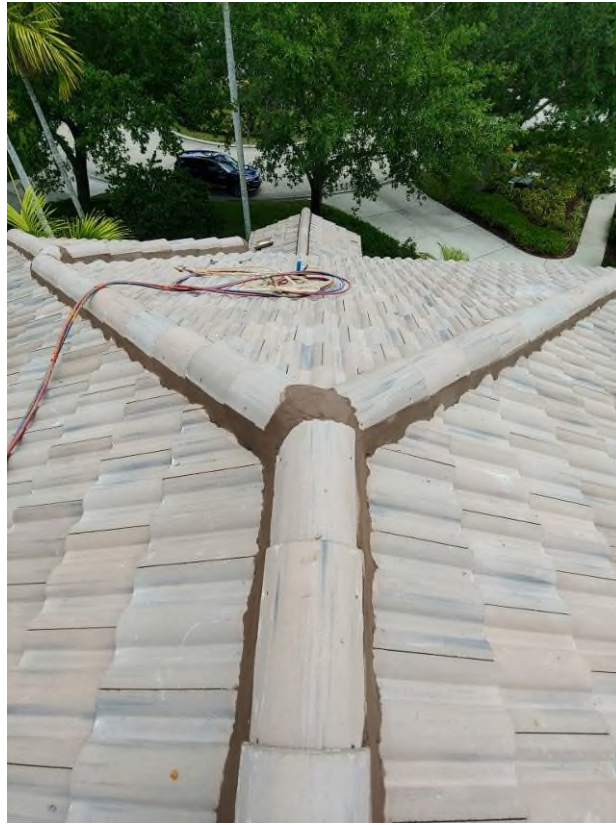
Photograph #1: Mortar adhesive application was in progress surrounding the ridge tiles and hip tiles on building 7840.

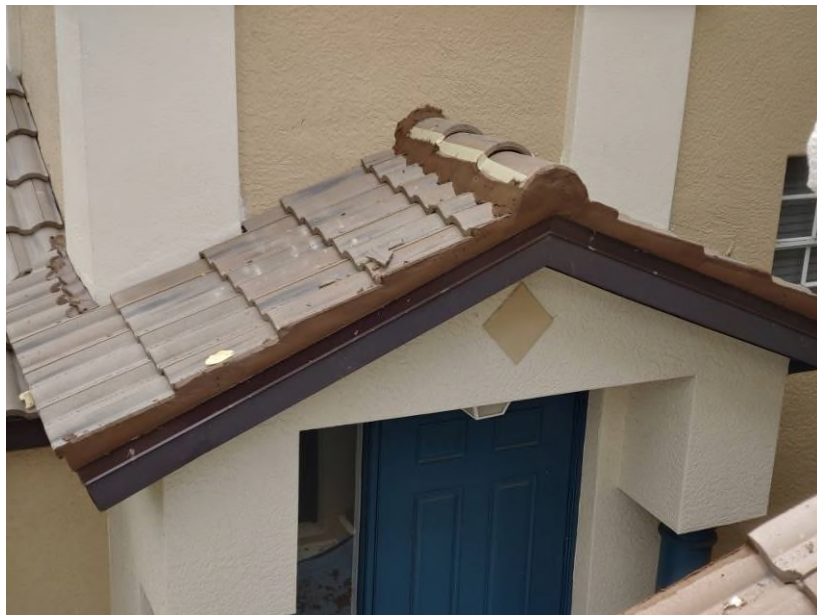
Photograph #2: Mortar adhesive application was in progress surrounding the ridge tiles and hip tiles on building 7840.

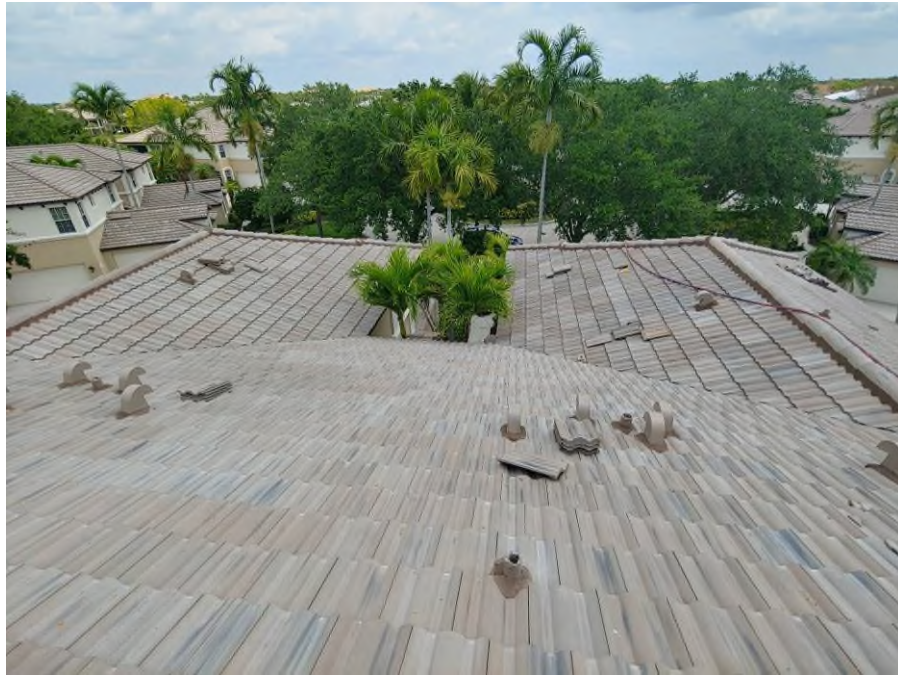
Photograph #3: Mortar adhesive application was in progress surrounding the pipes and exhaust vents on building 7840.

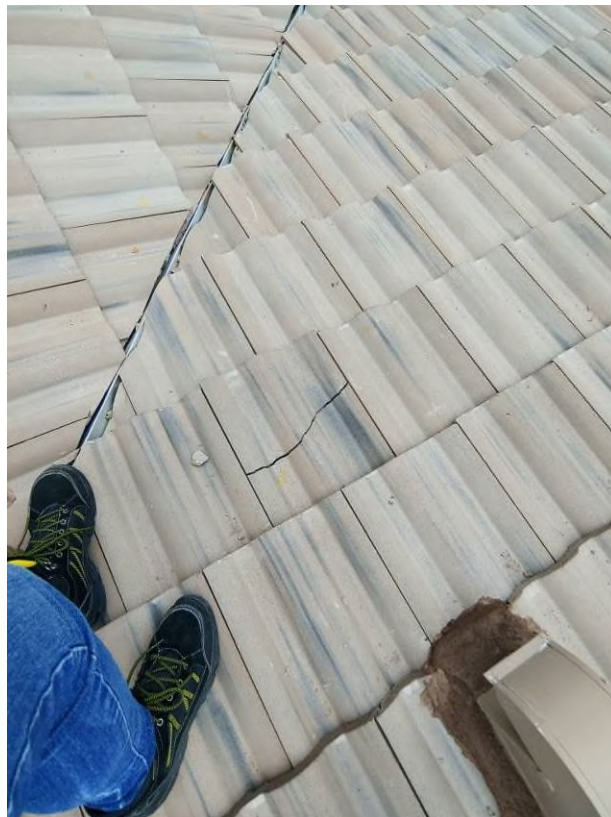
Photograph #4: Broken field tile replacement must be addressed on building 7840.

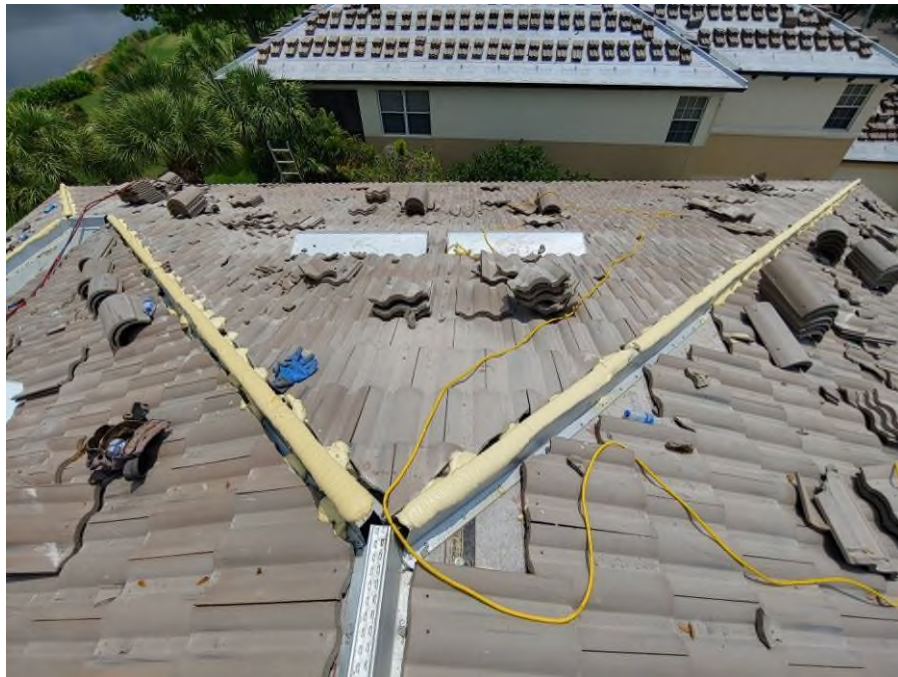
Photograph #5: Roof field, ridge and hip tile installations with polyurethane foam adhesive was in progress on building 21741.

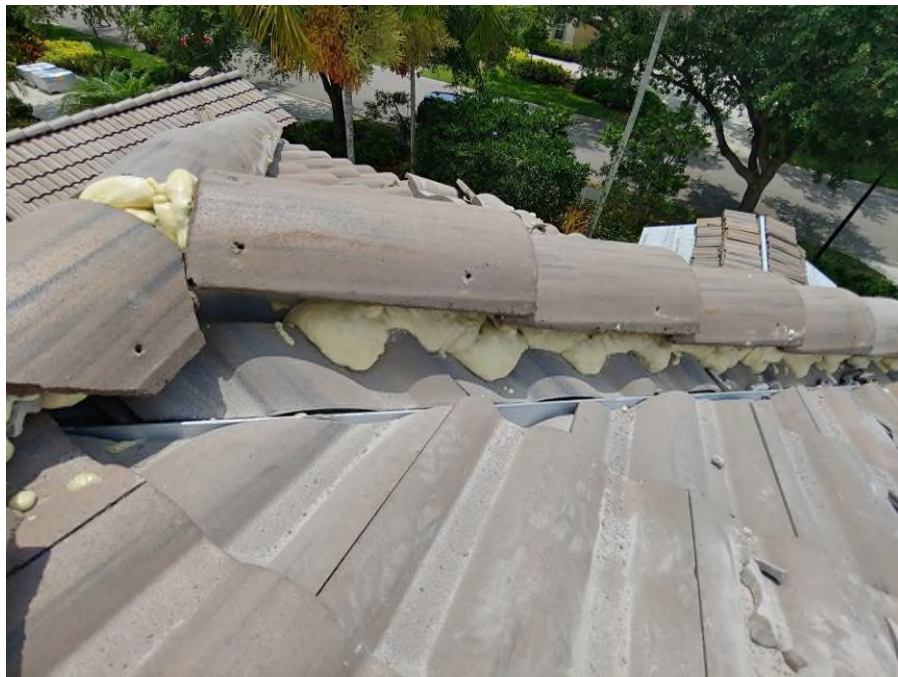
Photograph #6: Roof field, ridge and hip tile installations with polyurethane foam adhesive was in progress on building 21741.

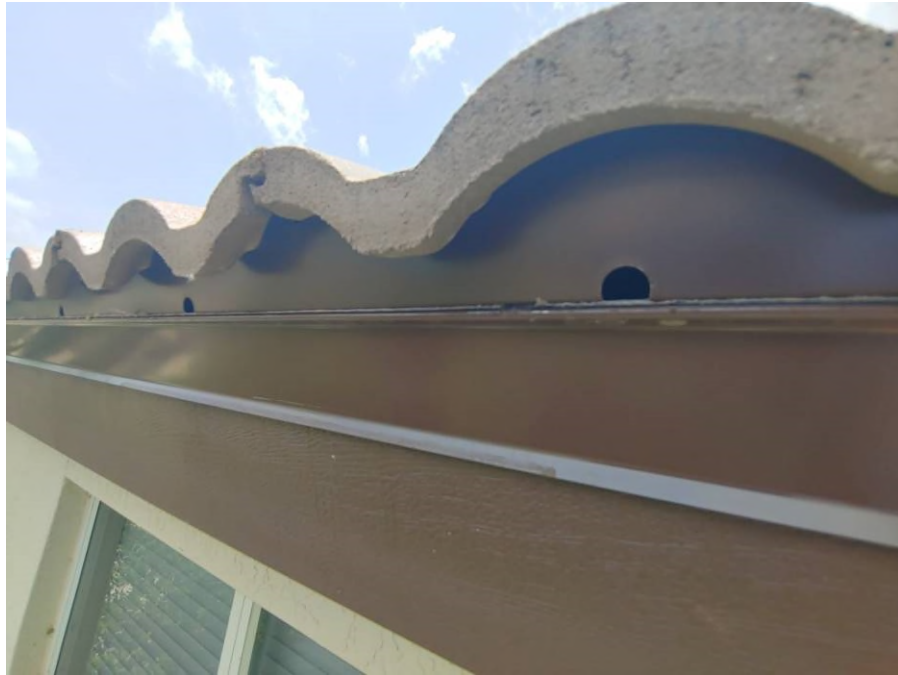
Photograph #7: Bird-stop metal flashing installation was in progress on building 21741.

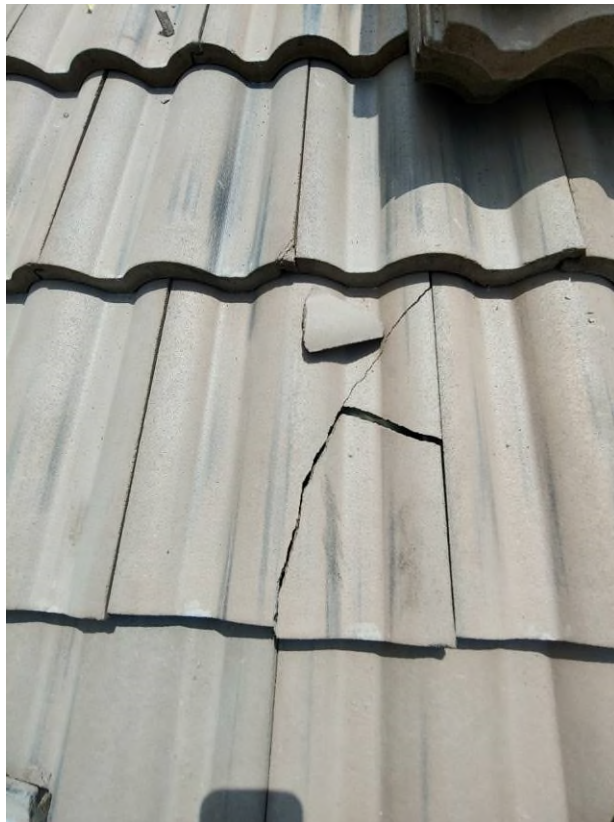
Photograph #8: Broken field tile replacement must be addressed on building 21741.

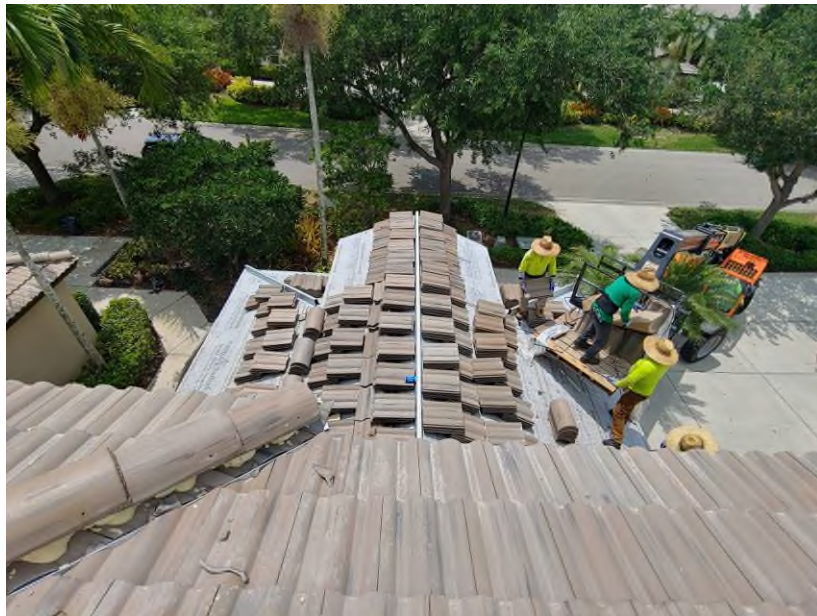
Photograph #9: Roof tiles were set in place for installation on building 21741.

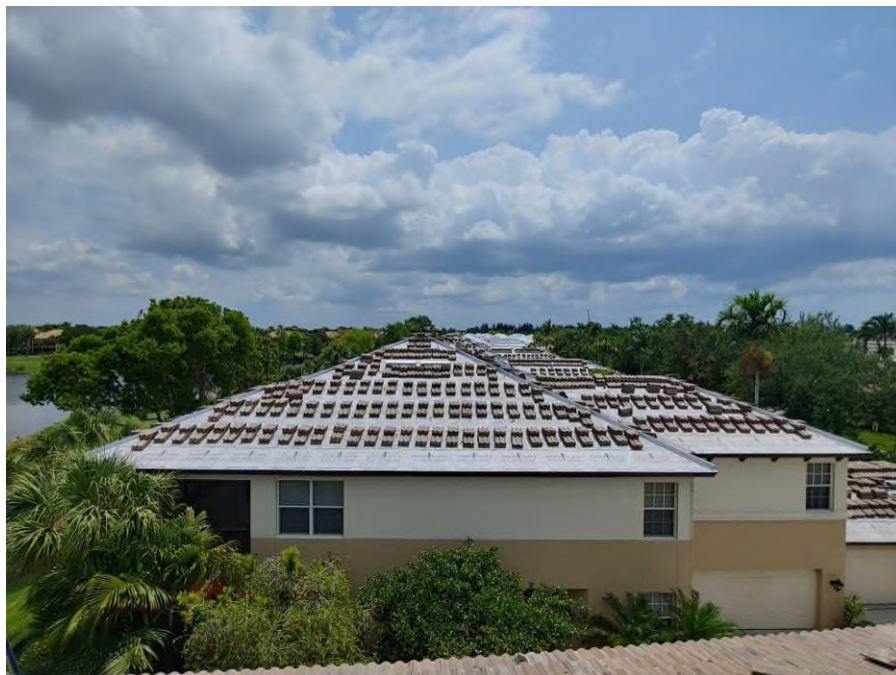
Photograph #10: Roof tiles were set in place for installation on building 21751.

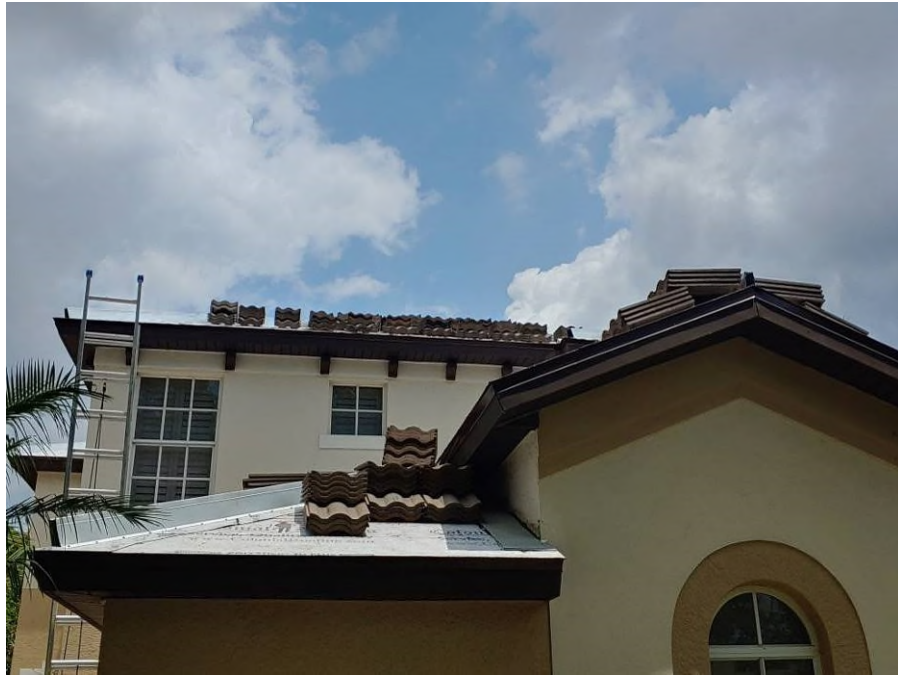
Photograph #11: Roof tiles were set in place for installation on building 21761.

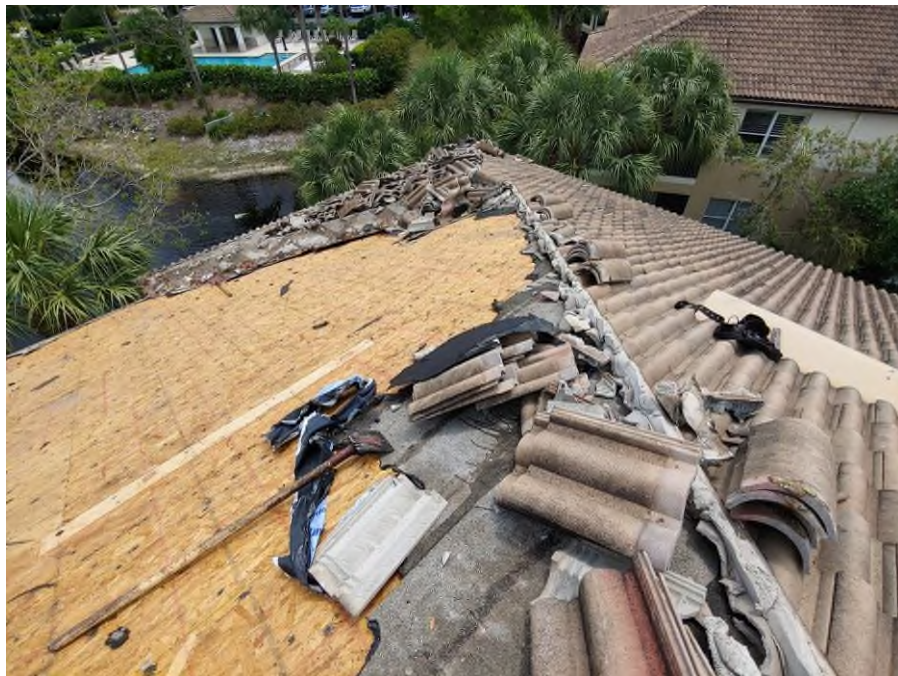
Photograph #12: Roof tile removal was in progress on building 21821.

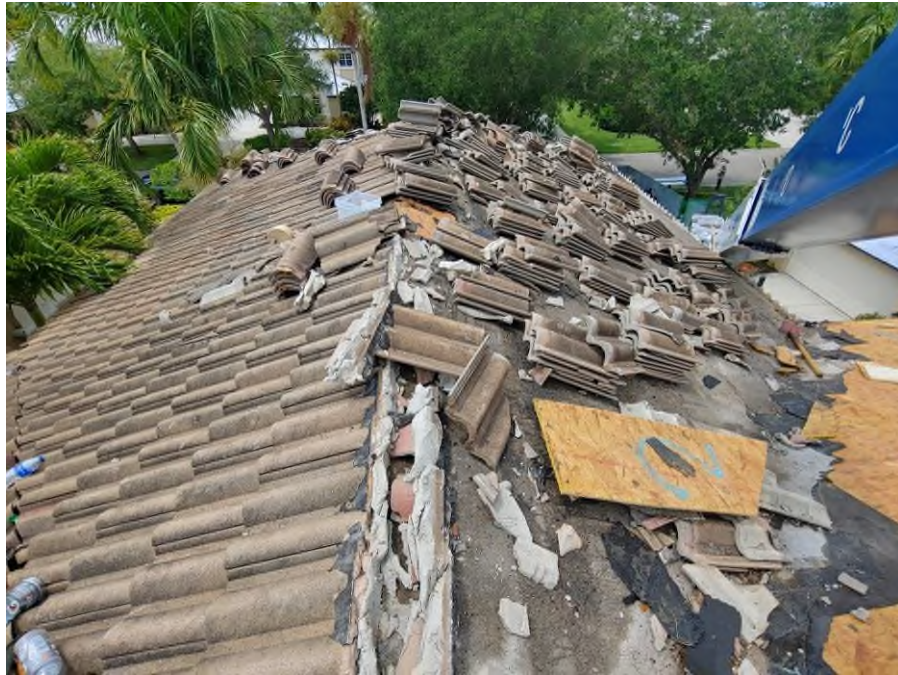
Photograph #13: Roof tile removal was in progress on building 21821.

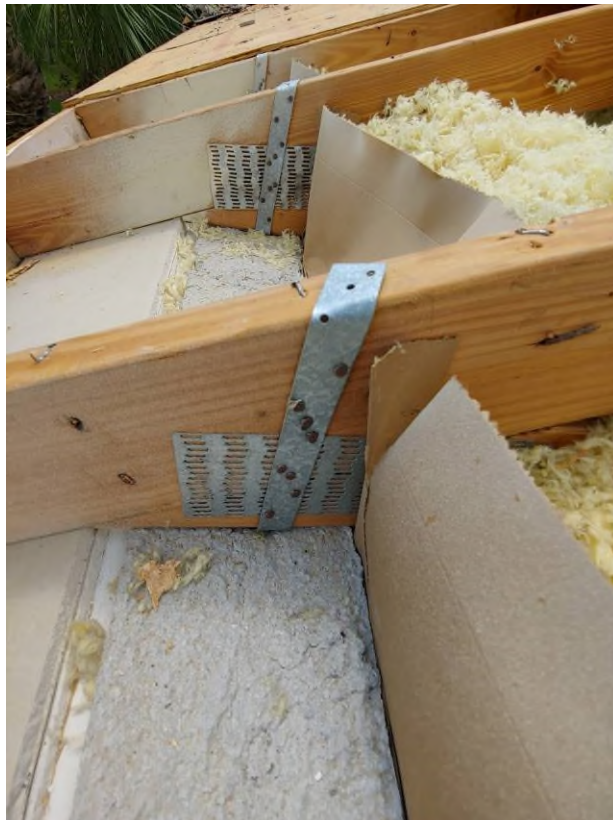
Photograph #14: Existing strap clips on the trusses have the required minimum of 5 nails on building 21821.

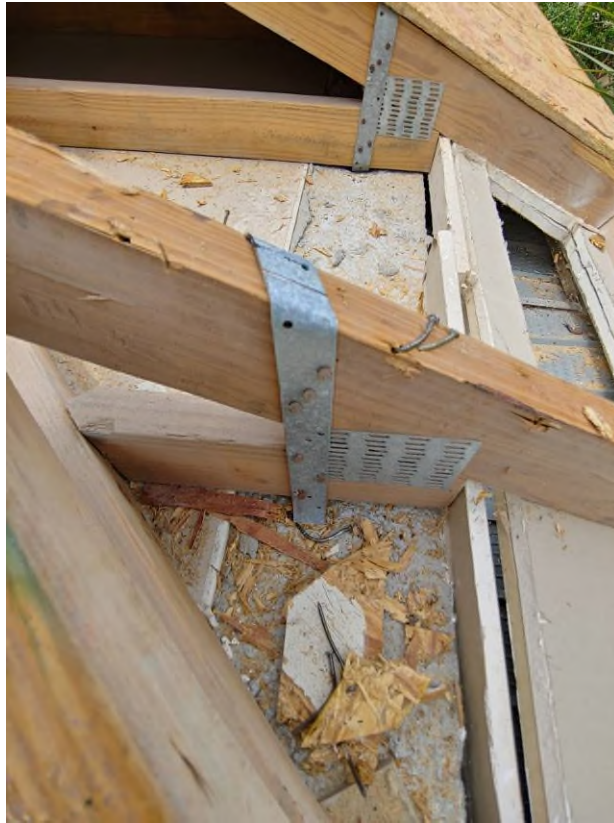
Photograph #15: Existing strap clips on the trusses have the required minimum of 5 nails on building 21821.

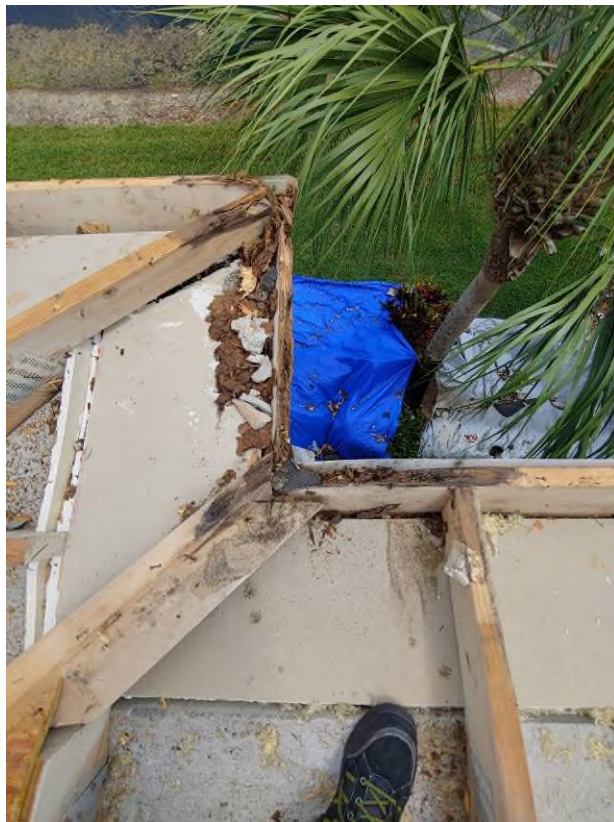
Photograph #16: Rotten fascia, trusses and plywood sheathing were observed on building 21821.

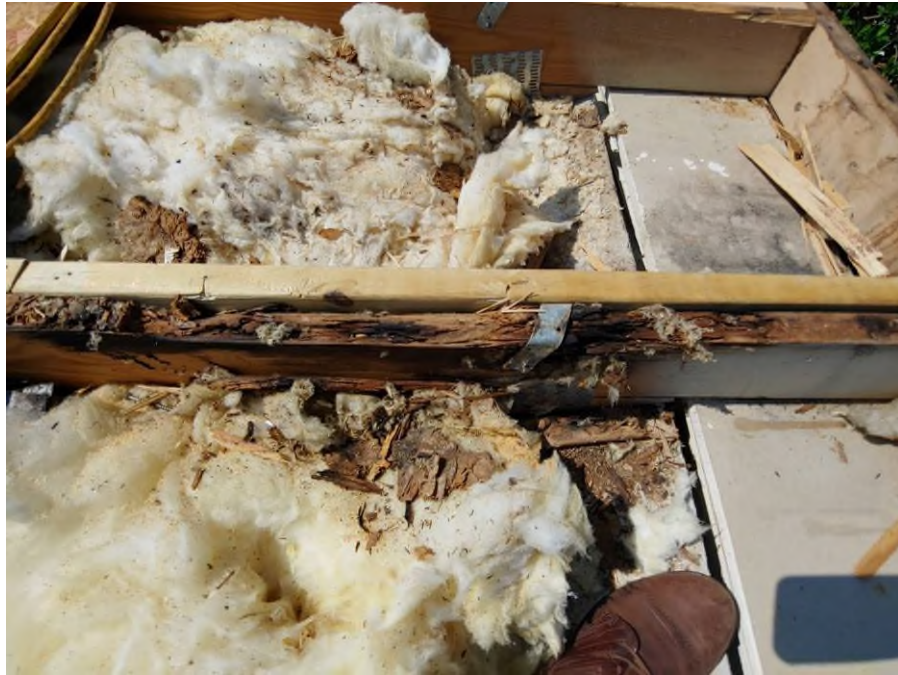
Photograph #15: Rotten fascia, trusses and plywood sheathing were observed on building 21811.

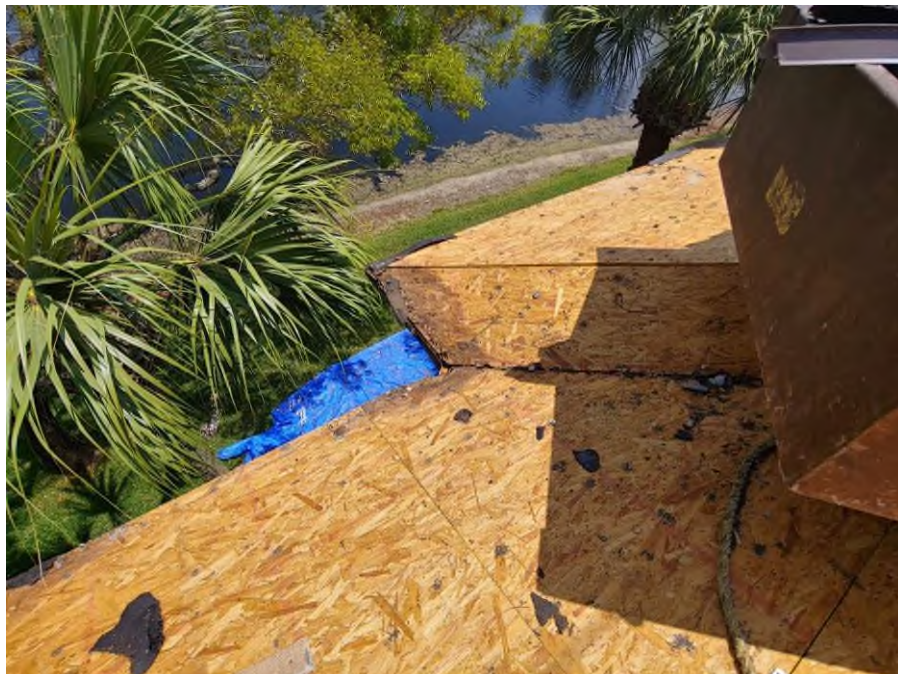
Photograph #16: Rotten fascia, trusses and plywood sheathing were observed on building 21811.

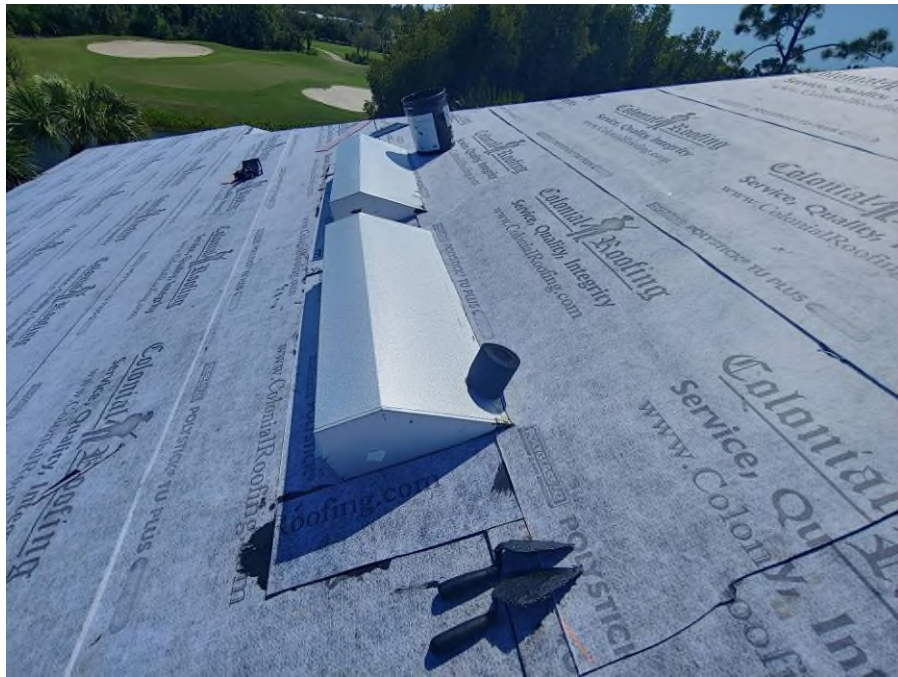
Photography #1: Exhaust vent installation was in progress on unit 7870.

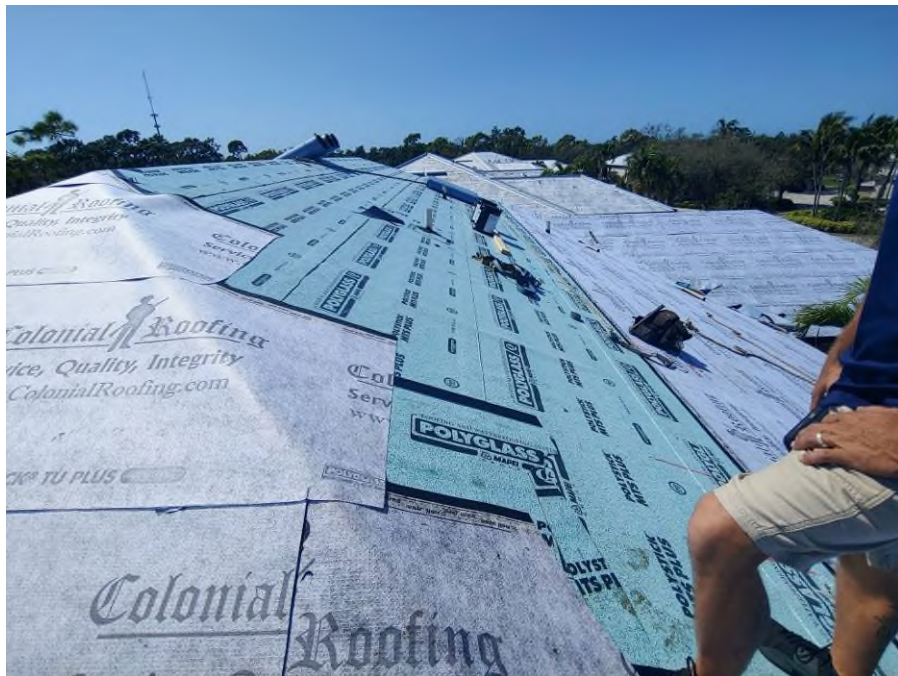
Photography #2: Polystick MTS Plus underlayment installation was completed and the second layer of underlayment installation was in progress on building 7870.

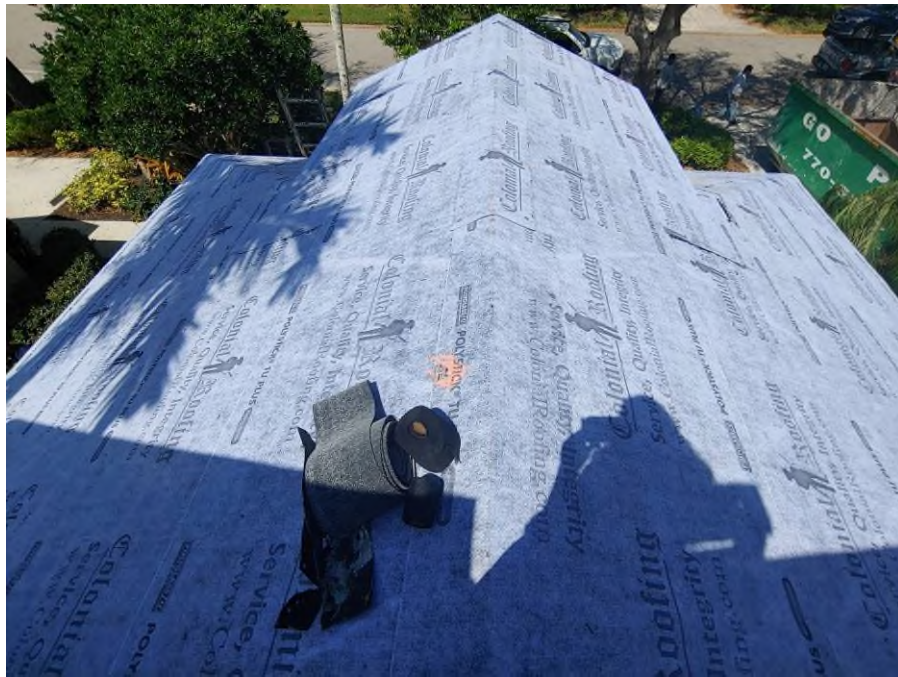
Photography #3: Second layer of underlayment installation was in progress on building 7870.

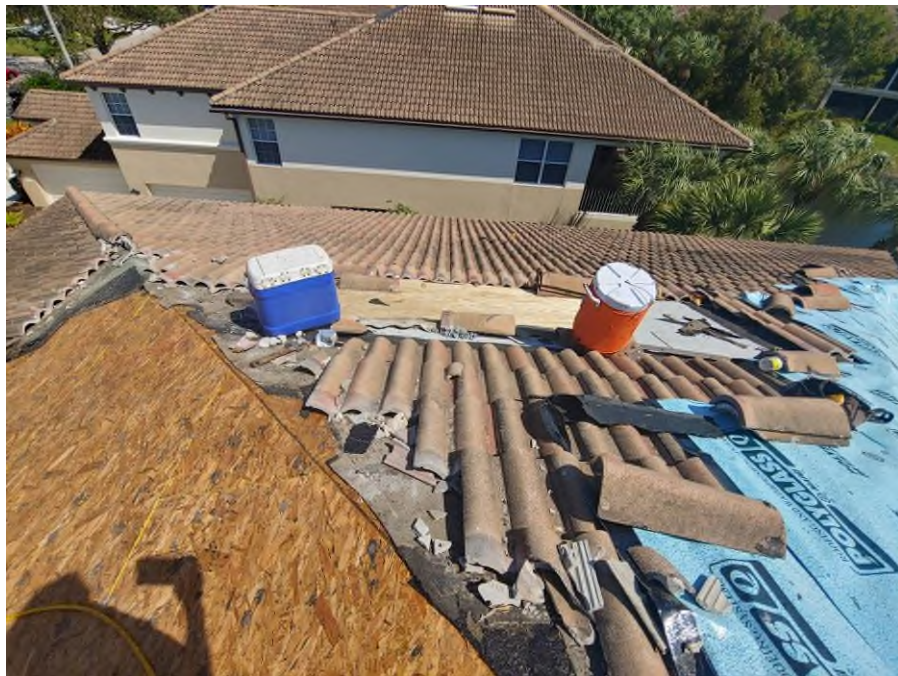
Photography #4: Roof tile removal was in progress on building 7880.

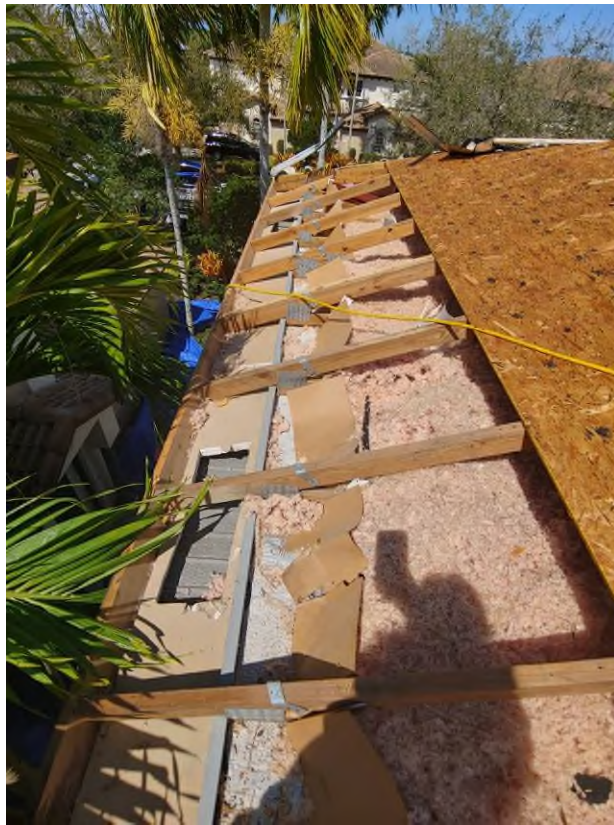
Photography #5: Existing strap clips on the trusses have the required minimum quantity of nails on building 7880.

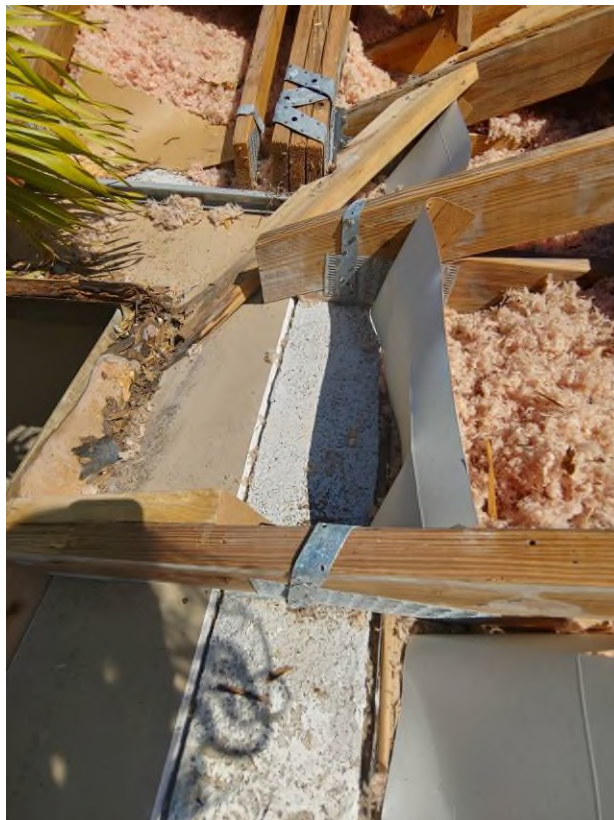
Photography #6: Existing strap clips on the trusses have the required minimum quantity of nails on building 7880.

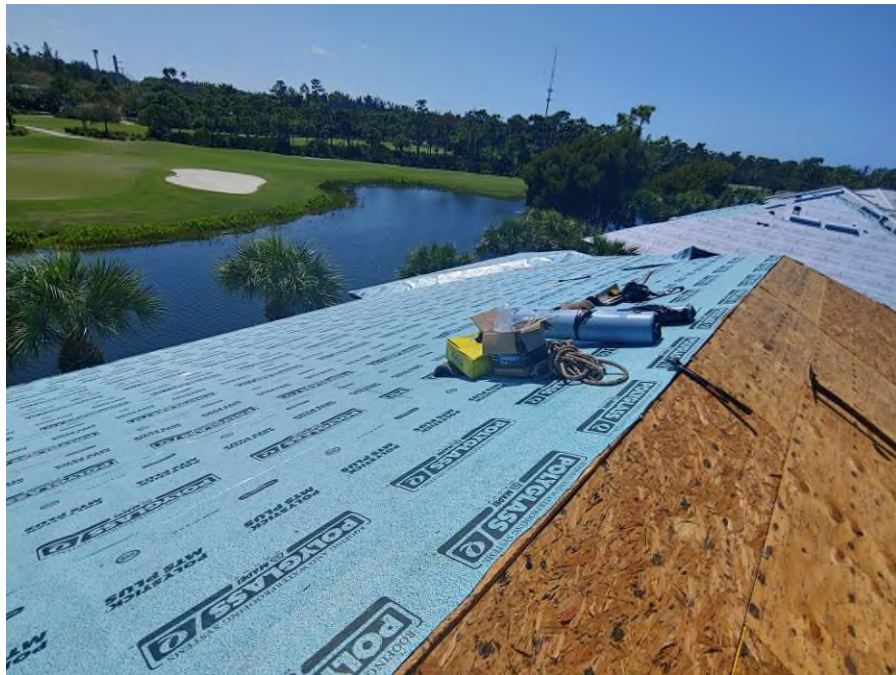
Photography #7: Polystick MTS Plus underlayment installation was in progress on building 7880.

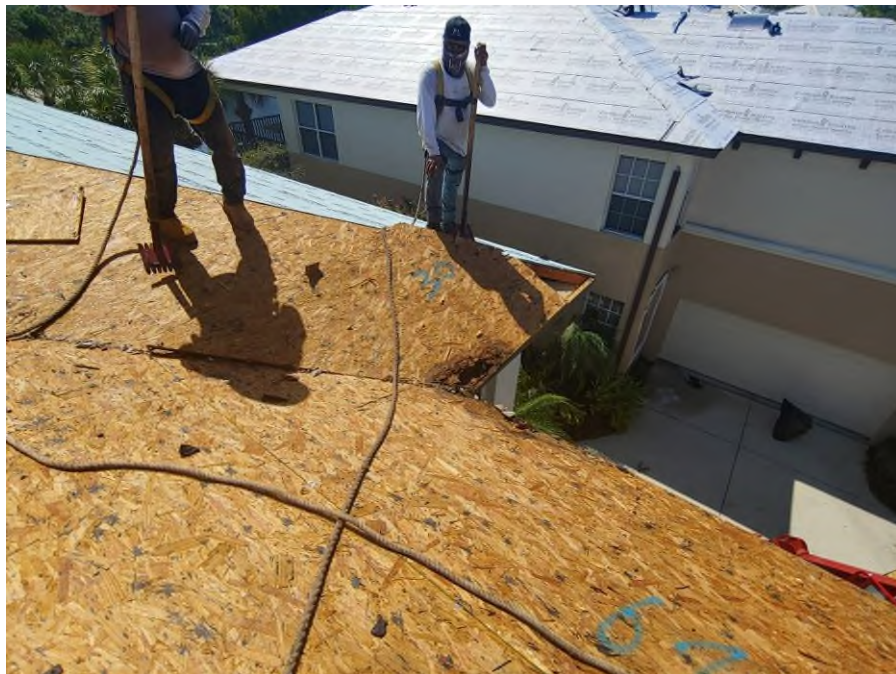
Photography #8: Rotten plywood sheathing was observed on building 7880.

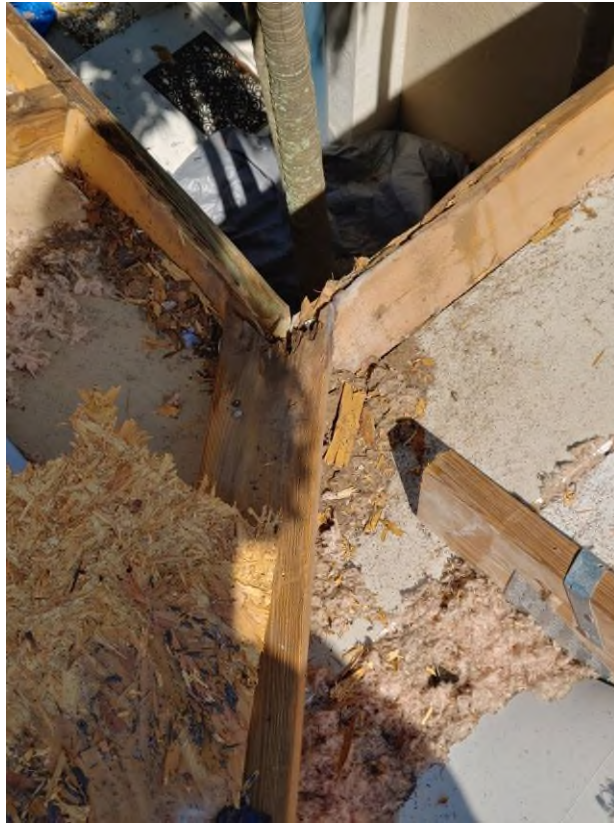
Photography #9: Rotten fascia and truss were observed on building 7880.

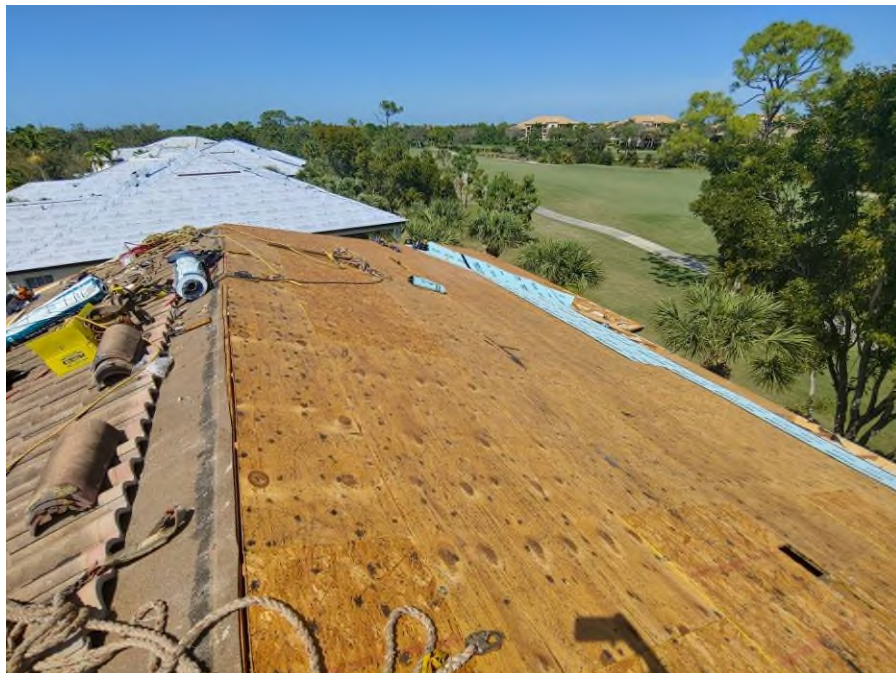
Photography #10: Roof tile removal was in progress on building 21741.

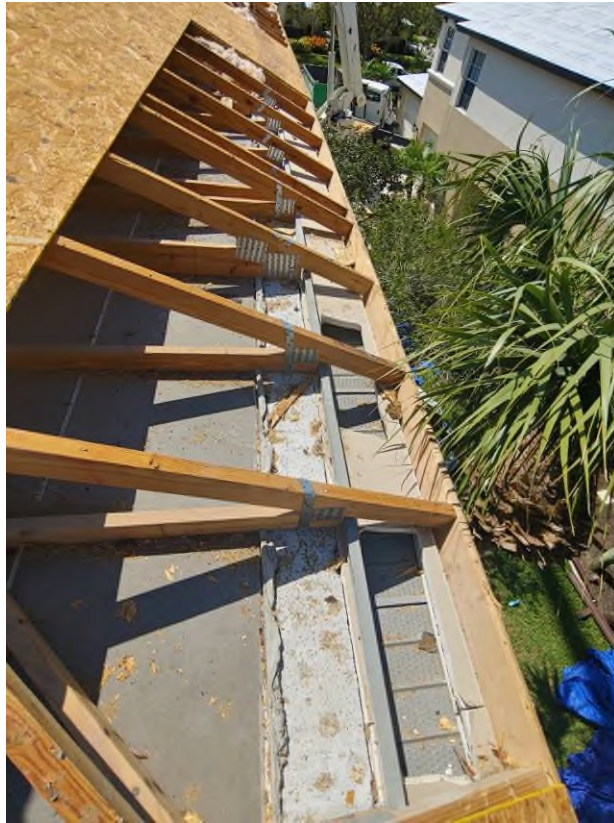
Photography #11: Existing strap clips on the trusses have the required minimum quantity of nails on building 21741.

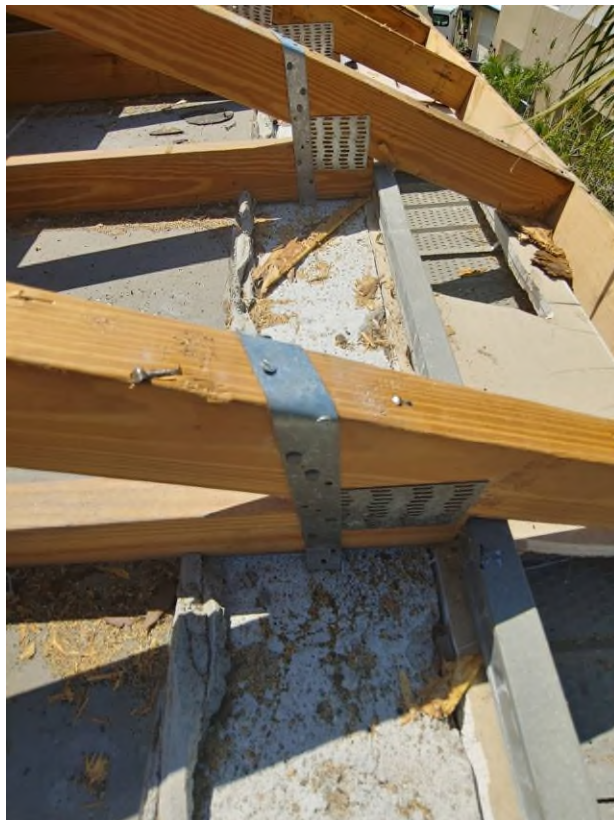
Photography #12: Existing strap clips on the trusses have the required minimum quantity of nails on building 21741.

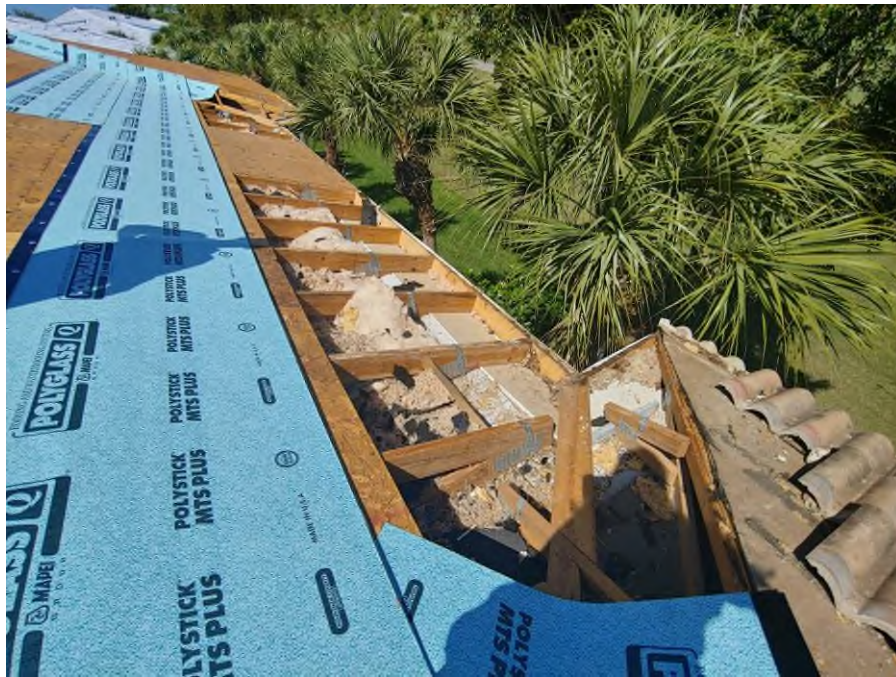
Photography #13: Polystick MTS Plus underlayment installation was in progress on building 21741.

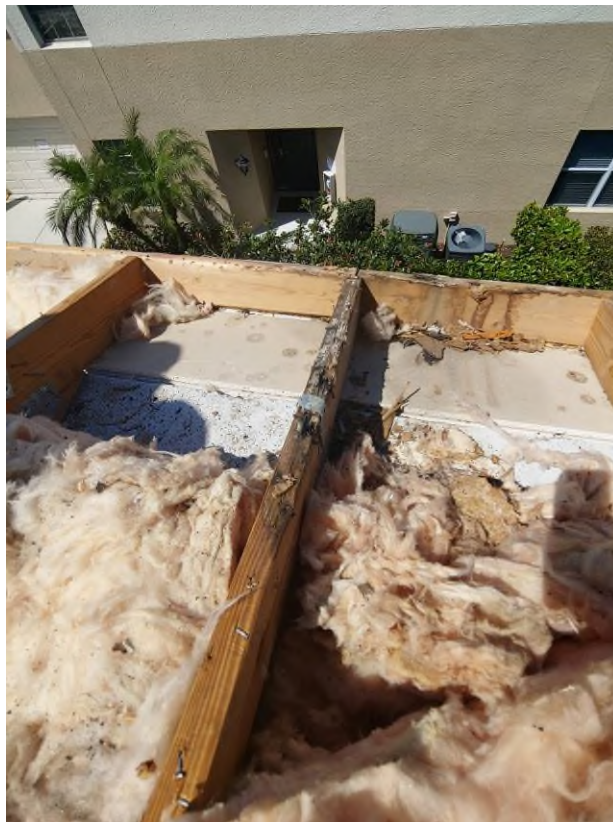
Photography #14: Rotten fascia and truss were observed on building 21741.
