Uniform Mitigation Verification Inspection Form

Inspection Date: 6-2-2020		
Owner Information		
Owner Name: Palmetto Dunes Pelican Sound Condominium Association Inc.		Contact Person:
Address: 21791 Palmetto Dunes Drive Units 101,102,201,202		Home Phone:
City: Estero	Zip: 33928	Work Phone:
County:		Cell Phone:
Insurance Company:		Policy #:
Year of Home: 2001	# of Stories: 2	Email:

RE: Palmetto Dunes Condominium
21791 Palmetto Dunes Drive
Estero, FL 33928
Roofing Restoration
KEG File #20RN-0085
Wind Mitigation
Permit # 1722056-0

DATE	April 10, 2020	JOB NO.	20RN-0085
Palmetto Dunes CAI – Roofing Project			
LOCATION	Palmetto Dunes Drive		
CONTRACTOR	EnviroStruct, LLC	Palmetto Dunes CAI	
WEATHER	Sunny	TEMP.	Time
		84° F	12:00PM
PRESENT AT SITE	Rahmin Bahar, EnviroStruct (ES) Teresita Nazario-Acosta, Karins Engineering Group (KEG)

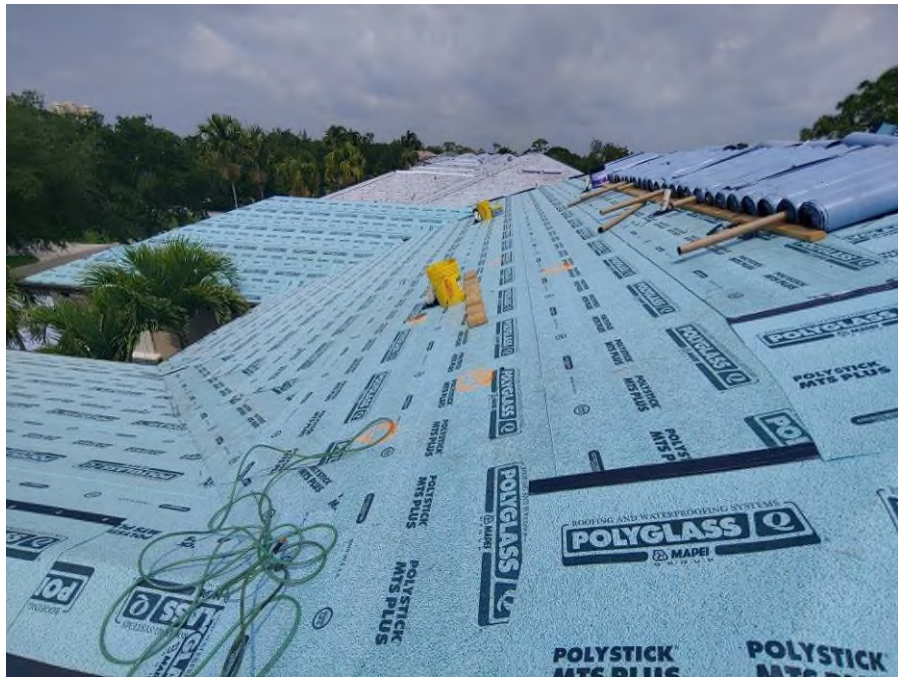
Photograph #1: Polystick MTS Plus underlayment installation was completed on building 21791.

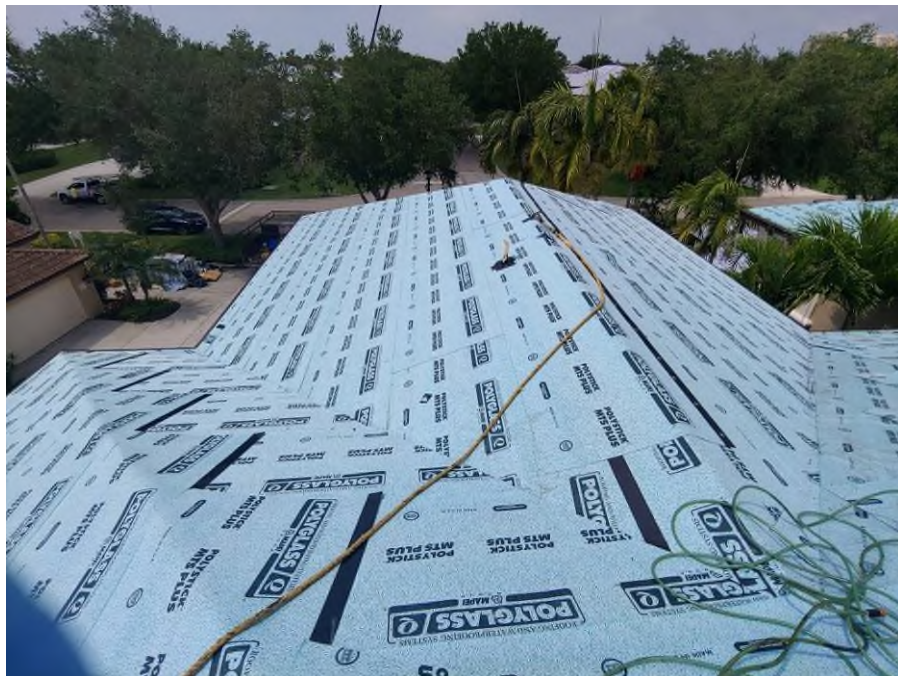
Photograph #2: Polystick MTS Plus underlayment installation was completed on building 21791.

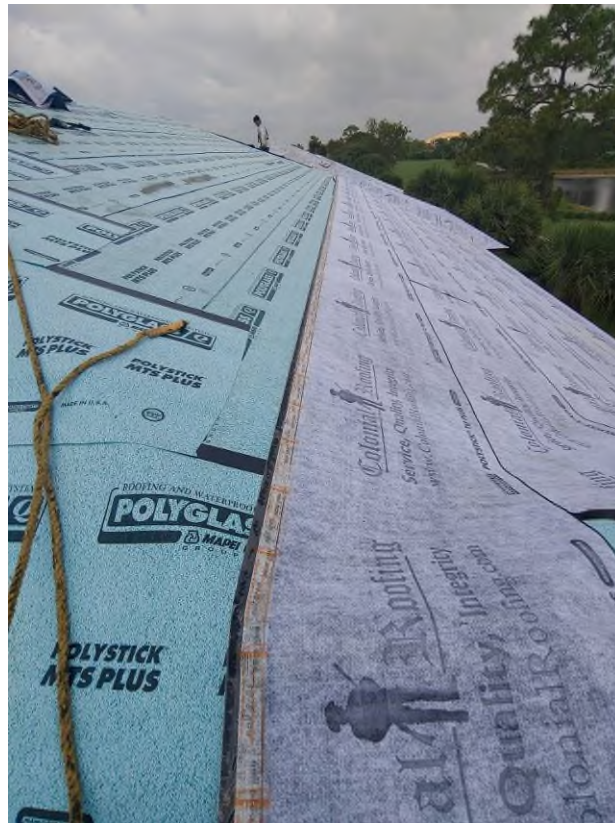
Photograph #3: Second layer of underlayment installation was in progress on building 21791.

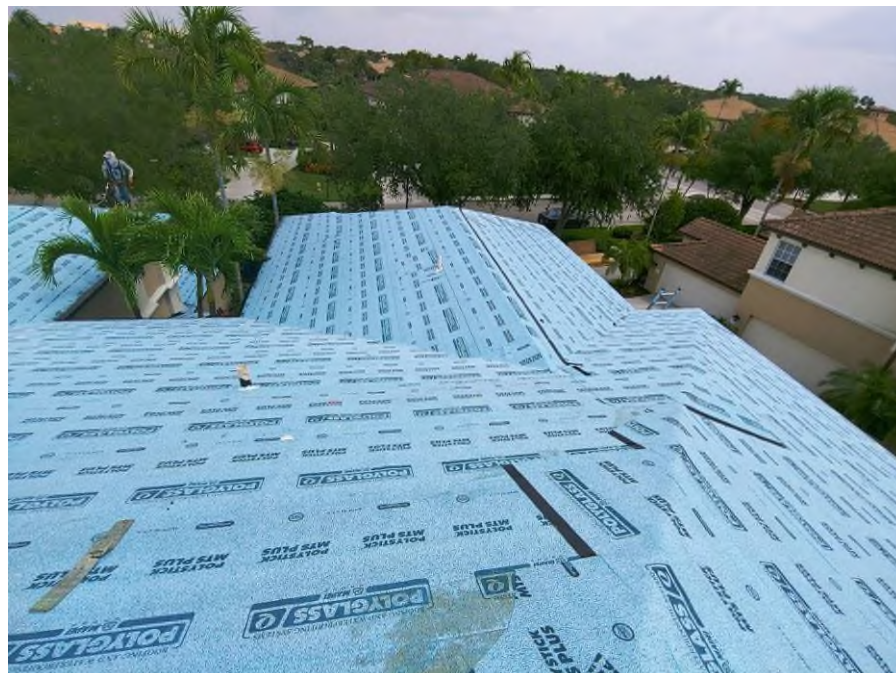
Photograph #4: Polystick MTS Plus underlayment installation was completed on building 21840.

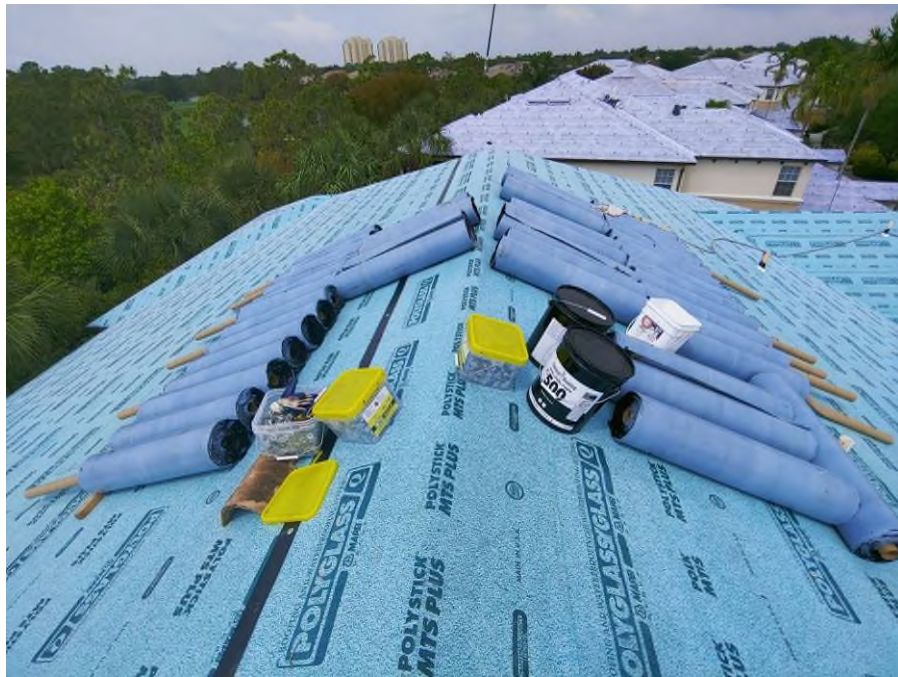
Photograph #5: Second layer of underlayment installation was set in place for installation on building 21840.

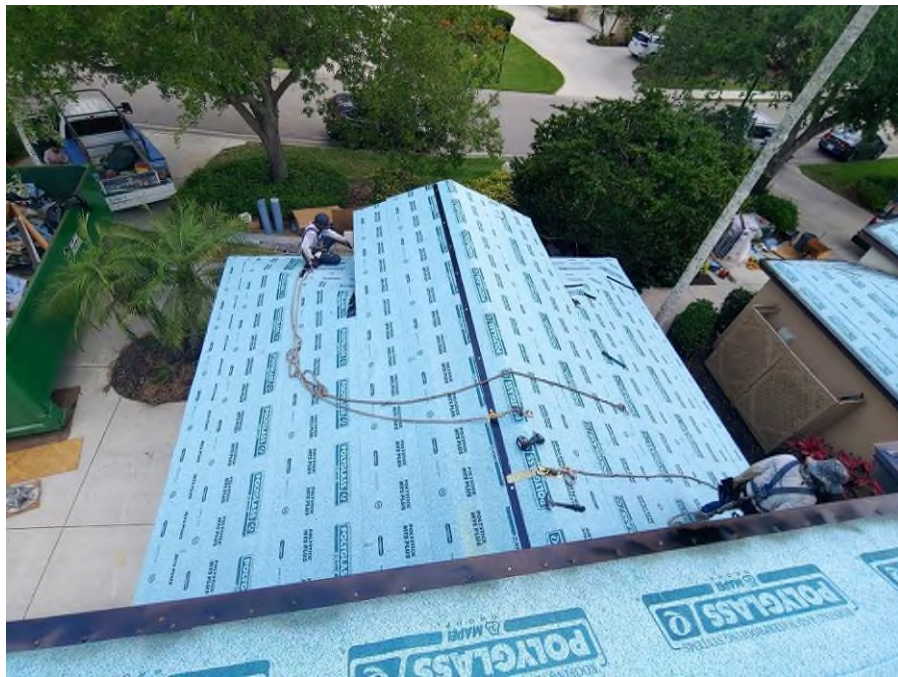
Photograph #6: Drip-edge flashing installation was in progress on building 21840.

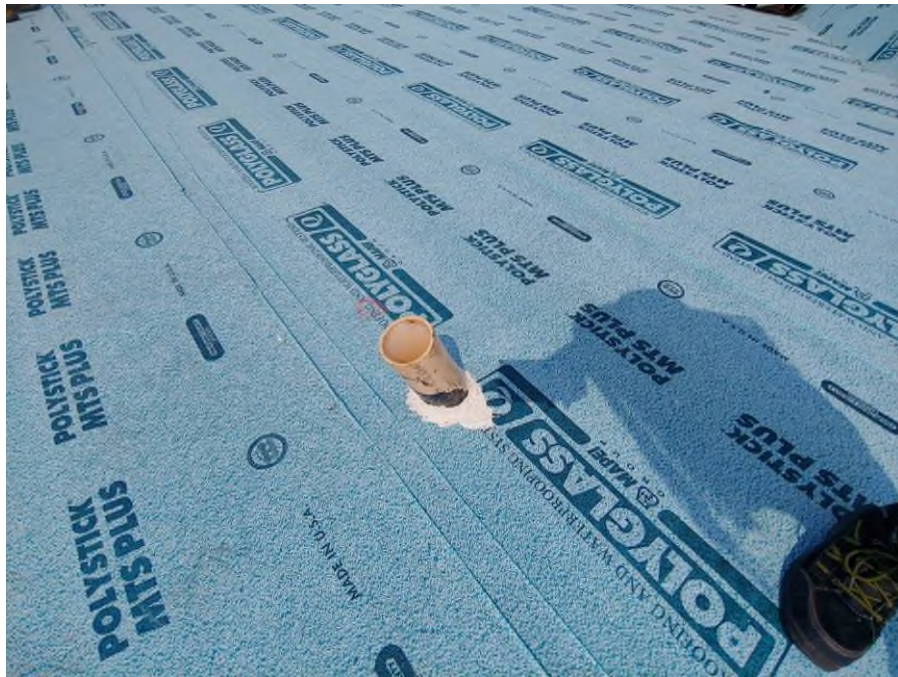
Photograph #7: Sealant application surrounding the exhaust vent pipe was in progress on building 21840.

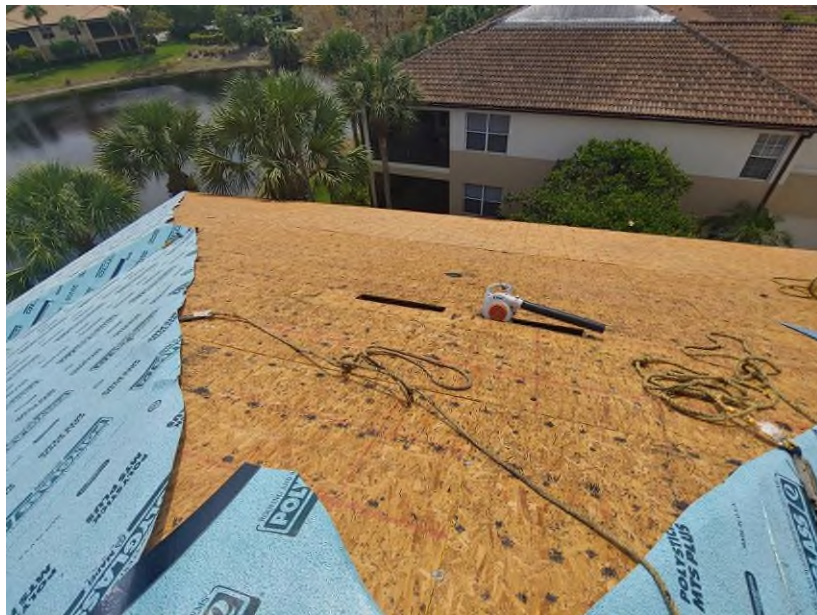
Photograph #8: Roof tile removal was completed on building 21801.

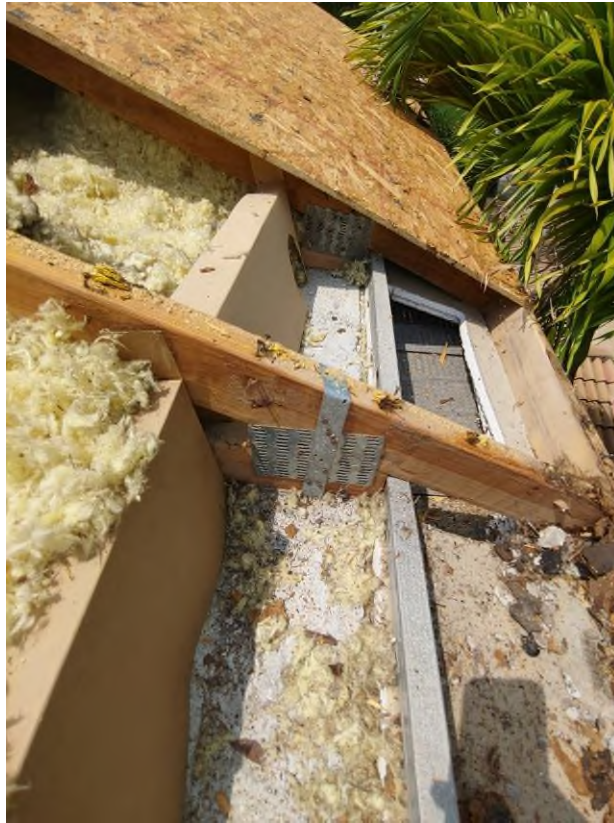
Photograph #9: Existing strap clips on the trusses have the required minimum quantity of 5 nails on building 21801.

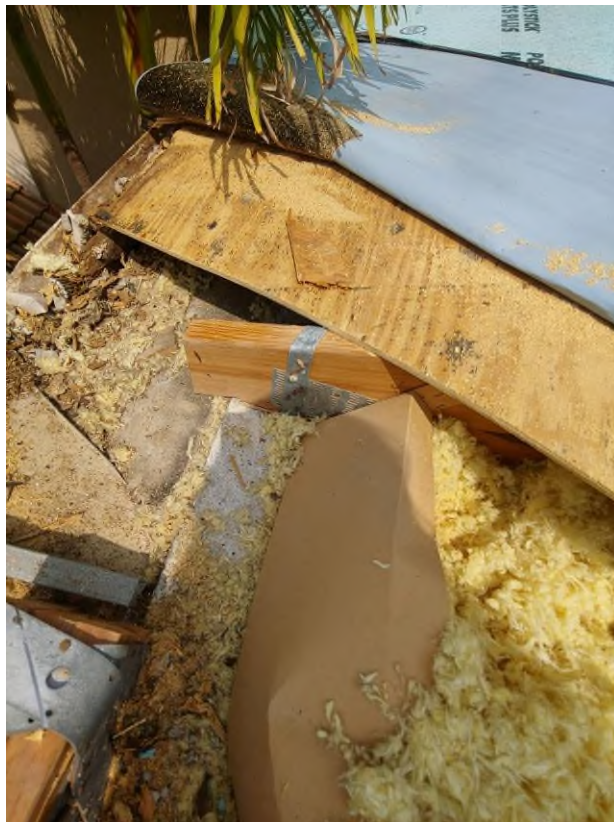
Photograph #10: Existing strap clips on the trusses have the required minimum quantity of 5 nails on building 21801.

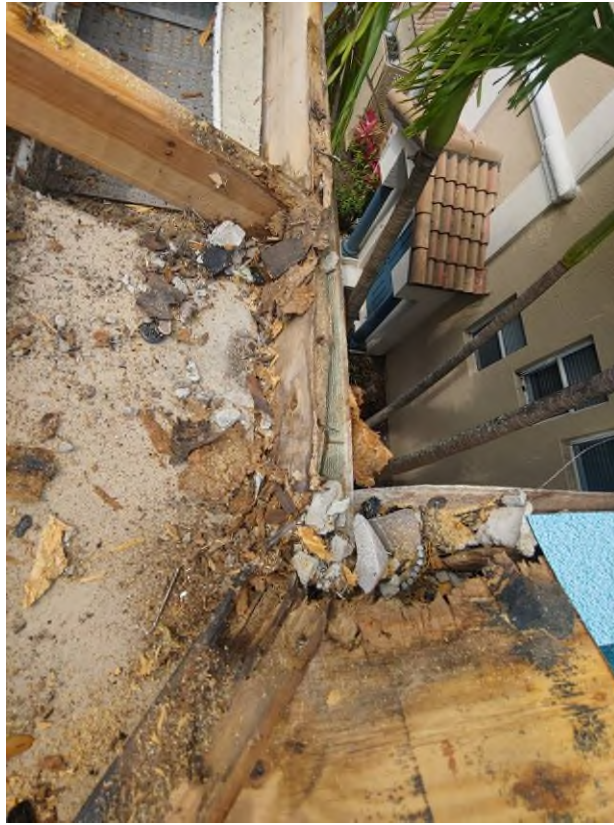
Photograph #11: Rotten fascia, trusses and plywood sheathing were observed on building 21801.

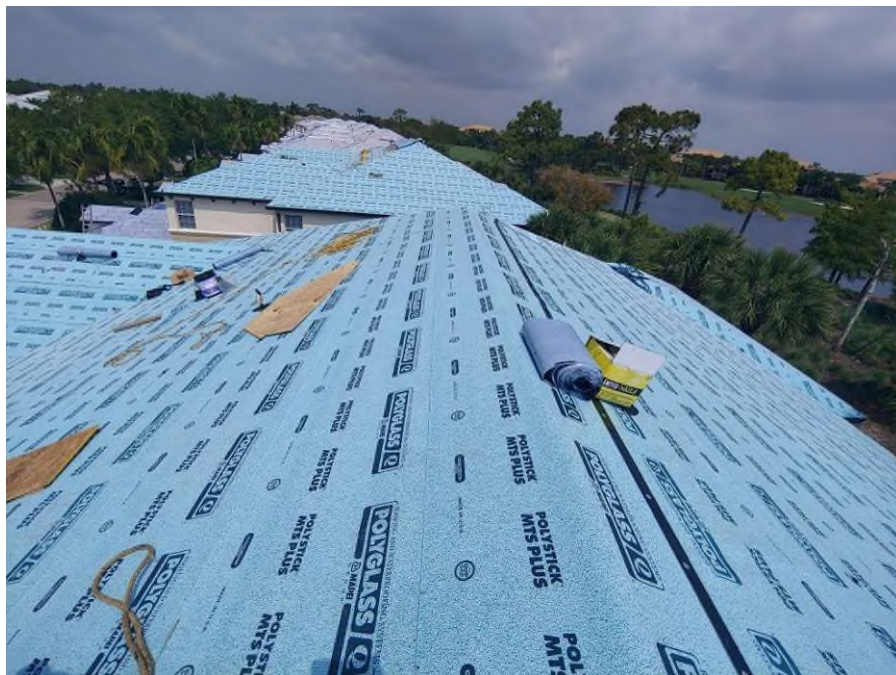
Photograph #12: Polystick MTS Plus underlayment installation was in progress on building 21801.

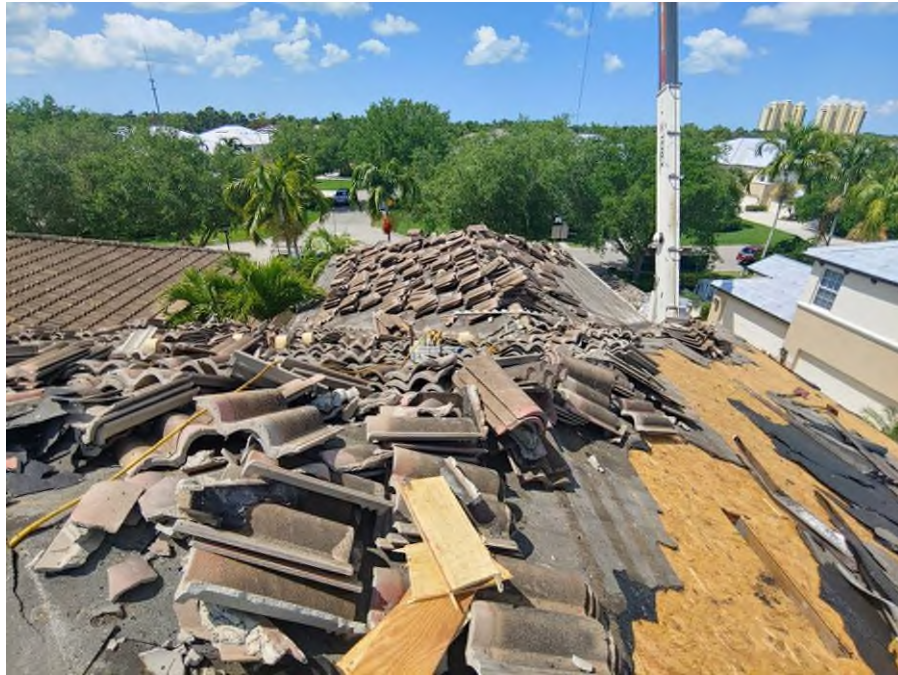
Photograph #1: Roof tile removal was in progress on building 21791.

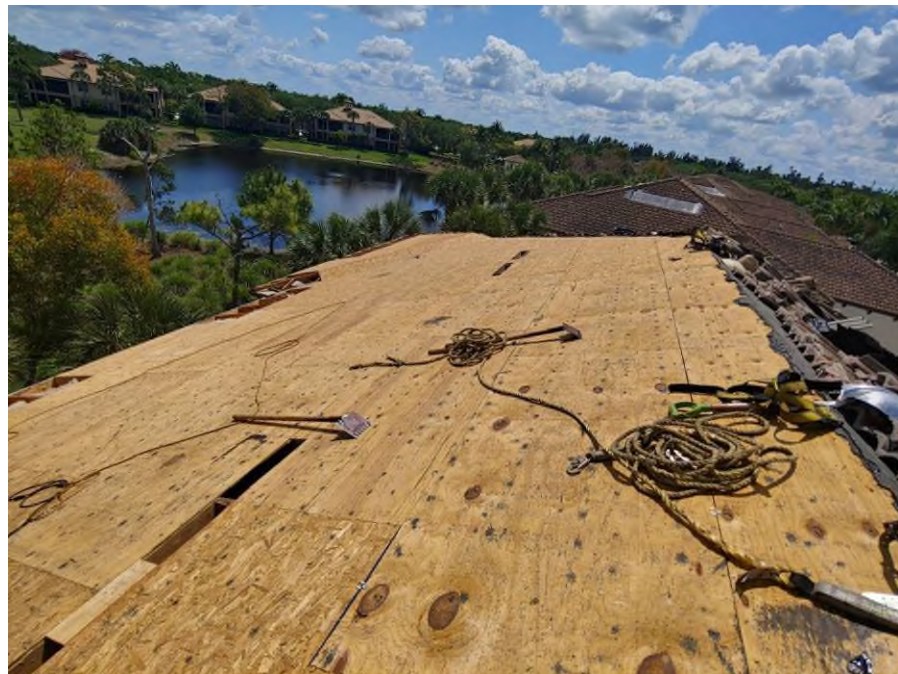
Photograph #2: Roof tile removal was in progress on building 21791.

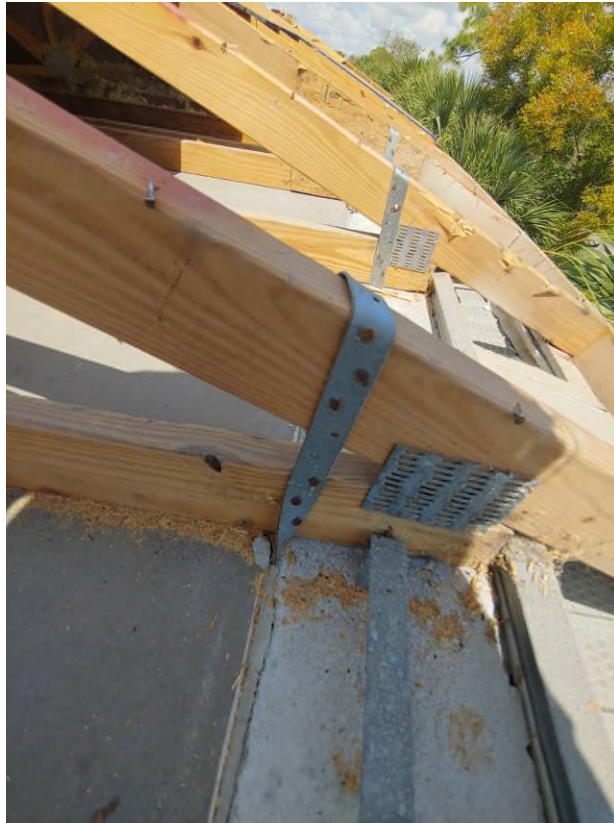
Photograph #3: Existing strap clips on the trusses have the required minimum of 5 nails on building 21791.

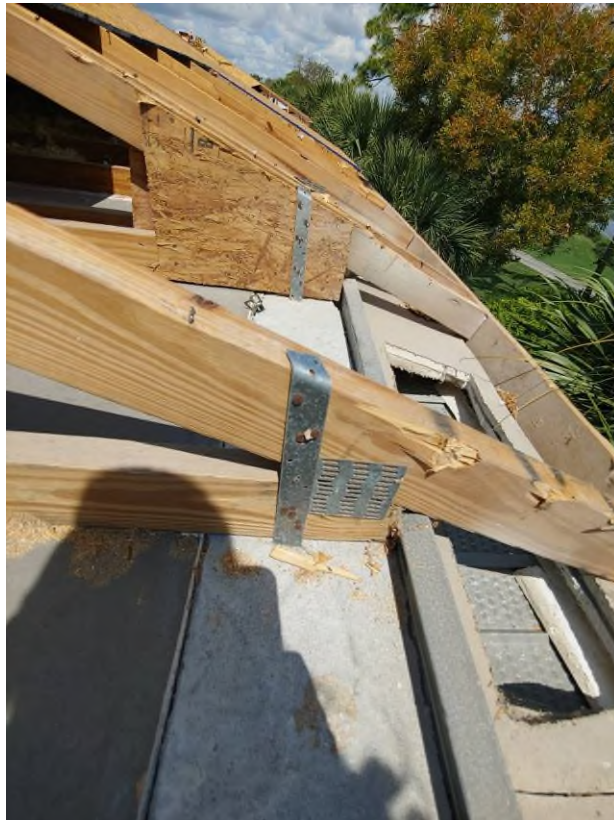
Photograph #4: Existing strap clips on the trusses have the required minimum of 5 nails on building 21791.

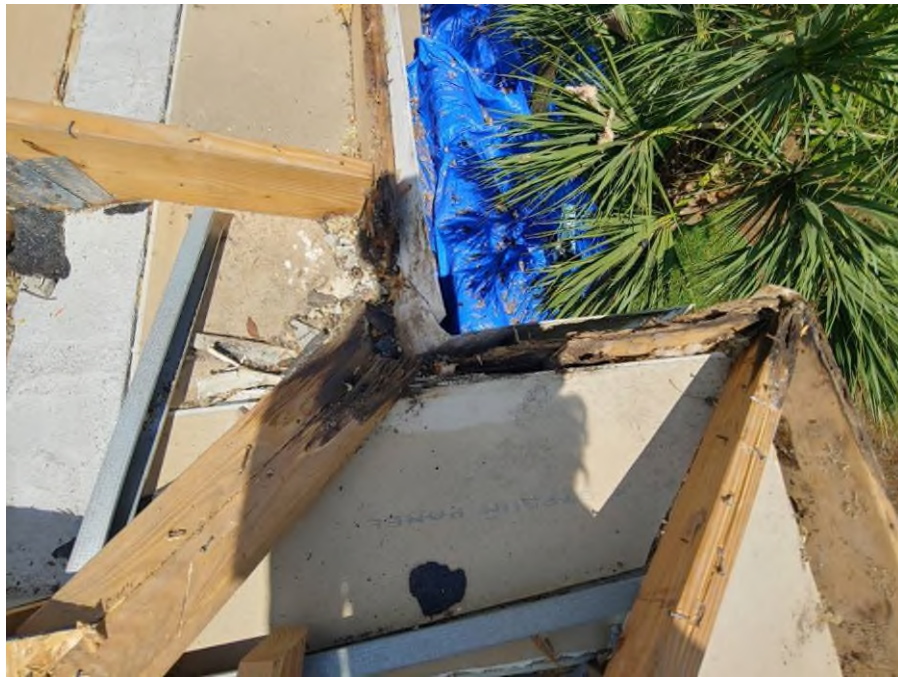
Photograph #5: Rotten fascia, truss and plywood sheathing were observed on building 21791.

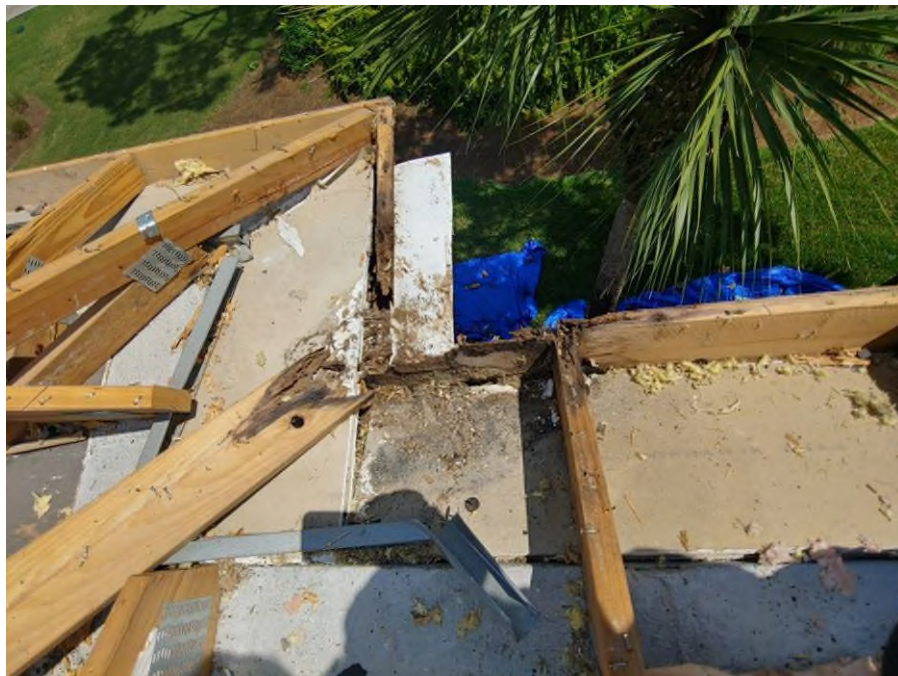
Photograph #6: Rotten fascia, truss and plywood sheathing were observed on building 21791.

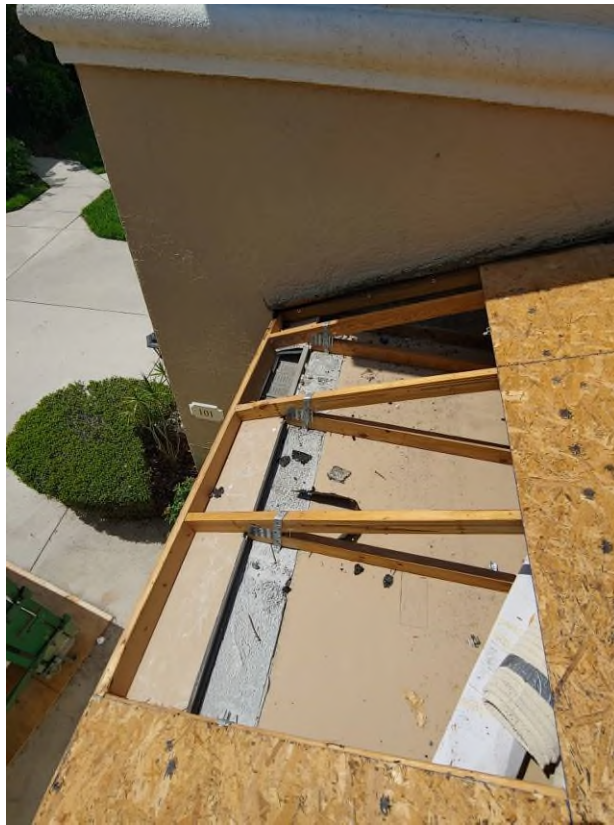
Photograph #7: Existing strap clips on the trusses have the required minimum of 5 nails on building 21830.

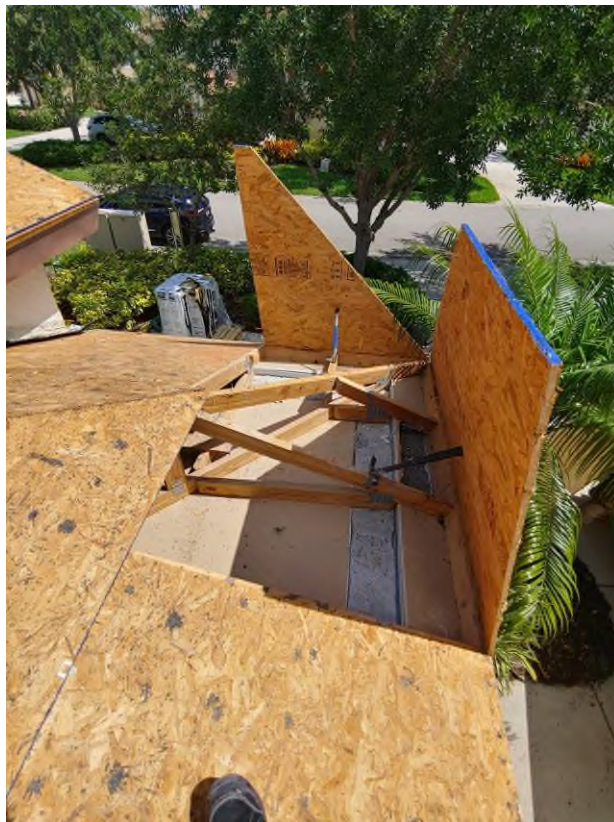
Photograph #8: Existing strap clips on the trusses have the required minimum of 5 nails on building 21830.

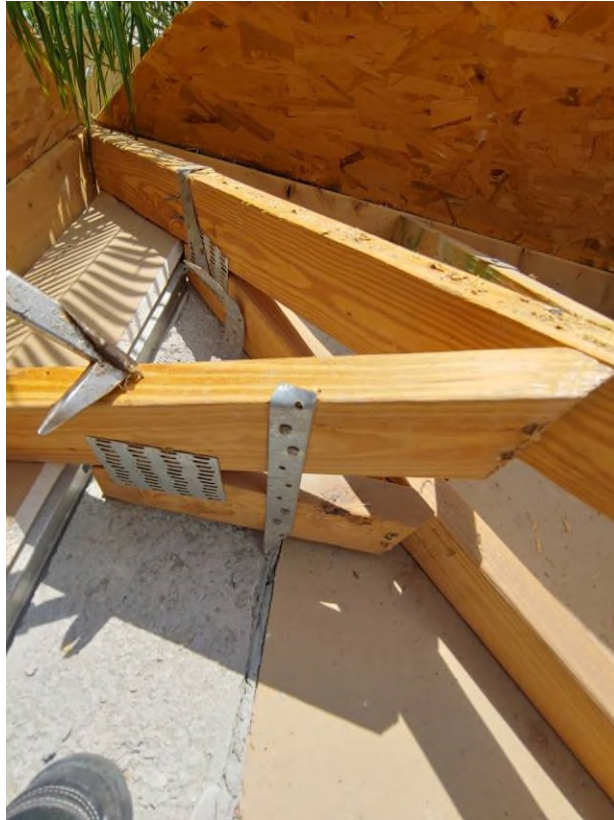
Photograph #9: Existing strap clips on the trusses have the required minimum of 5 nails on building 21830.

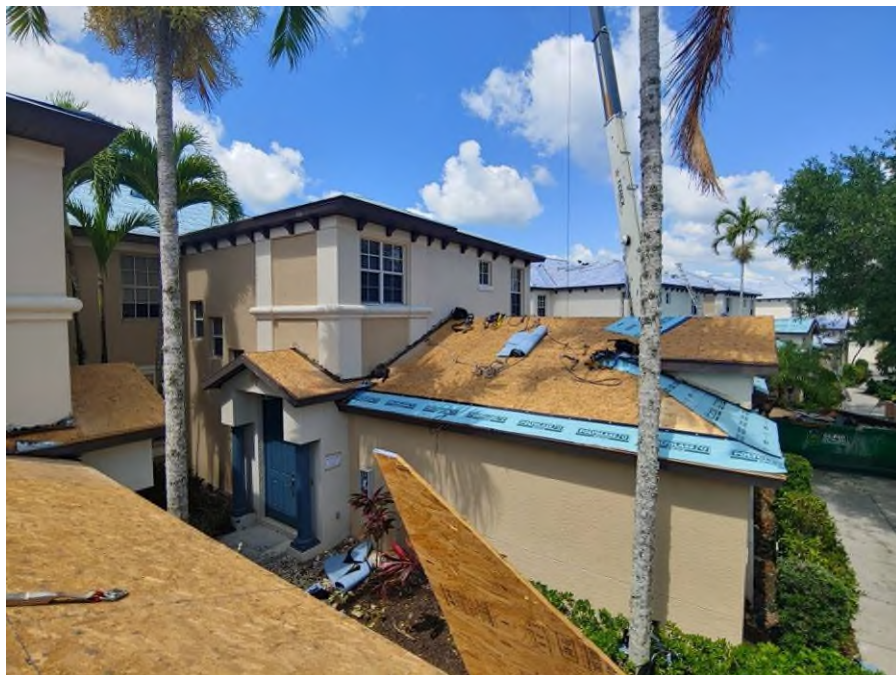
Photograph #10: Polystick MTS Plus underlayment installation was in progress on building 21830.
