Uniform Mitigation Verification Inspection Form

Maintain a copy of this form and any documentation provided with the insurance policy

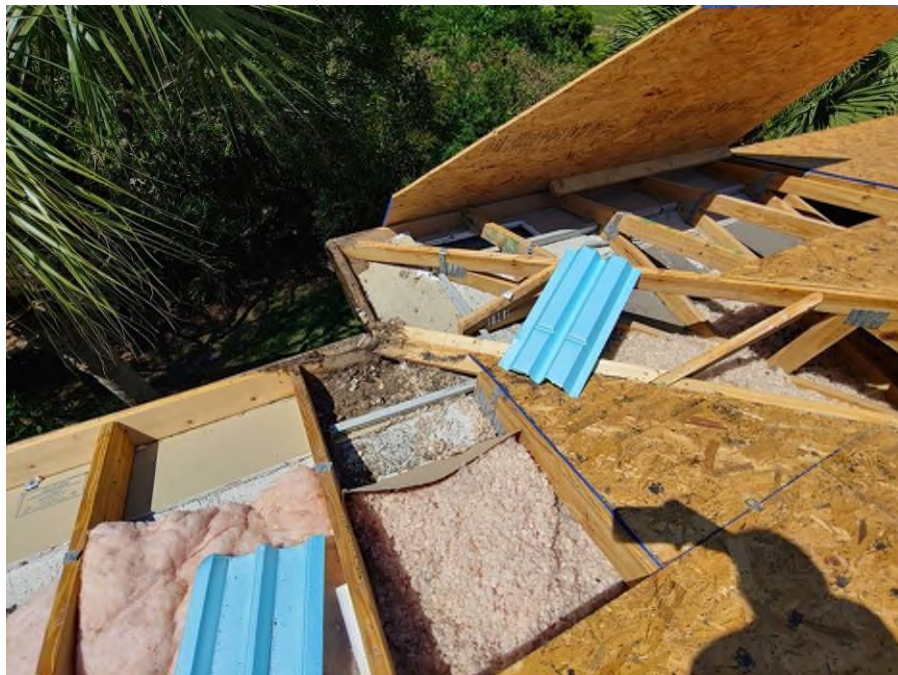
Photograph #10: Rotten fascia, truss and plywood sheathing were observed on building 21830.
