# Uniform Mitigation Verification Inspection Form

Inspection Date: 6-2-2020		
<b>Owner Information</b>		
Owner Name: Palmetto Dunes Pelican Sound Condominium Association Inc.		Contact Person:
Address: 21800 Palmetto Dunes Drive Units 101,102,201,202		Home Phone:
City: Estero	Zip: 33928	Work Phone:
County: Lee		Cell Phone:
Insurance Company:		Policy #:
Year of Home: 2001	# of Stories: 2	Email:

DATE	April 22, 2020	JOB NO.	20RN-0085
Palmetto Dunes CAI – Roofing Project			
LOCATION	Palmetto Dunes Drive		
CONTRACTOR	EnviroStruct, LLC	Palmetto Dunes CAI	
WEATHER	Sunny	TEMP.	Time
		85° F	12:30PM
PRESENT AT SITE	Rahmin Bahar, EnviroStruct (ES) Teresita Nazario-Acosta, Karins Engineering Group (KEG)

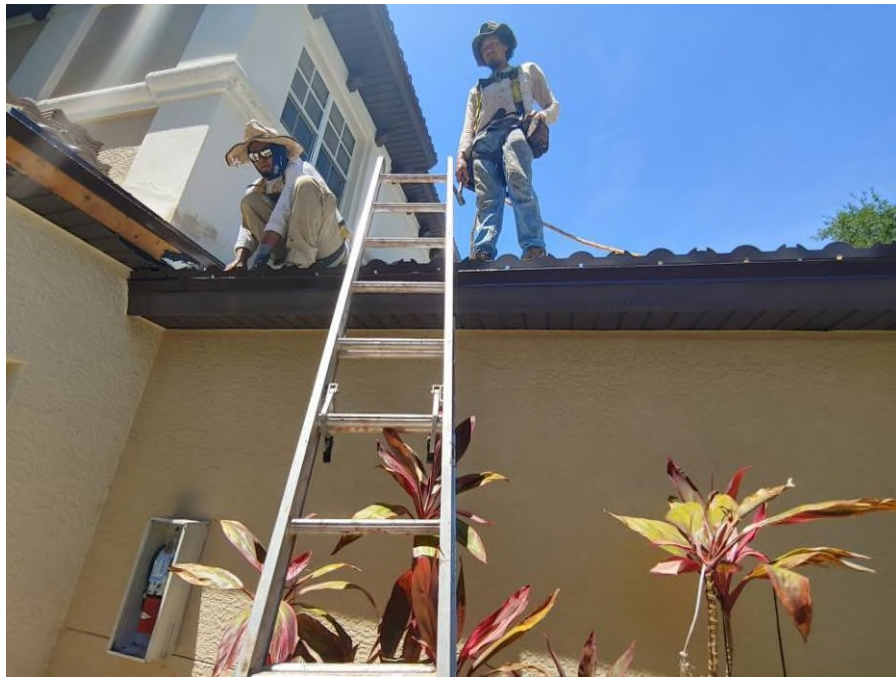
**Photograph #1: Bird-stop metal flashing installation was in progress on building 21800.**

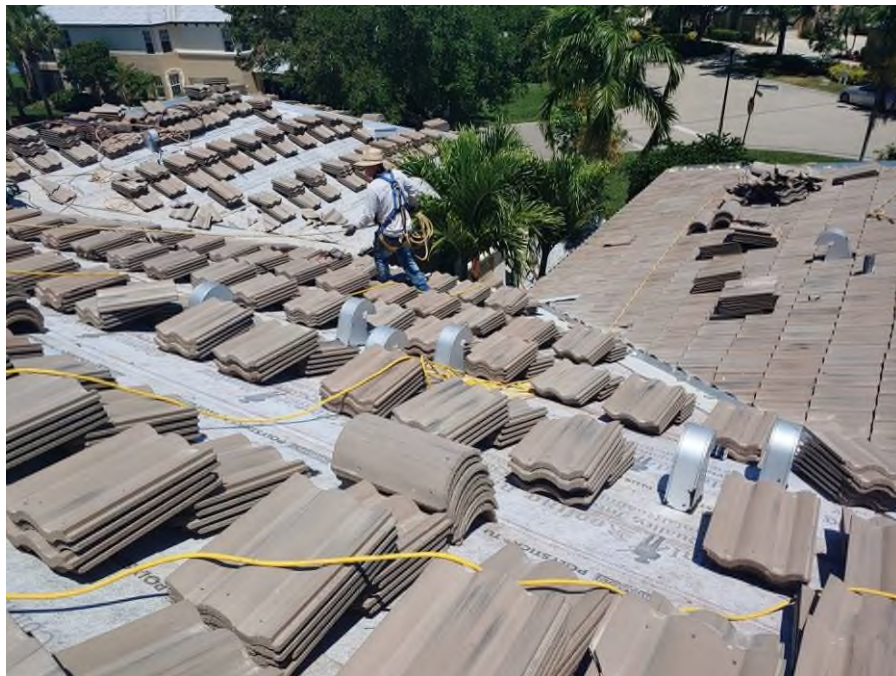
**Photograph #2: Roof field tile installation with polyurethane foam adhesive was in progress on building 21800.**

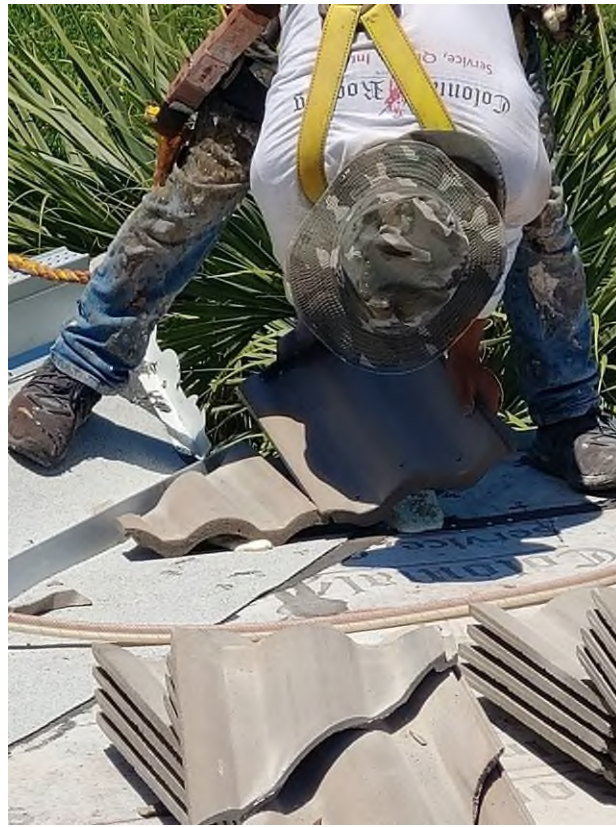
**Photograph #3: Roof field tile installation with polyurethane foam adhesive was in progress on building 21800.**

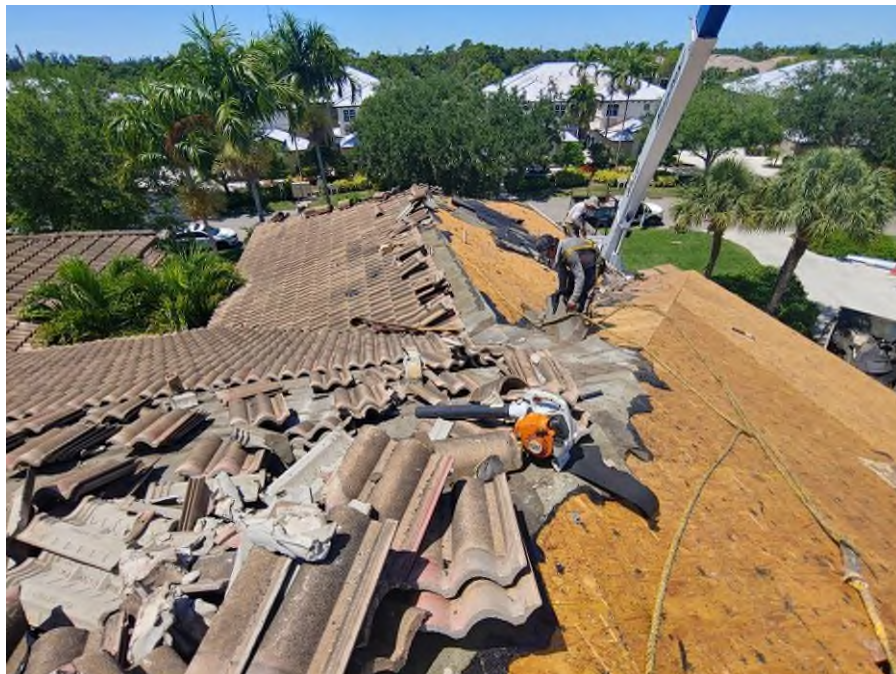
**Photograph #4: Roof tile removal was in progress on building 21831.**

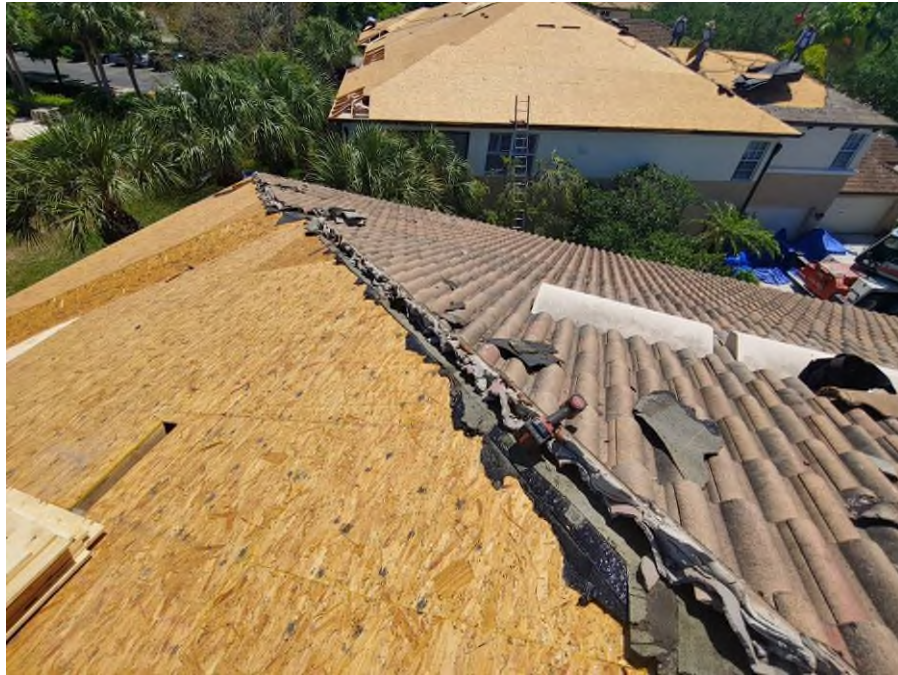
**Photograph #5: Roof tile removal was in progress on building 21831.**

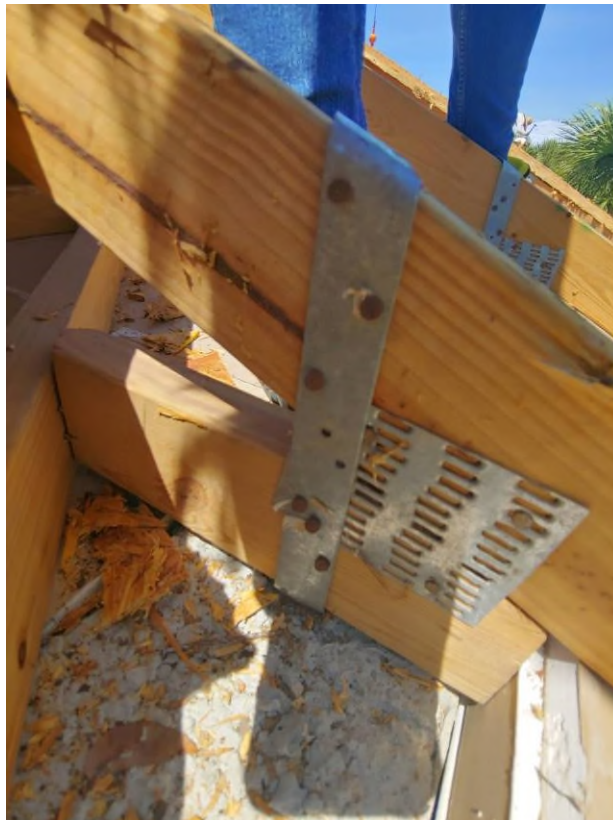
**Photograph #6: Existing strap clips on the trusses have the required minimum of 5 nails on building 21831.**

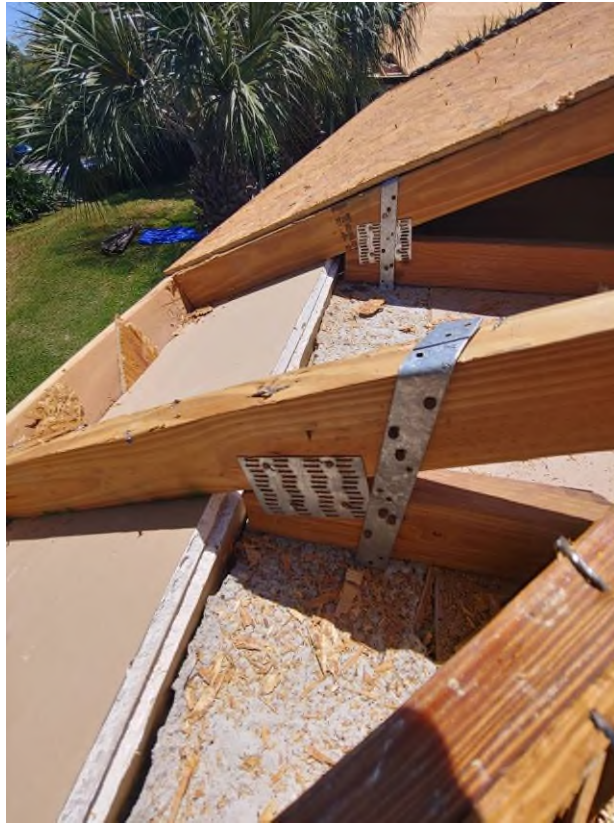
**Photograph #7: Existing strap clips on the trusses have the required minimum of 5 nails on building 21831.**

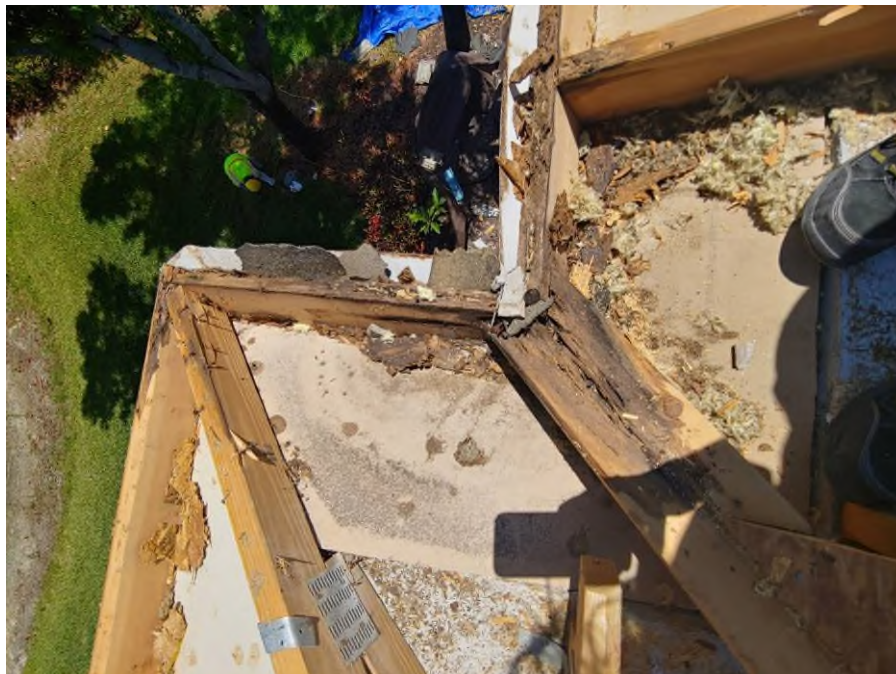
**Photograph #8: Rotten fascia and truss were observed on building 21831.**

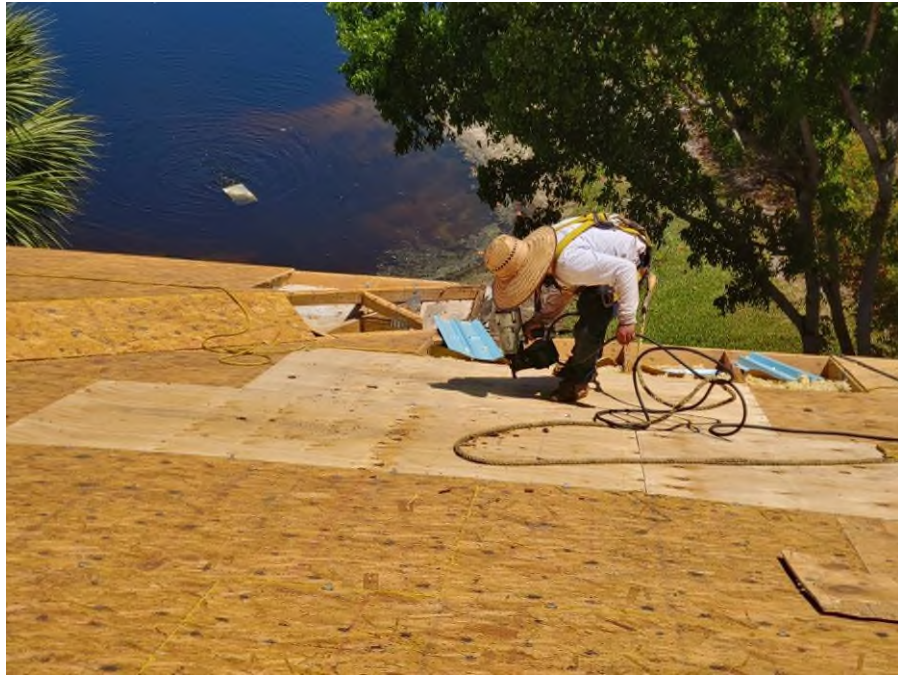
**Photograph #9: Re-nail pattern at the plywood sheathing was in progress on building 21831.**

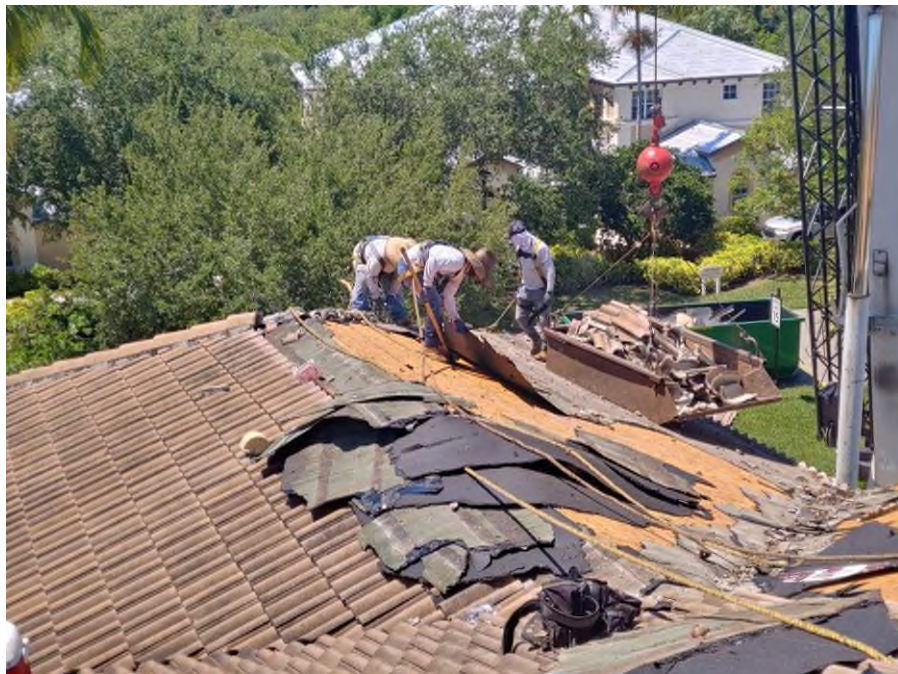
**Photograph #10: Roof tile removal was in progress on building 21841.**

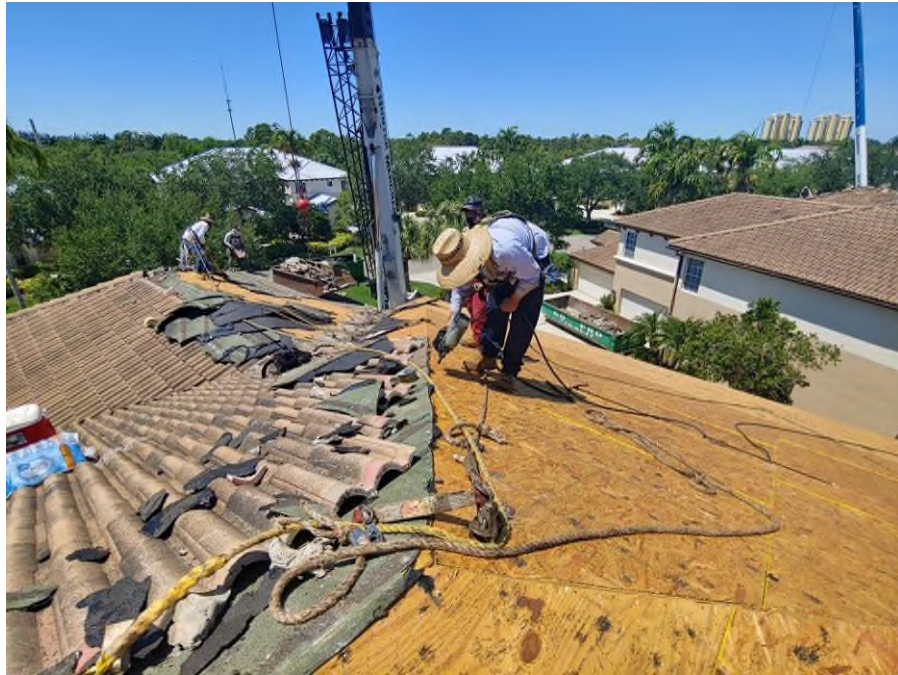
**Photograph #11: Re-nail pattern at the plywood sheathing was in progress on building 21841.**

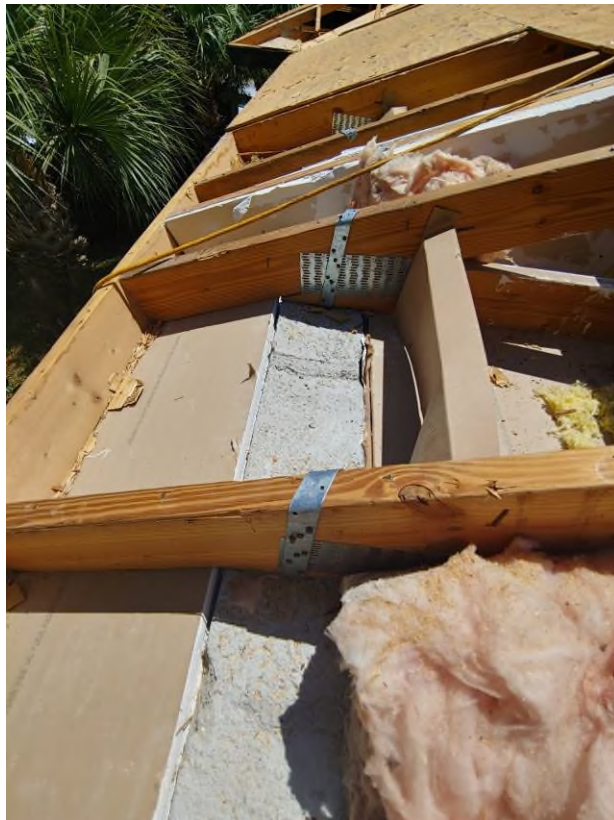
**Photograph #12: Existing strap clips on the trusses have the required minimum of 5 nails on building 21841.**

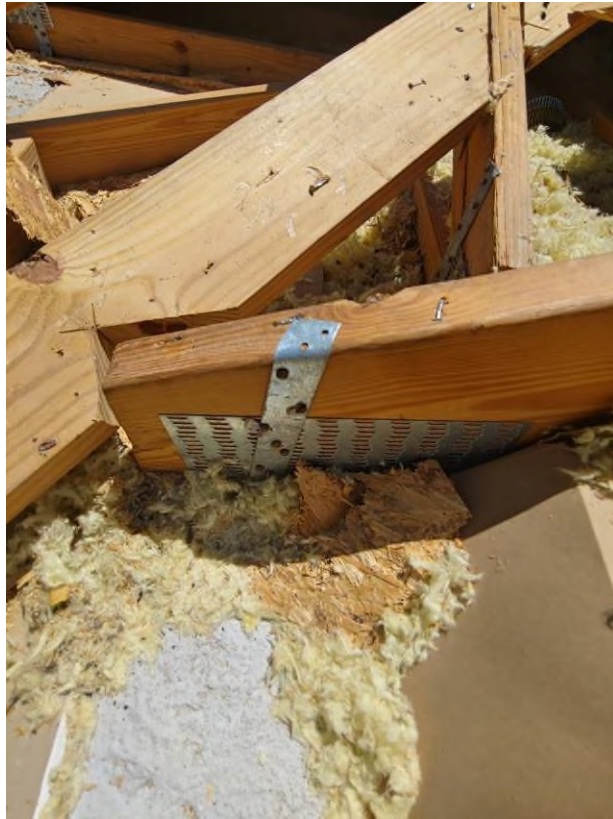
**Photograph #13: Existing strap clips on the trusses have the required minimum of 5 nails on building 21841.**

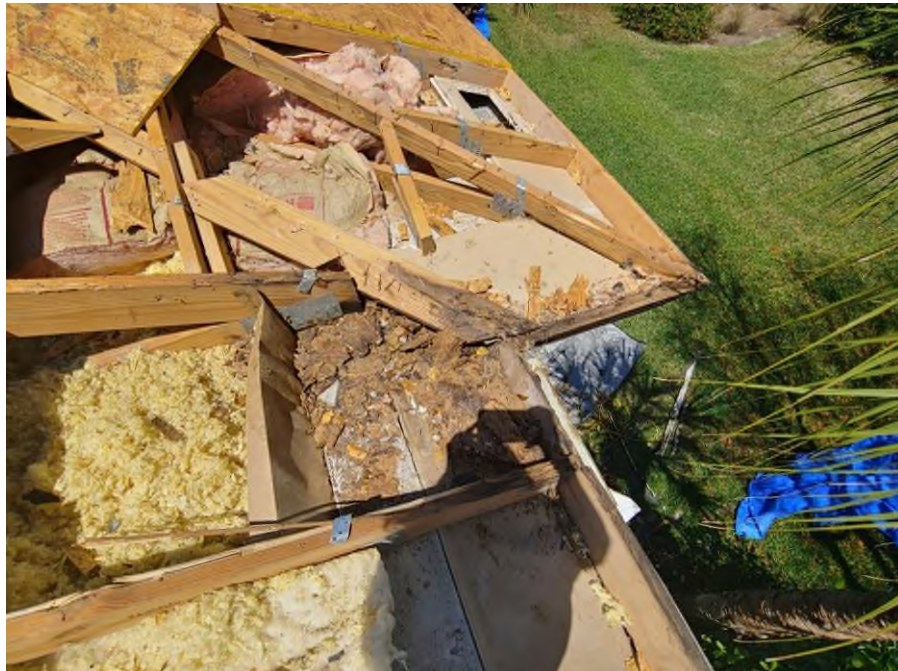
**Photograph #14: Rotten fascia and truss were observed on building 21841.**

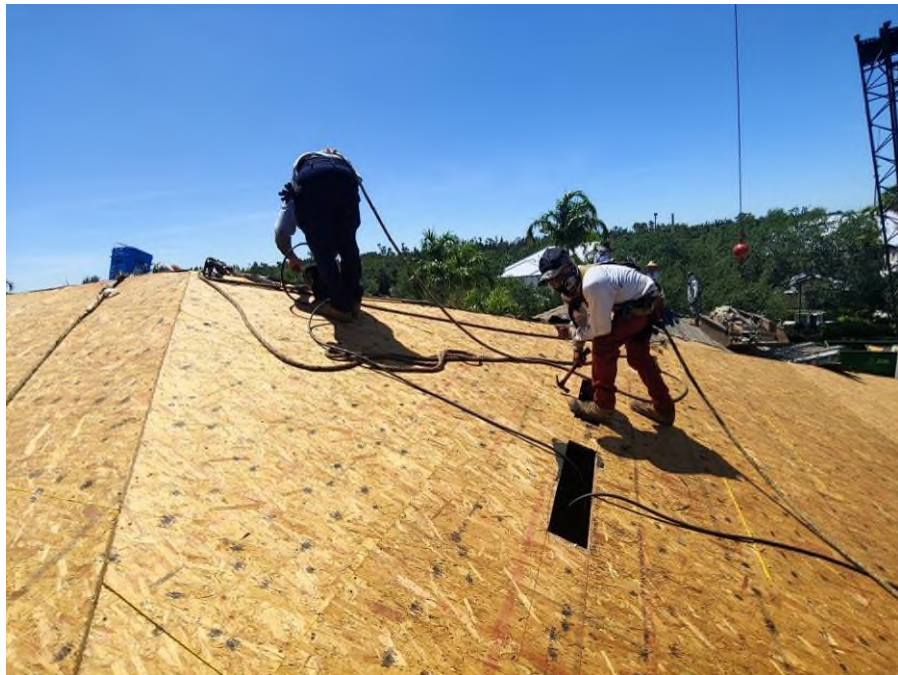
**Photograph #15: Re-nail pattern at the plywood sheathing was in progress on building 21841.**

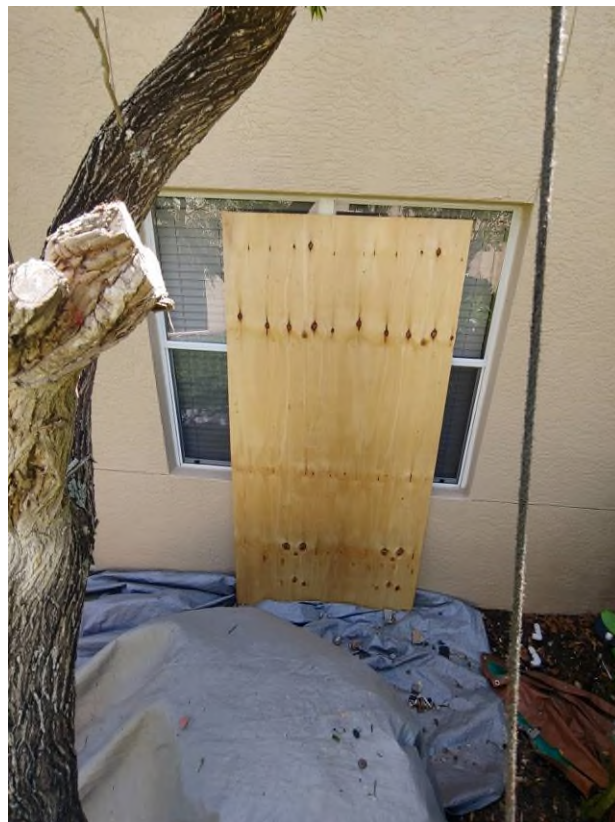
**Photograph #16: Window protection installation was observed on building 21841.**

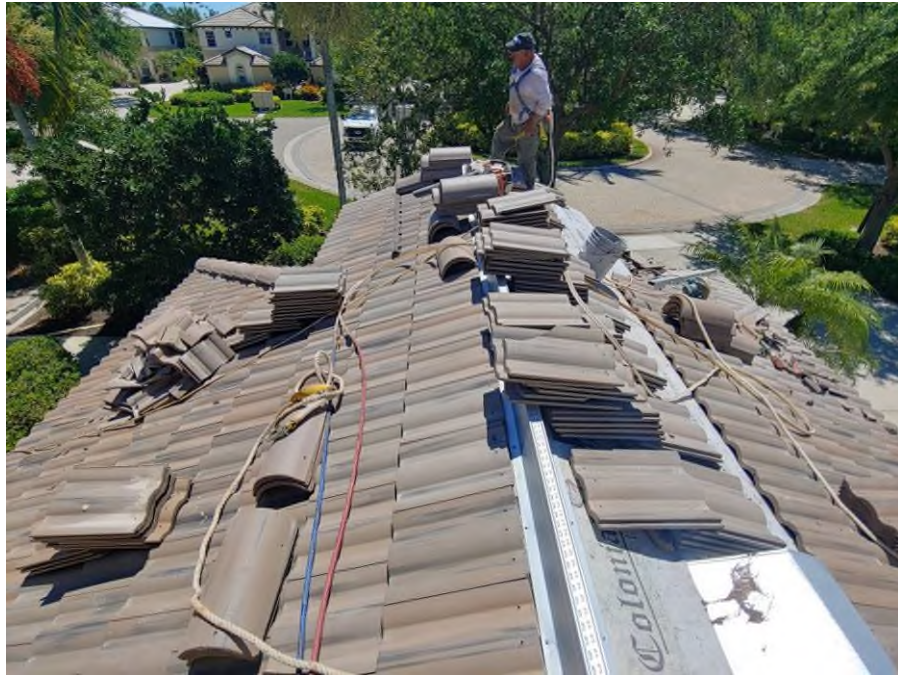
**Photograph #1: Roof field, ridge and hip tile installations with polyurethane foam adhesive were in progress on building 7851.**

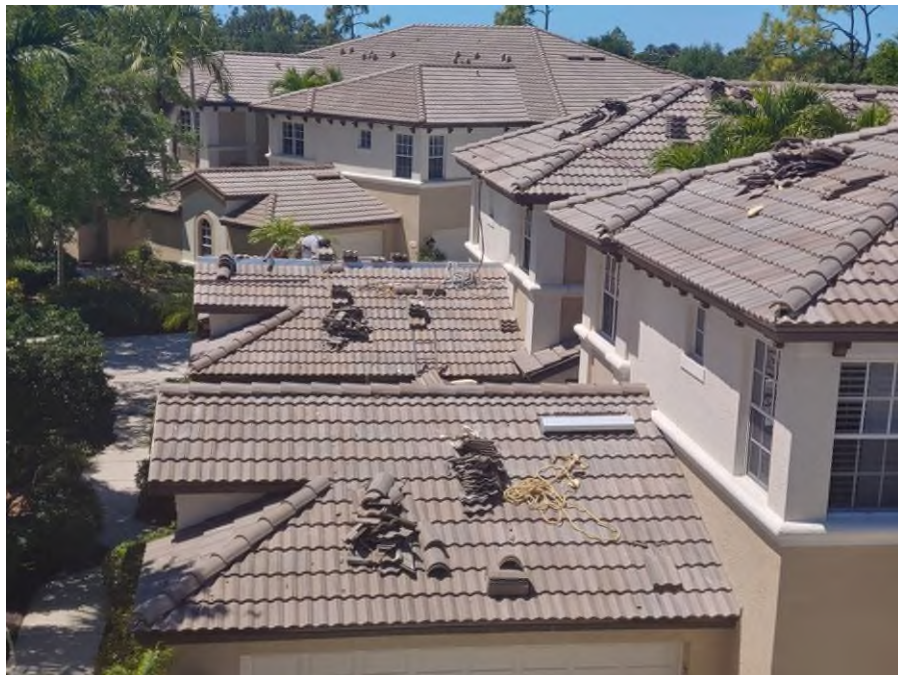
**Photograph #2: Roof field, ridge and hip tile installations with polyurethane foam adhesive were in progress on building 7851.**

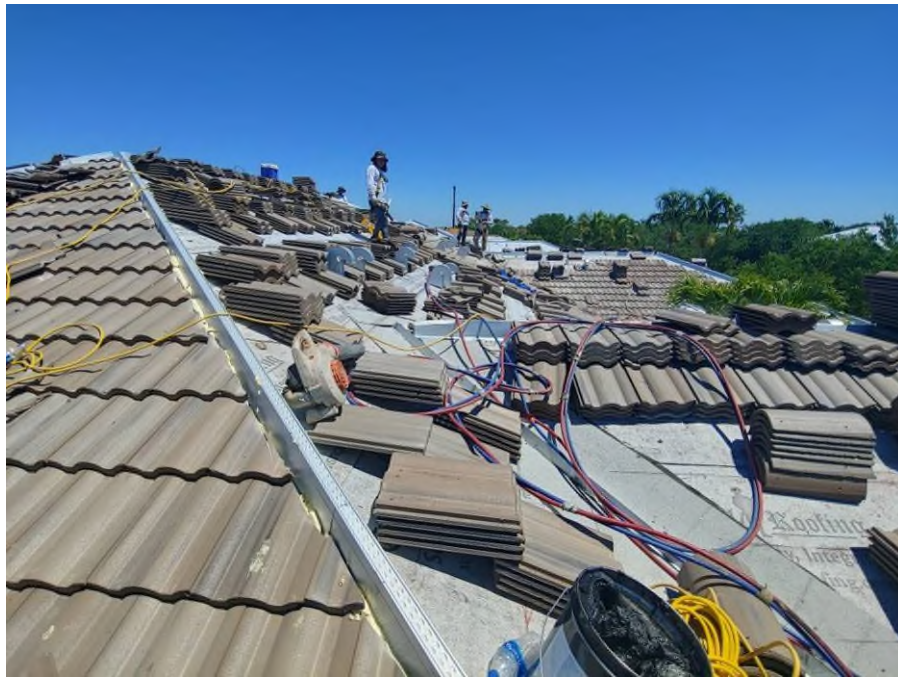
**Photograph #3: Roof field, ridge and hip tile installations with polyurethane foam adhesive were in progress on building 7861.**

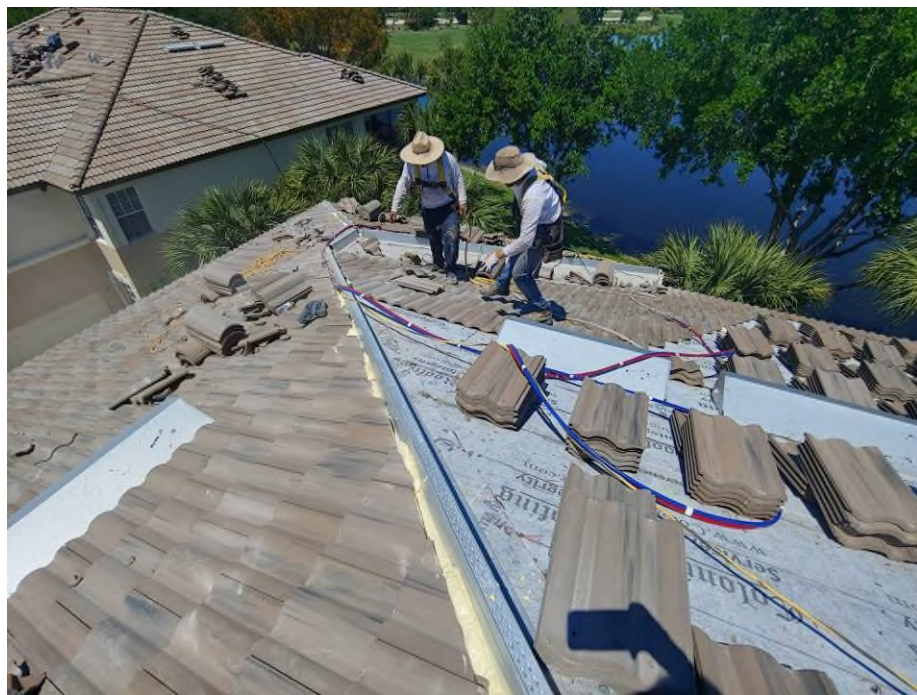
**Photograph #4: Roof field, ridge and hip tile installations with polyurethane foam adhesive were in progress on building 7861.**

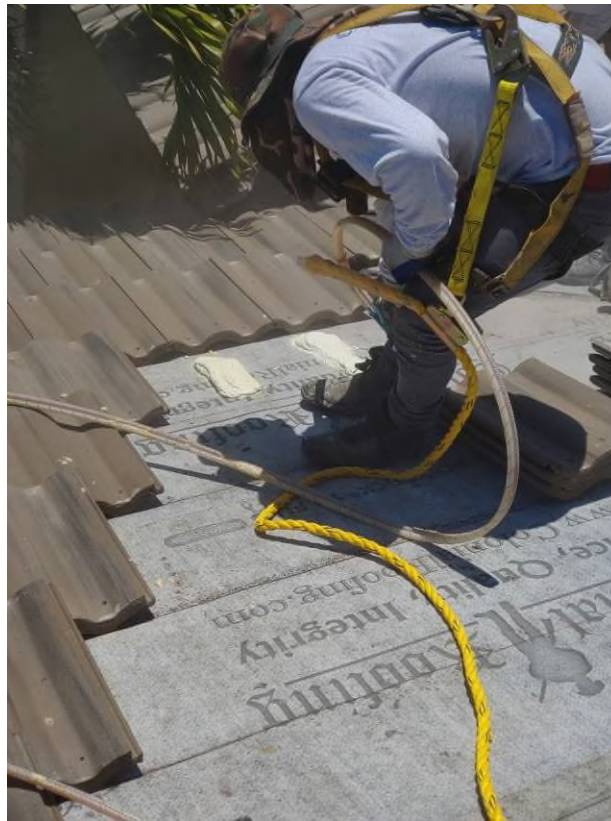
**Photograph #5: Roof field, ridge and hip tile installations with polyurethane foam adhesive were in progress on building 7861.**

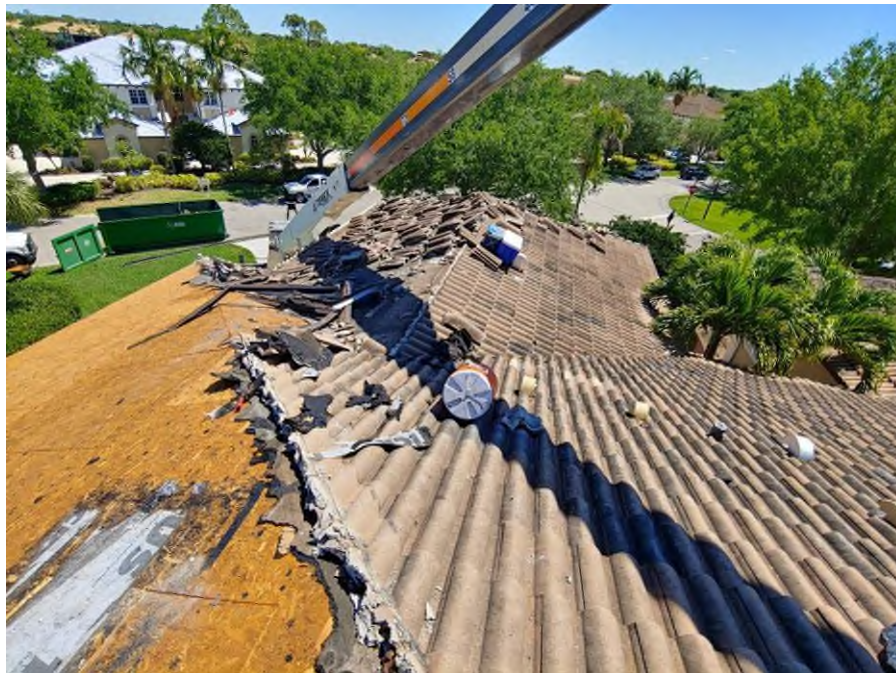
**Photograph #6: Roof tile removal was in progress on building 21780.**

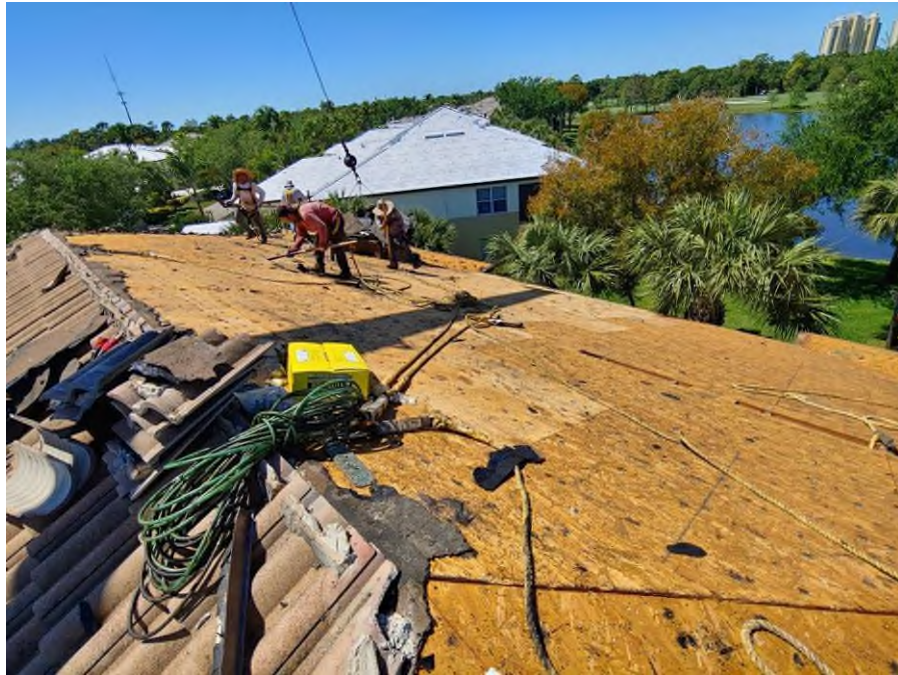
**Photograph #7: Roof tile removal was in progress on building 21780.**

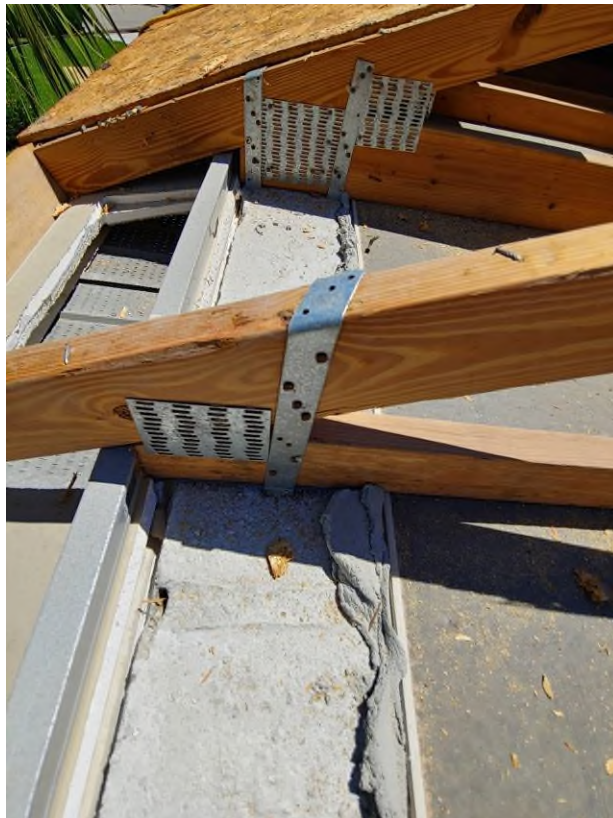
**Photograph #8: Existing strap clips on the trusses have the required minimum of 5 nails on building 21780.**

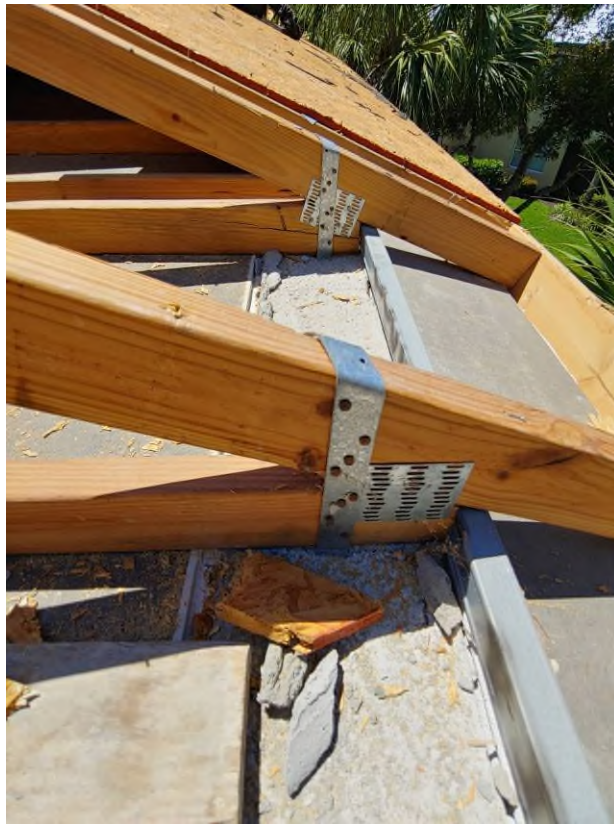
**Photograph #9: Existing strap clips on the trusses have the required minimum of 5 nails on building 21780.**

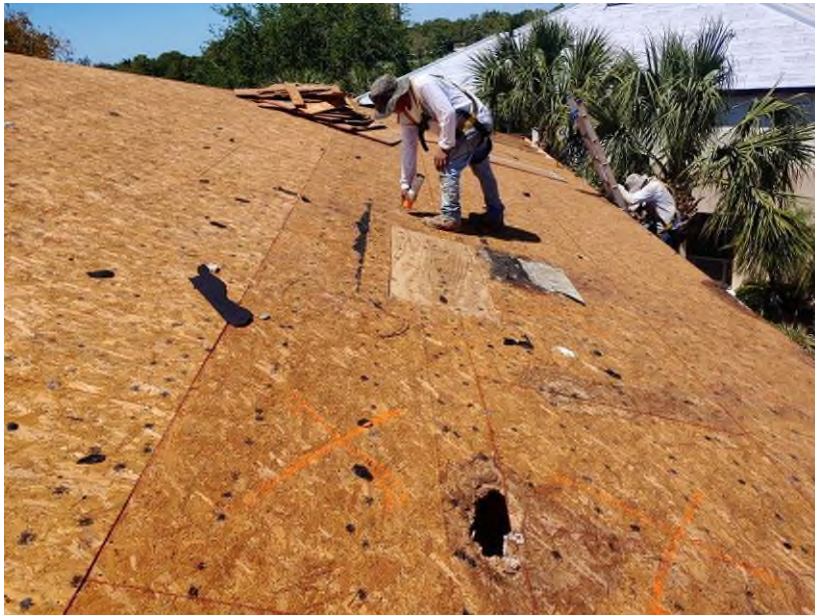
**Photograph #10: Rotten fascia, truss and plywood sheathing were observed and marked for replacement on building 21780.**

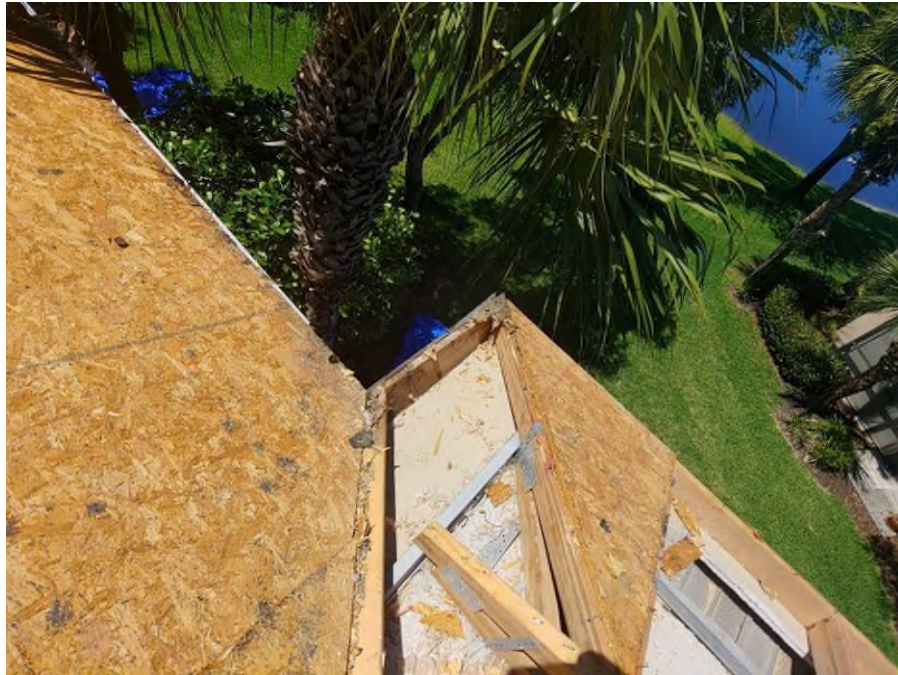
**Photograph #11: Rotten fascia, truss and plywood sheathing were observed and marked for replacement on building 21780.**

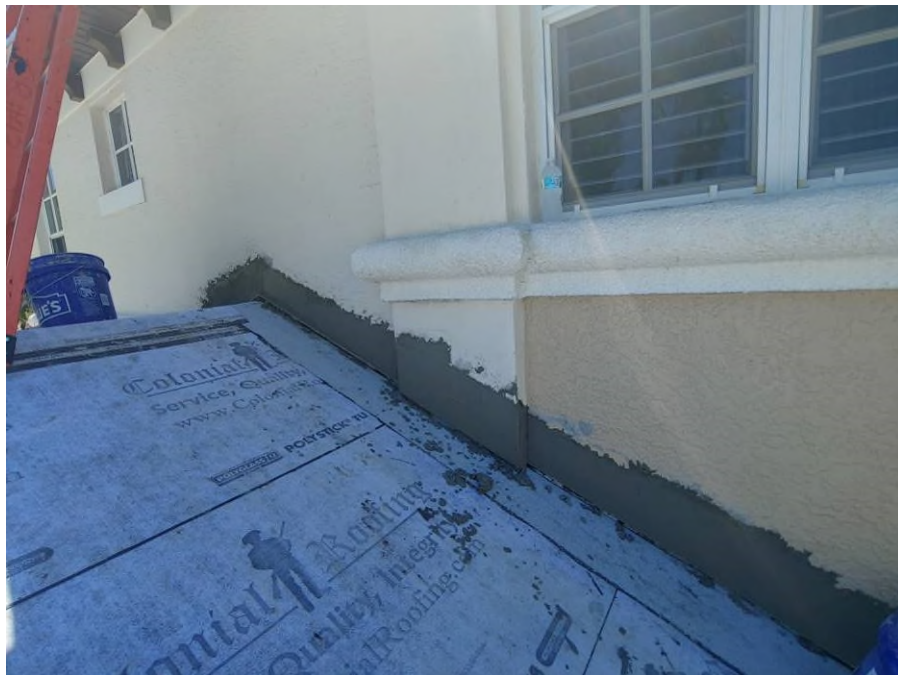
**Photograph #12: Stucco application was in progress at the bottom of the wall and columns on building 21800.**

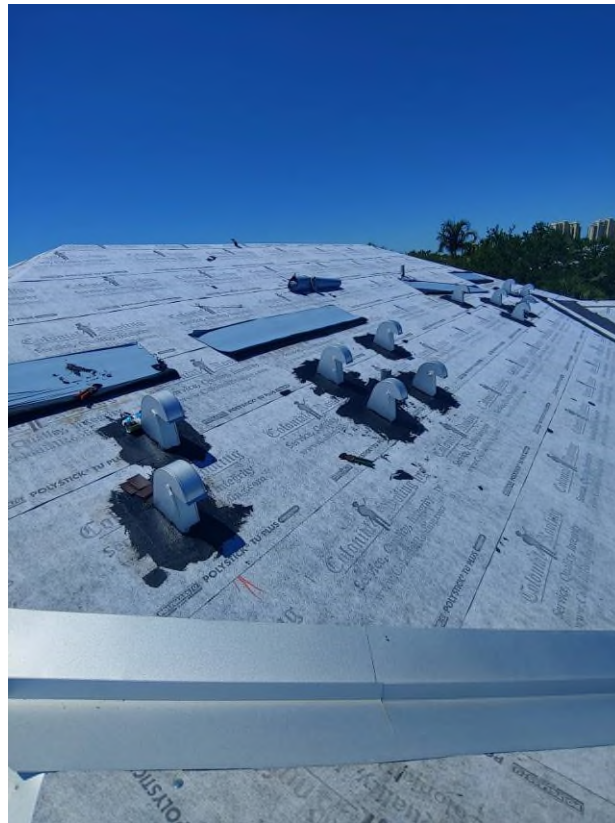
**Photograph #13: Asphalt plastic roofing cement application surrounding the exhaust vents and v-crimp metal valley flashing was in progress on building 21800.**

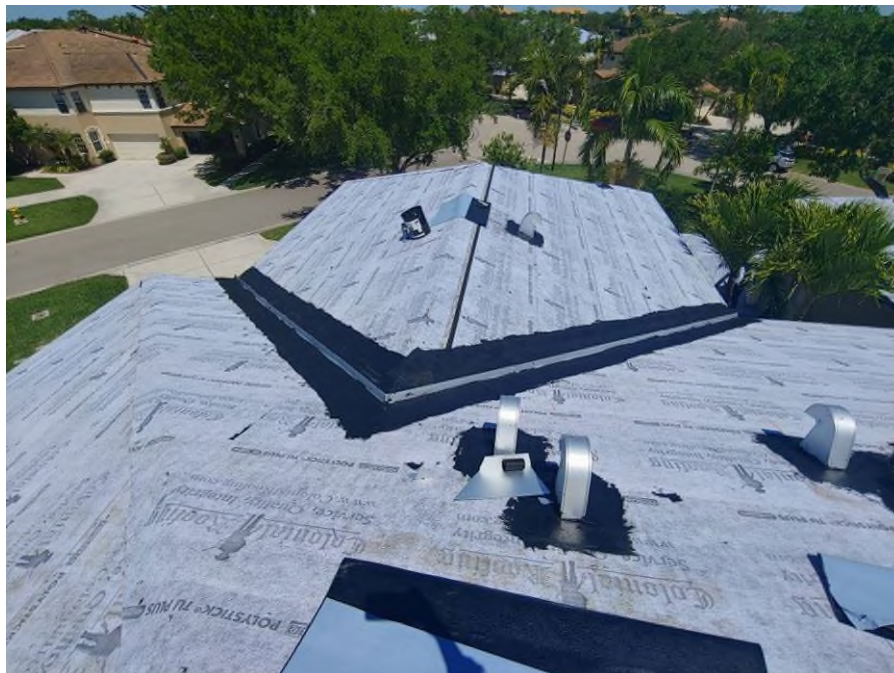
**Photograph #14: Asphalt plastic roofing cement application surrounding the exhaust vents and v-crimp metal valley flashing was in progress on building 21800.**

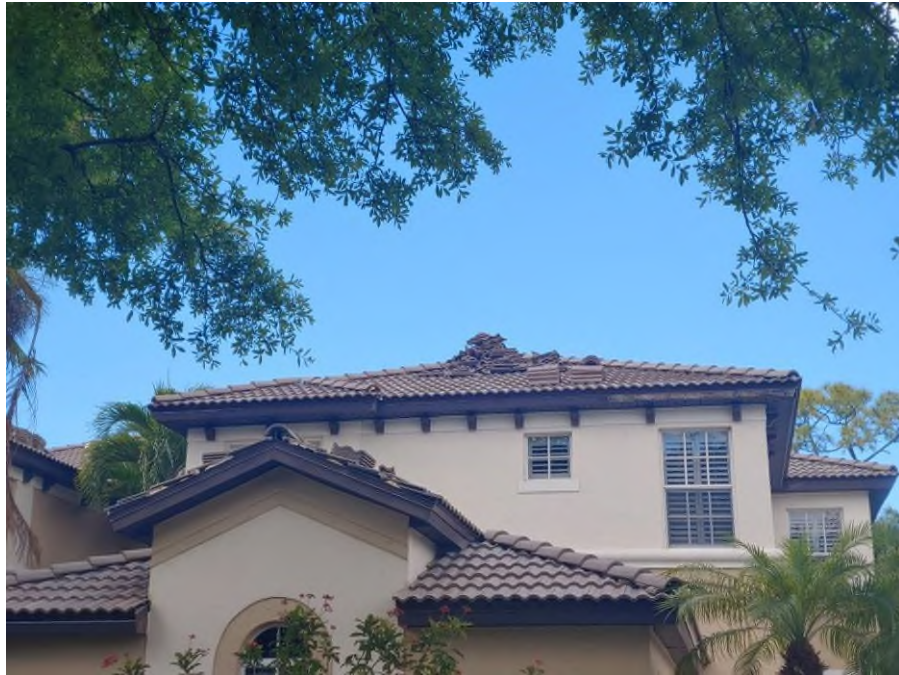
**Photograph #1: Roof tile installations were in progress on building 7841.**

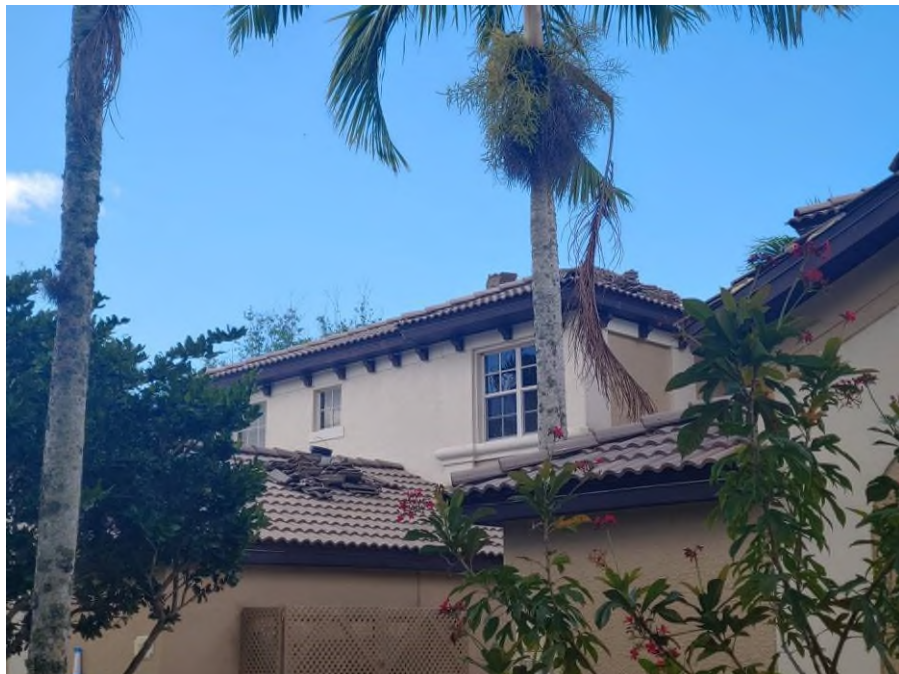
**Photograph #2: Roof tile installations were in progress on building 7841.**

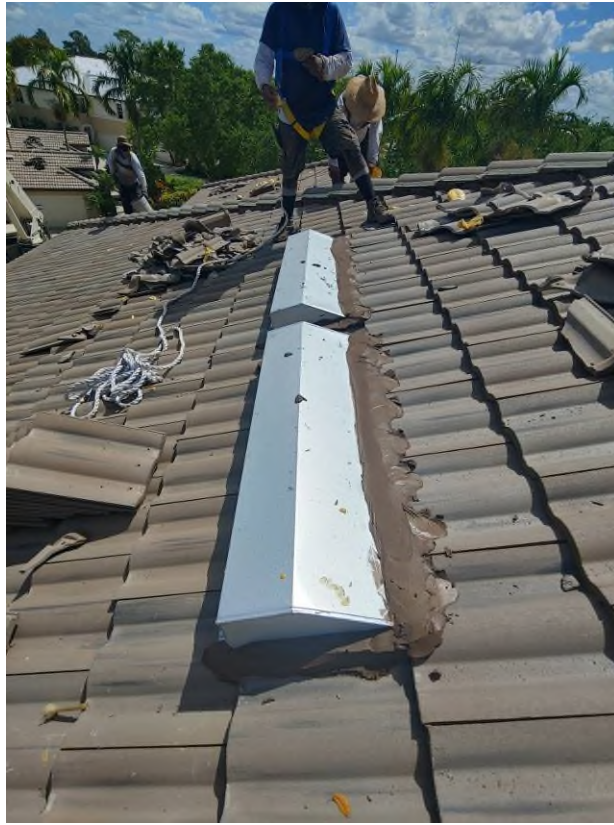
**Photograph #3: Mortar adhesive application was in progress surrounding the exhaust vents on building 21700.**

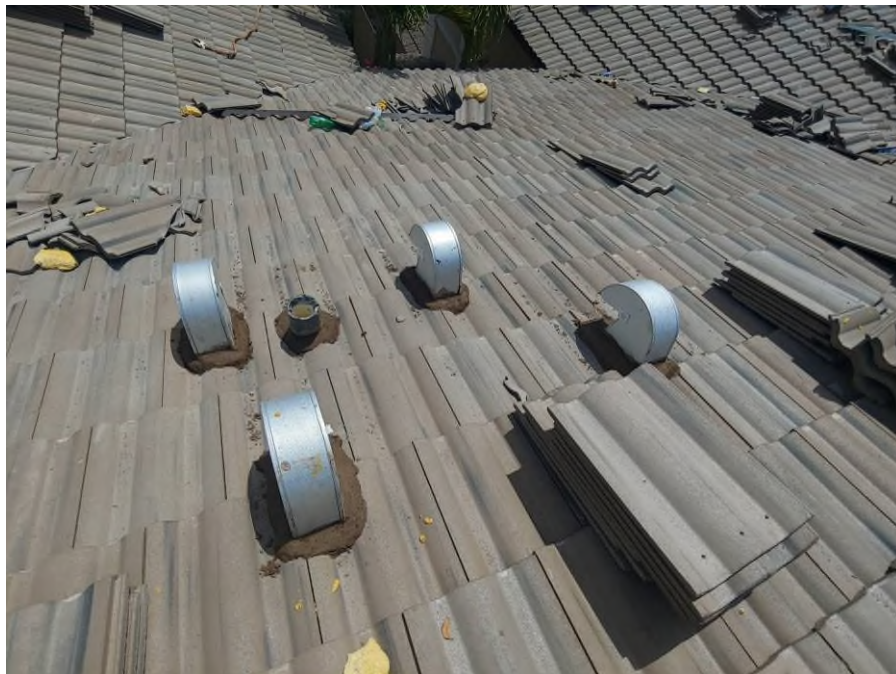
**Photograph #4: Mortar adhesive application was in progress surrounding the exhaust vents and pipes on building 21700.**

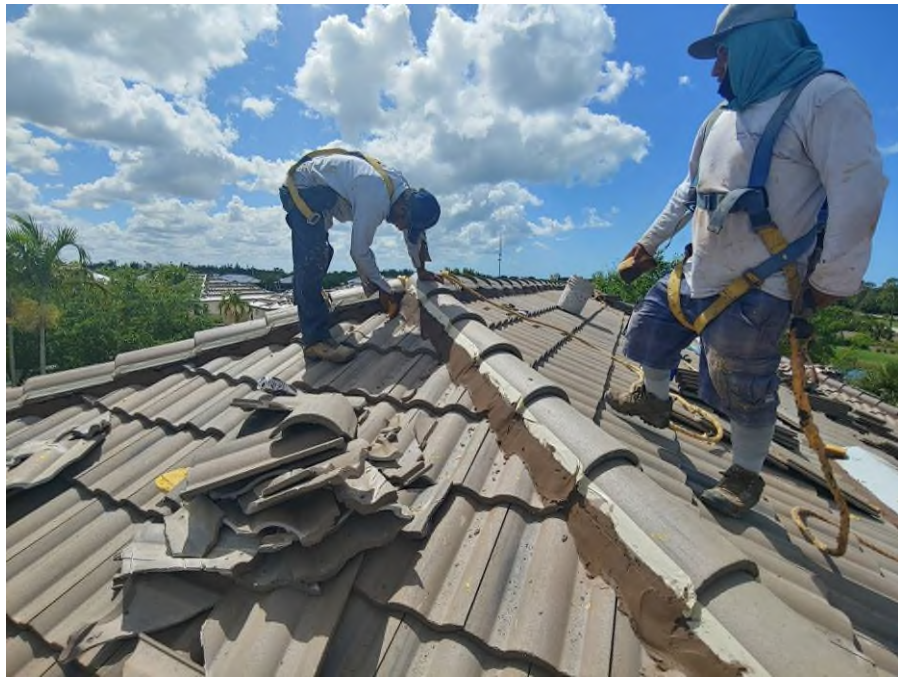
**Photograph #5: Mortar adhesive application was in progress surrounding the hip and ridge tiles on building 21700.**

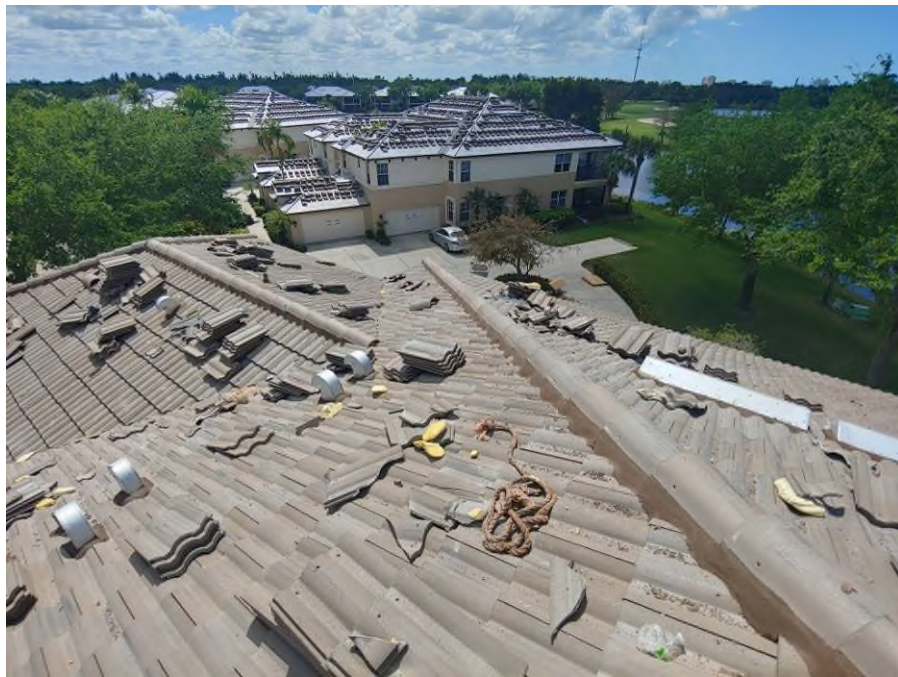
**Photograph #6: Mortar adhesive application was in progress surrounding the hip and ridge tiles on building 21700.**

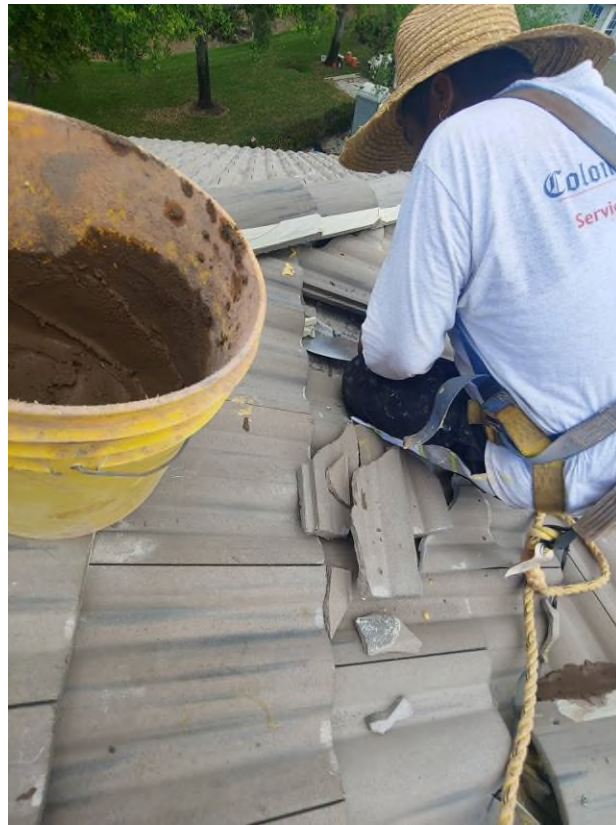
**Photograph #7: Broken field tile replacement was in progress on building 21700.**

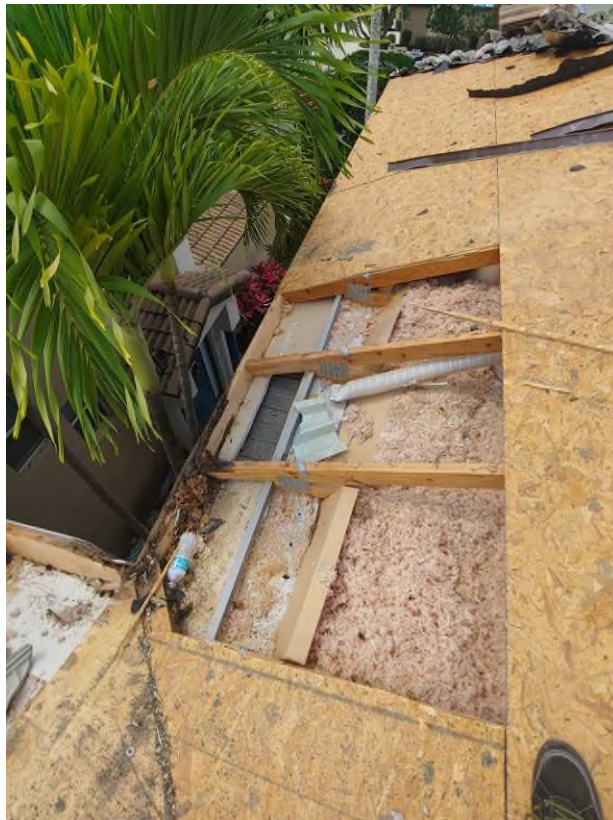
**Photograph #10: Existing strap clips on the trusses have the required minimum quantity of nails on building 21771.**
