# Uniform Mitigation Verification Inspection Form

Inspection Date: 6-2-2020		
<b>Owner Information</b>		
Owner Name: Palmetto Dunes Pelican Sound Condominium Association Inc.		Contact Person:
Address: 21800 Palmetto Dunes Drive Units 101,102,201,202		Home Phone:
City: Estero	Zip: 33928	Work Phone:
County: Lee		Cell Phone:
Insurance Company:		Policy #:
Year of Home: 2001	# of Stories: 2	Email:

DATE	April 22, 2020	JOB NO.	20RN-0085
Palmetto Dunes CAI – Roofing Project			
LOCATION	Palmetto Dunes Drive		
CONTRACTOR	EnviroStruct, LLC	Palmetto Dunes CAI	
WEATHER	Sunny	TEMP.	Time
		85° F	12:30PM
PRESENT AT SITE	Rahmin Bahar, EnviroStruct (ES) Teresita Nazario-Acosta, Karins Engineering Group (KEG)

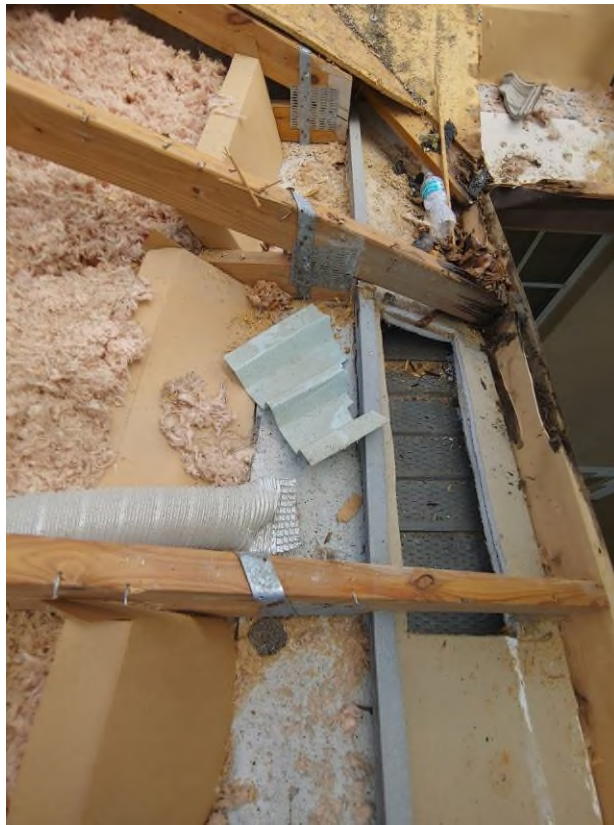
**Photograph #11: Existing strap clips on the trusses have the required minimum quantity of nails on building 21771.**

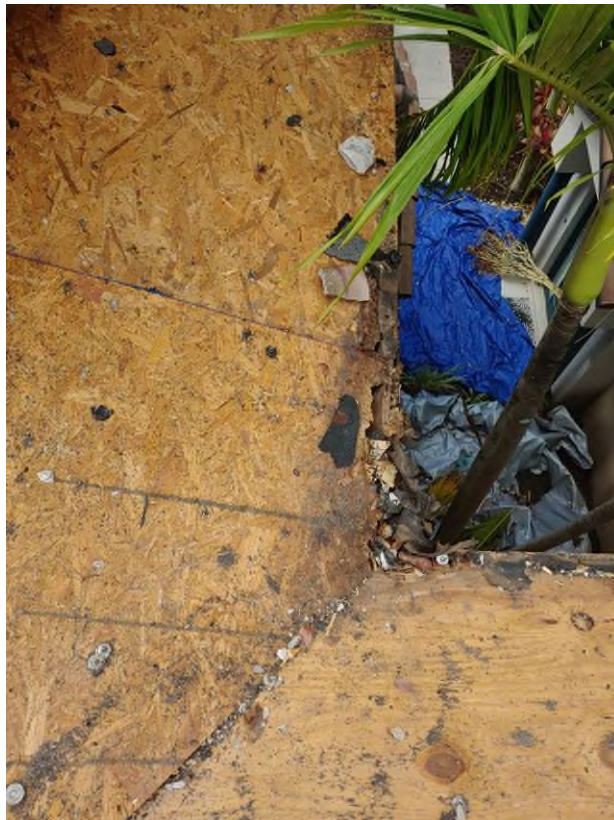
**Photograph #12: Rotten fascia, truss and plywood sheathing were observed on building 21771.**

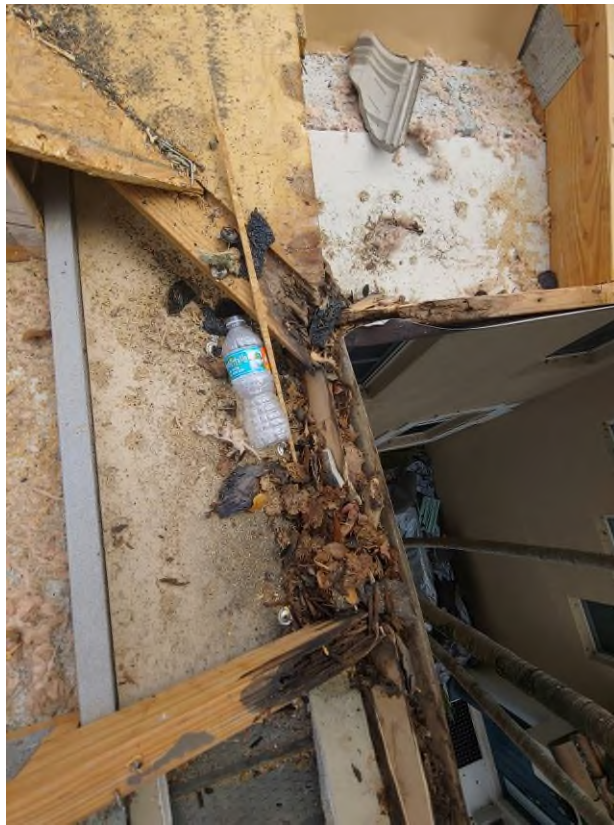
**Photograph #13: Rotten fascia, truss and plywood sheathing were observed on building 21771.**

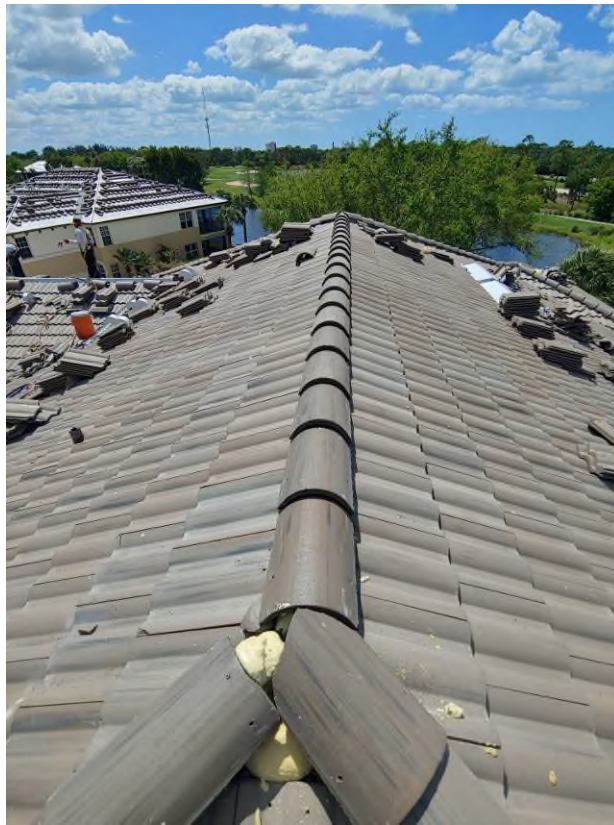
**Photograph #1: Roof field, ridge and hip tile installations with polyurethane foam adhesive were in progress on building 21700.**

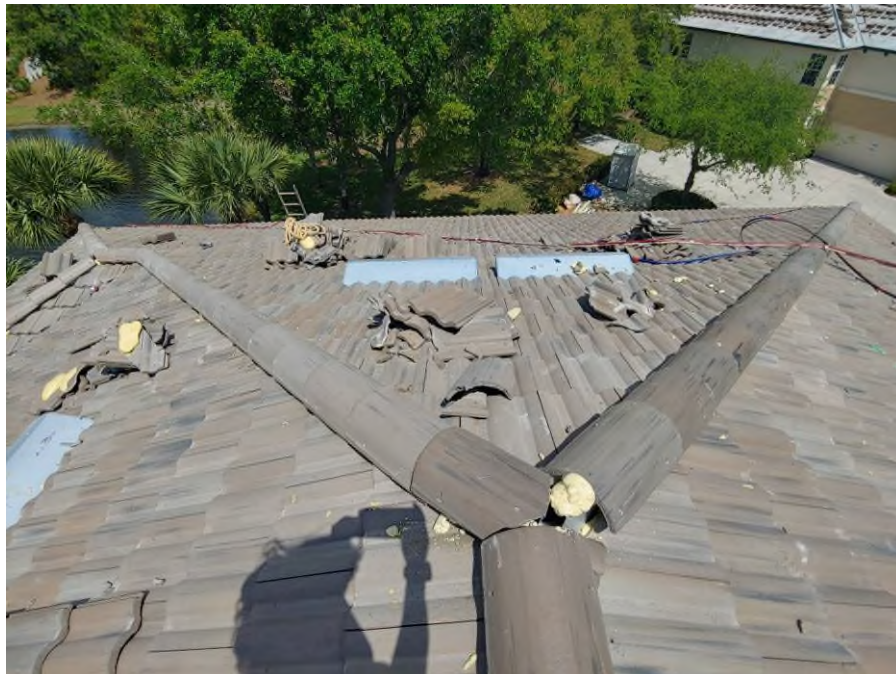
**Photograph #2: Roof field, ridge and hip tile installations with polyurethane foam adhesive were in progress on building 21700.**

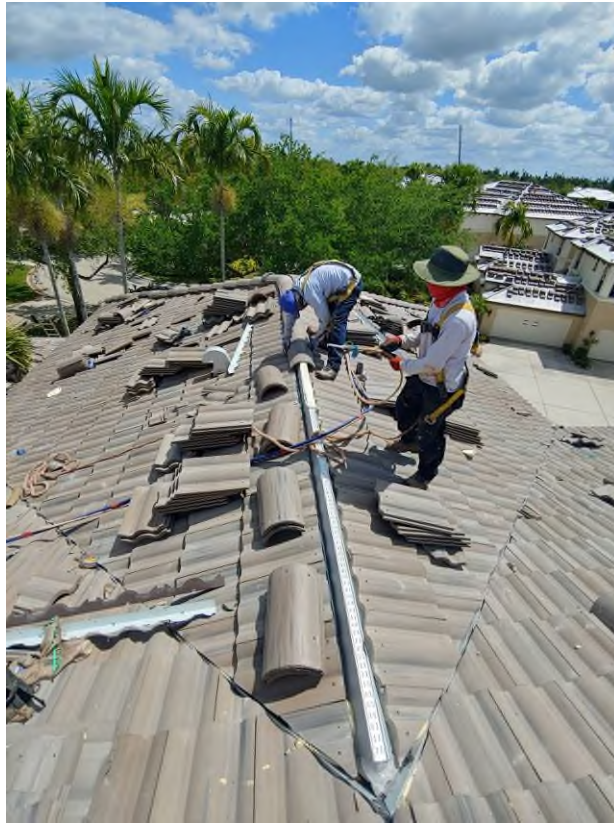
**Photograph #3: Roof field, ridge and hip tile installations with polyurethane foam adhesive were in progress on building 21700.**

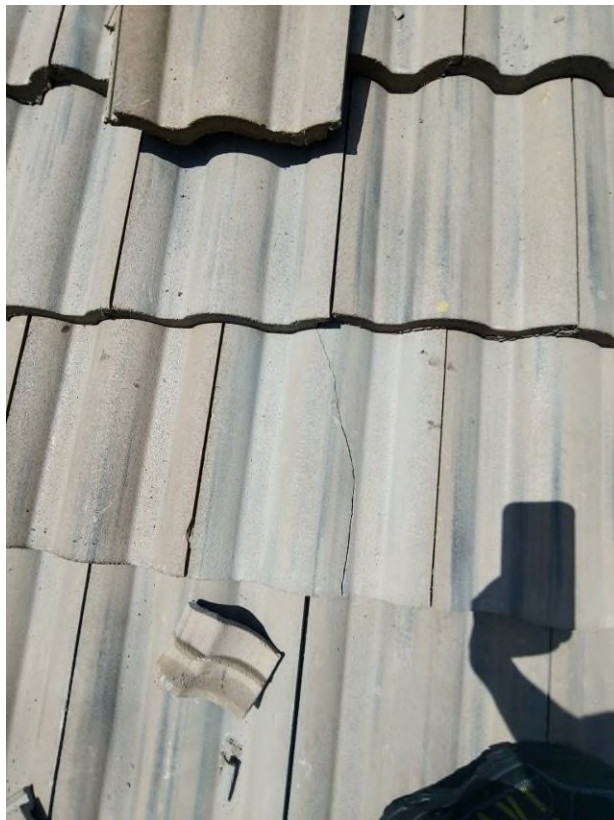
**Photograph #4: Contractor must replace the broken-field tiles that were noted on building 21700 during the site visit.**

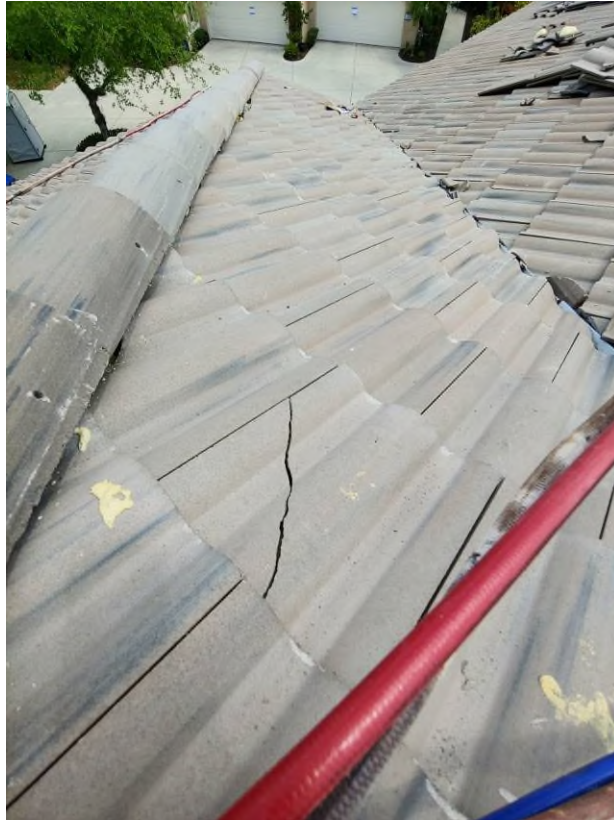
**Photograph #5: Contractor must replace the broken-field tiles that were noted on building 21700 during the site visit.**

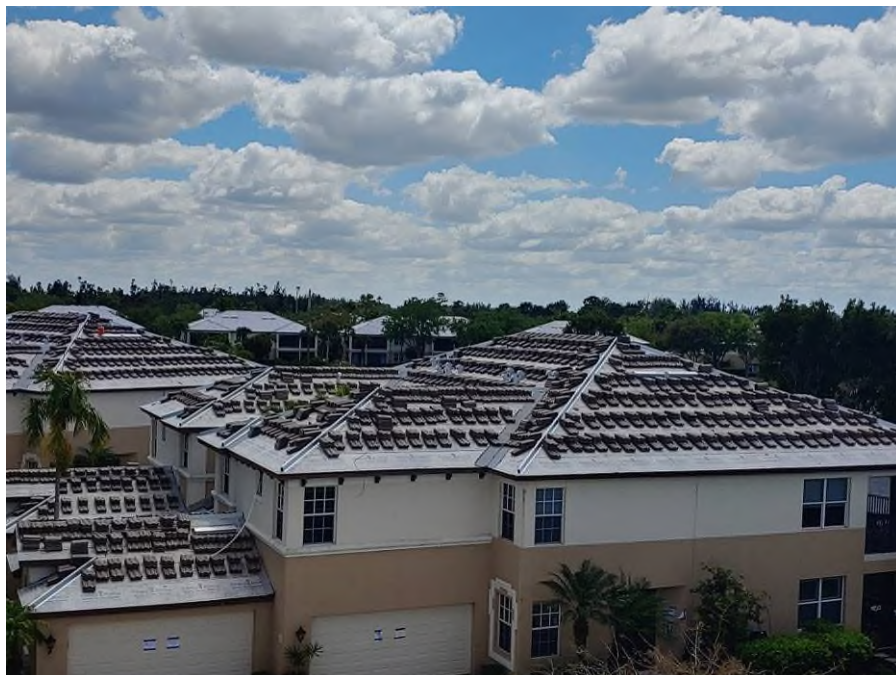
**Photograph #6: Roof tiles were set in place for installation on building 21710.**

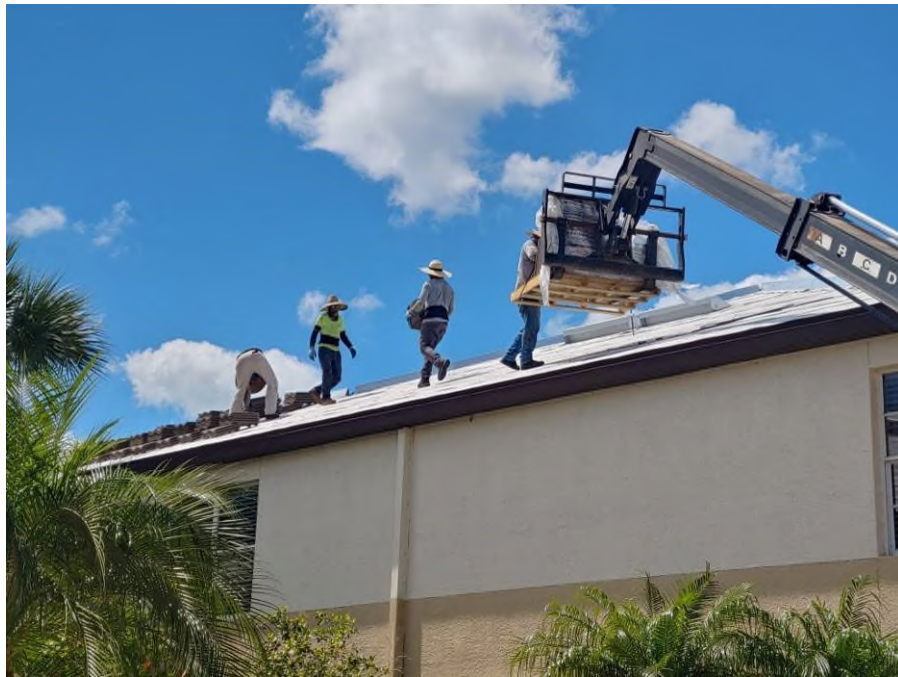
**Photograph #7: Roof tiles were set in place for installation on building 21720.**

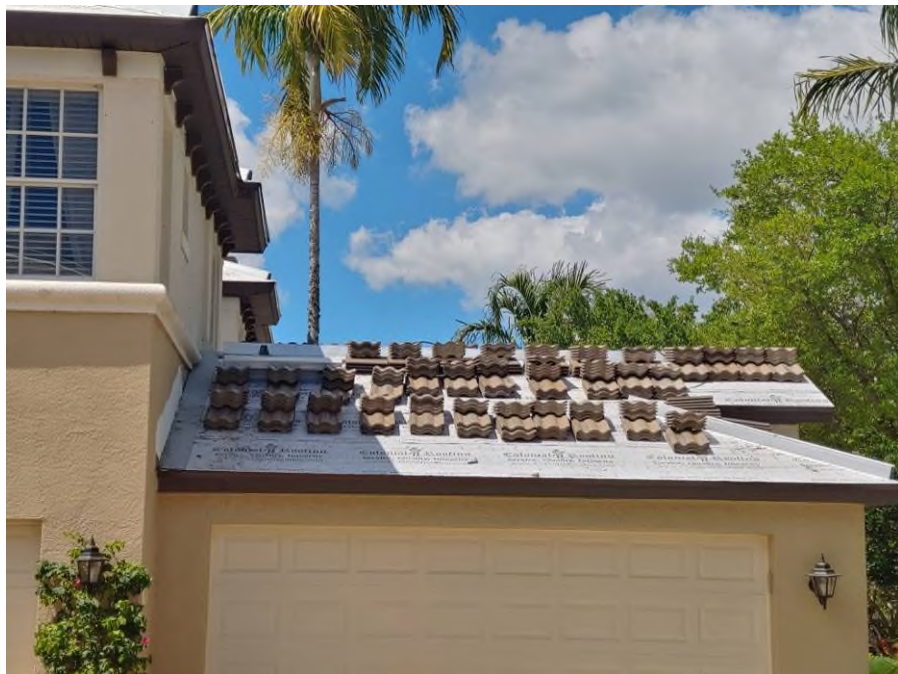
**Photograph #8: Roof tiles were set in place for installation on building 21720.**

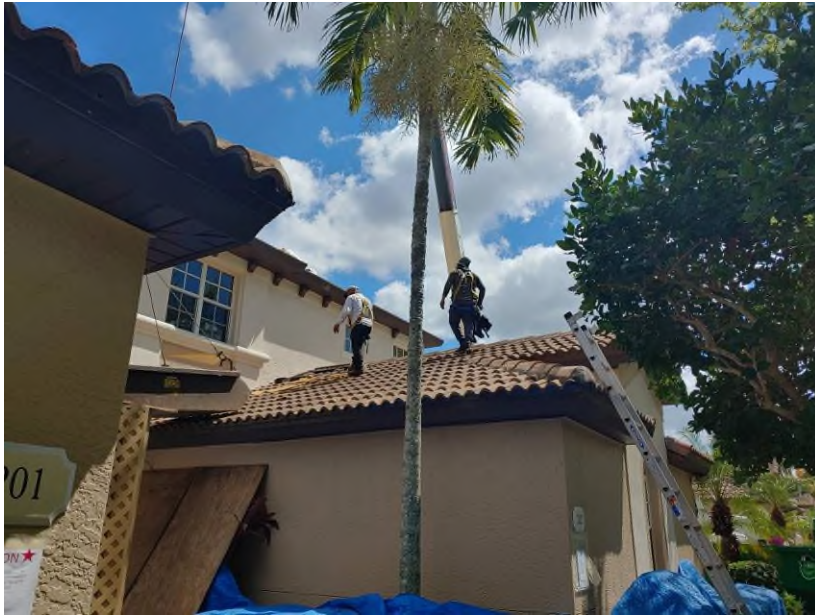
**Photograph #9: Roof tile removal was in progress on on building 21761.**

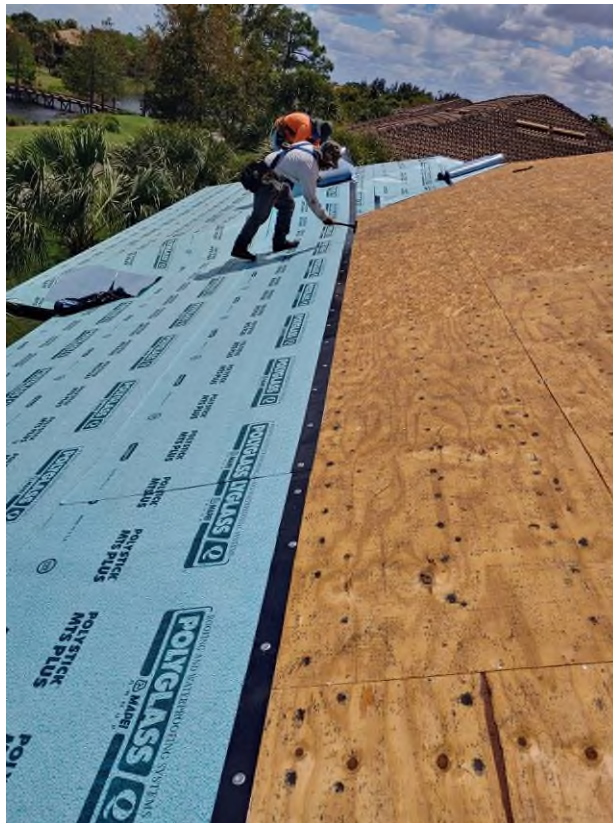
**Photograph #10: Polystick MTS Plus underlayment installation was in progress on building 21761.**

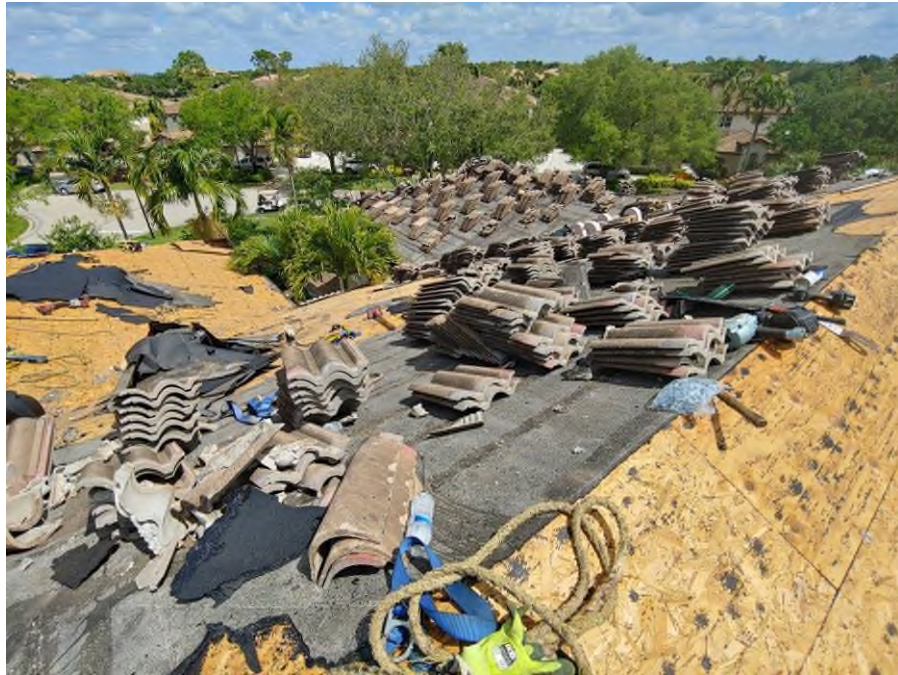
**Photograph #11: Roof tile removal was in progress on building 21800.**

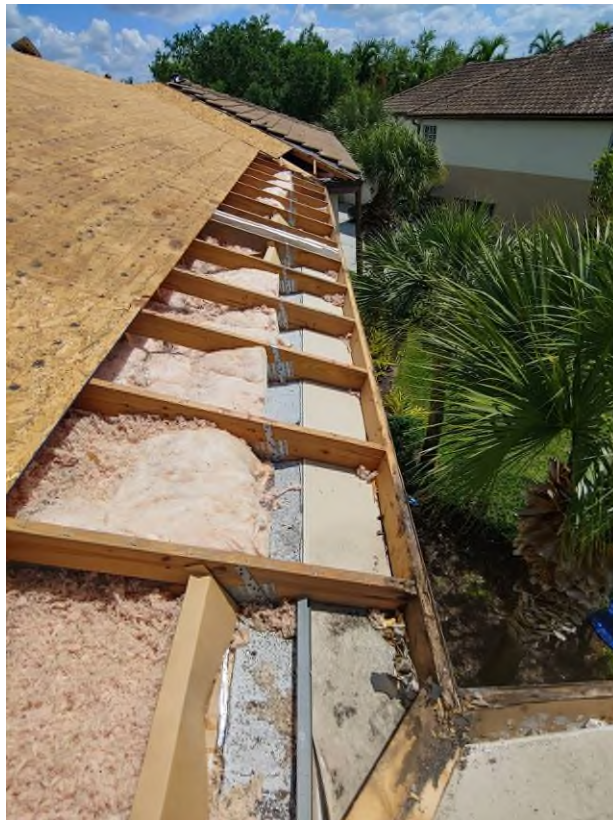
**Photograph #12: Existing strap clips on the trusses have the required minimum of nails on building 21800.**

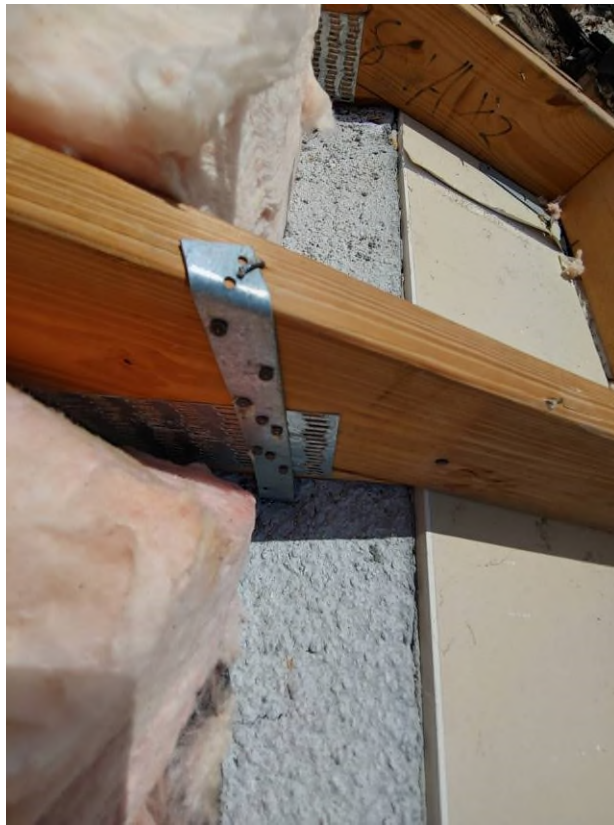
**Photograph #13: Existing strap clips on the trusses have the required minimum of nails on building 21800.**

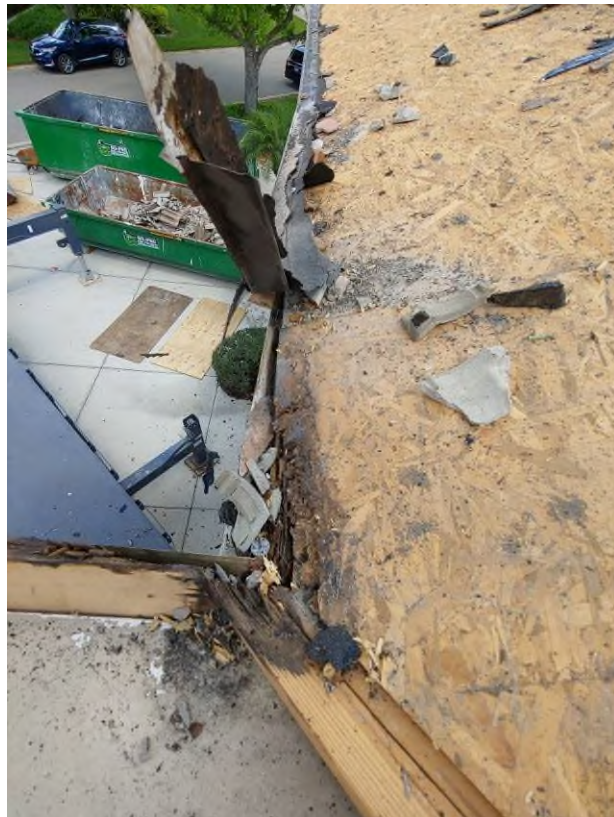
**Photograph #14: Rotten fascia, truss and plywood sheathing were observed on building 21800.**
