Uniform Mitigation Verification Inspection Form

RE: Palmetto Dunes Condominium
21850 Palmetto Dunes Drive
Estero, FL 33928
Roofing Restoration
KEG File #20RN-0085
Wind Mitigation
Permit # 1722051-0

DATE	April 13, 2020	JOB NO.	20RN-0085
Palmetto Dunes CAI – Roofing Project			
LOCATION	Palmetto Dunes Drive		
CONTRACTOR	EnviroStruct, LLC	Palmetto Dunes CAI	
WEATHER	Sunny	TEMP.	Time
		88° F	12:30PM
PRESENT AT SITE	Rahmin Bahar, EnviroStruct (ES) Teresita Nazario-Acosta, Karins Engineering Group (KEG)

REPORT: FR # 25

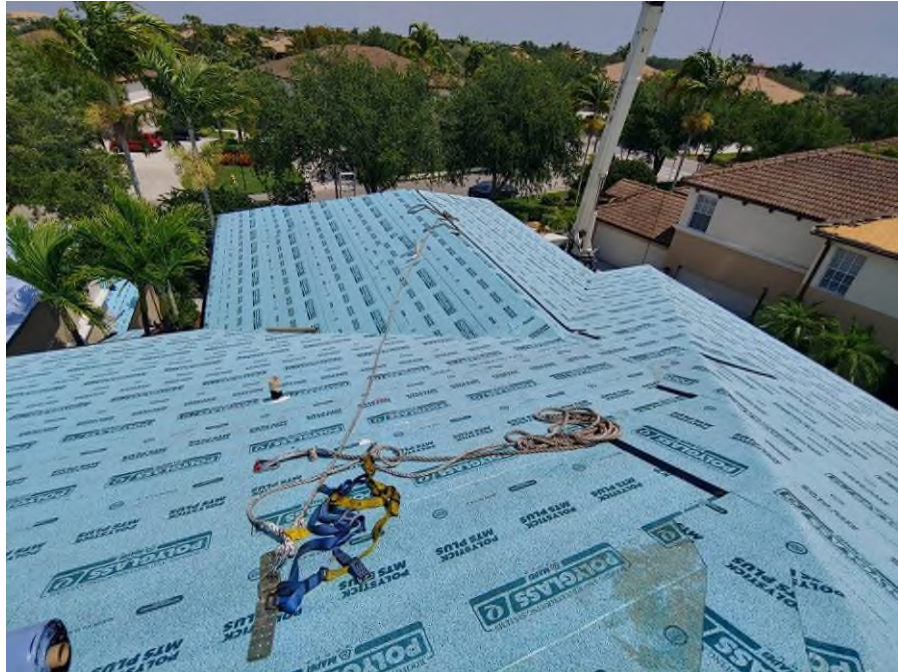
Photograph #1: Polystick MTS Plus underlayment installation was completed on building 21840.

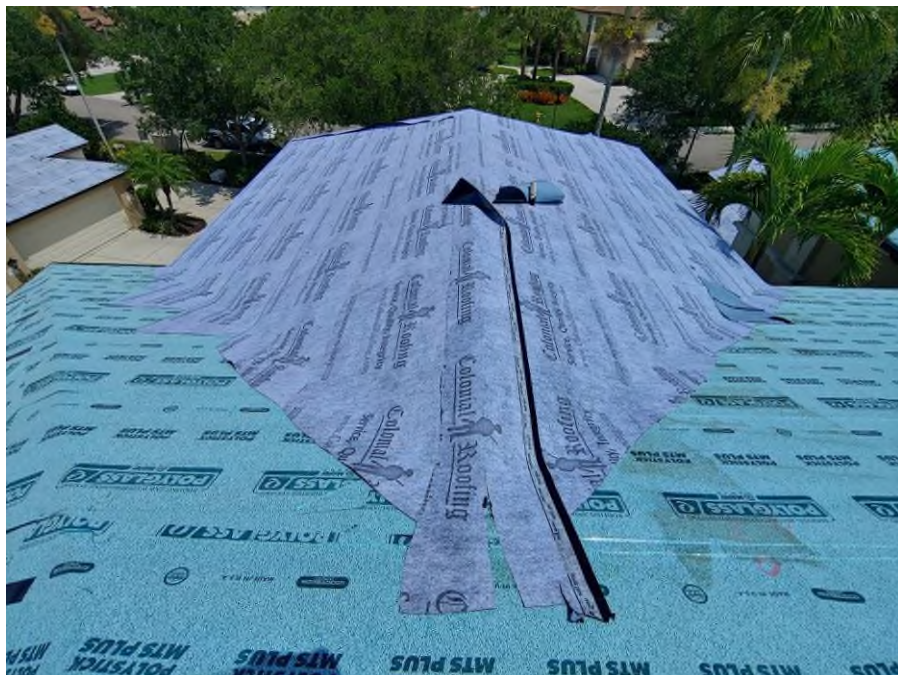
Photograph #2: Second layer of underlayment installation began on building 21840.

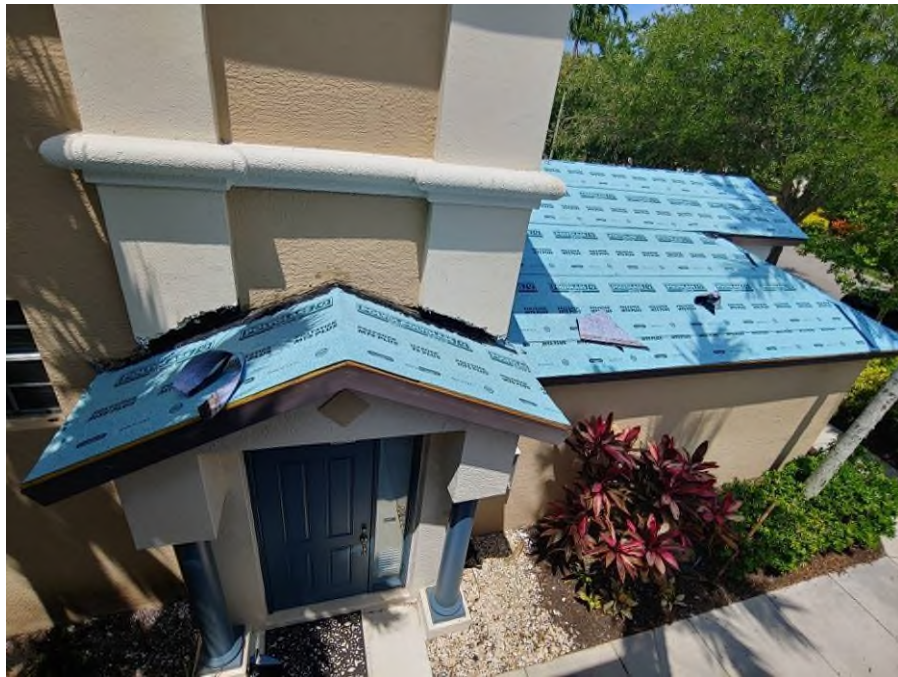
Photograph #3: Missing drip-edge flashing installation was observed on the garage of building 21840.

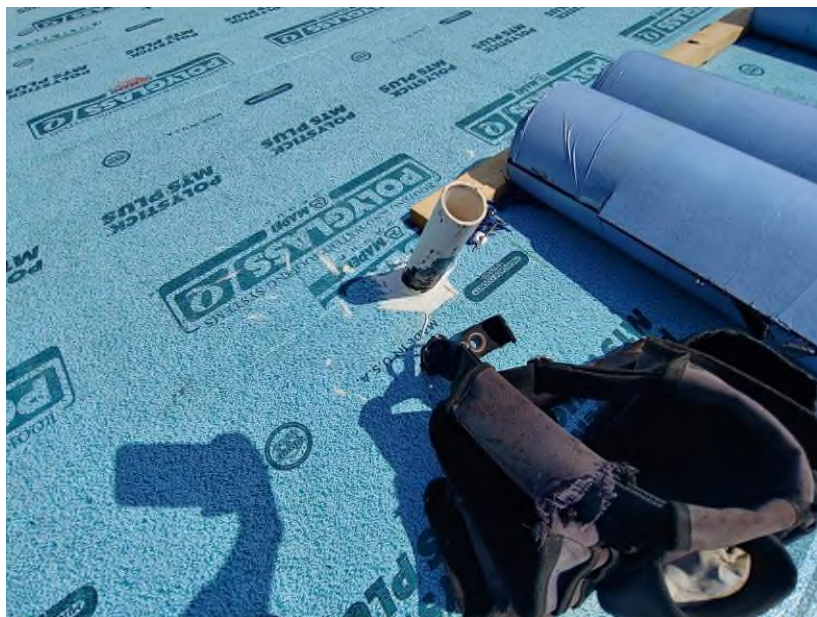
Photograph #4: Sealant application surrounding the exhaust vent pipe was in progress on building 21840.

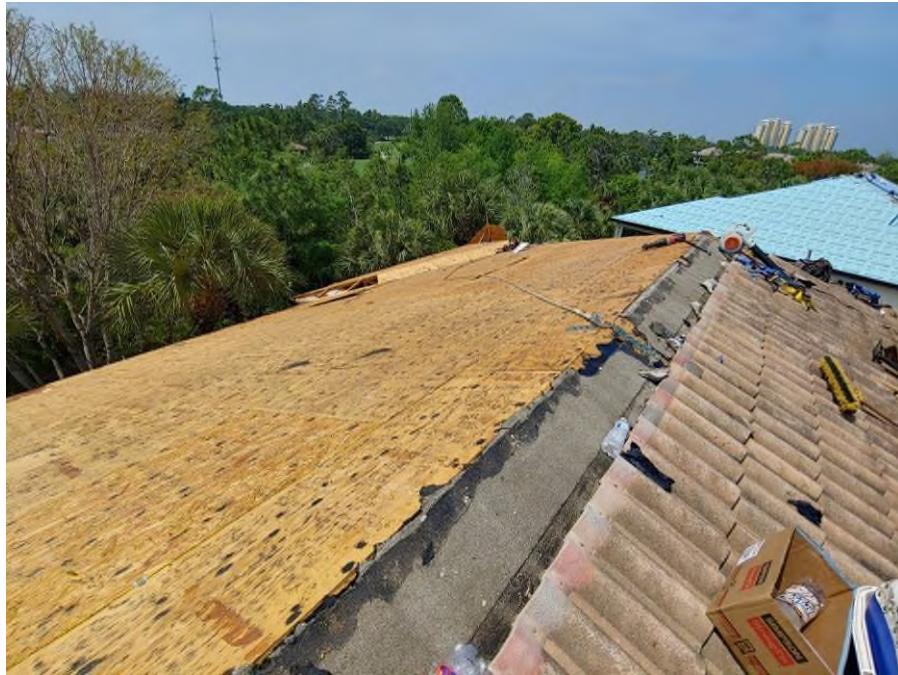
Photograph #5: Roof tile removal was in progress on building 21850.

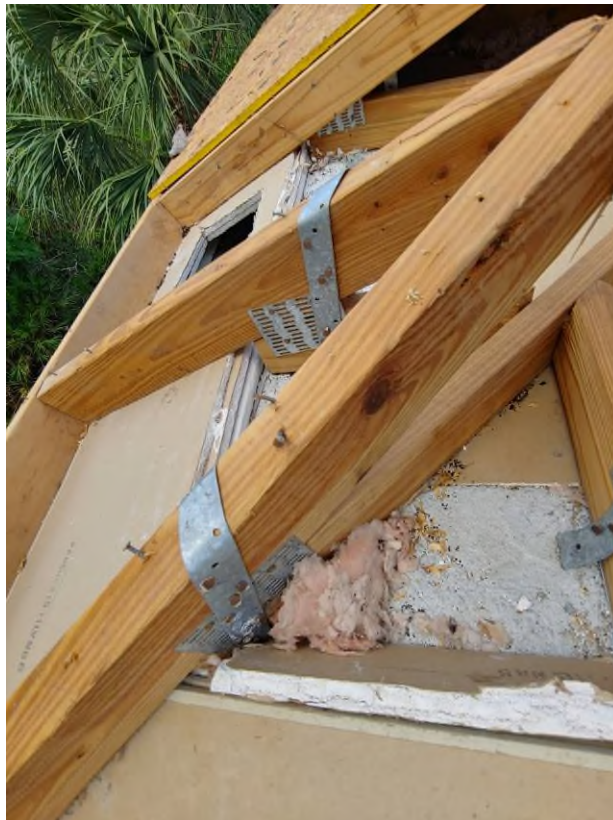
Photograph #6: Existing strap clips on the trusses have the required minimum quantity of 5 nails on building 21850.

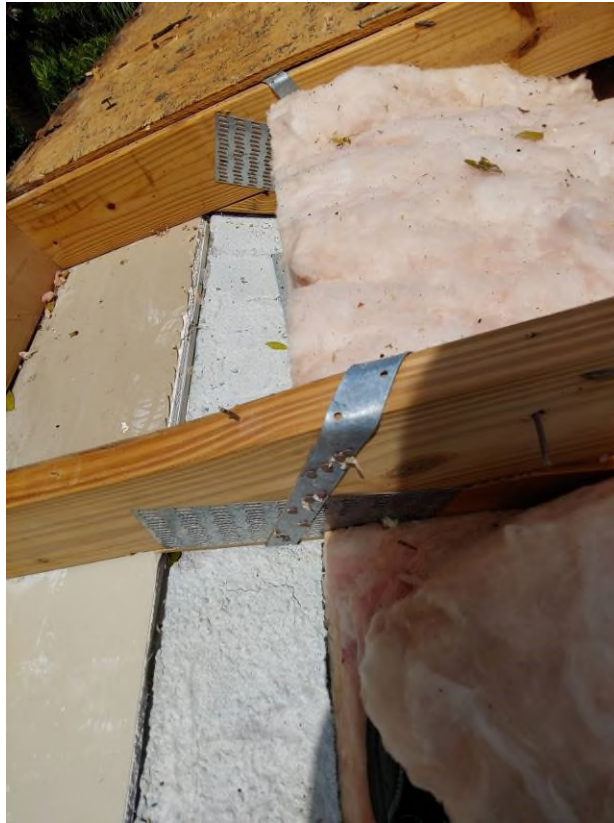
Photograph #7: Existing strap clips on the trusses have the required minimum quantity of 5 nails on building 21850.

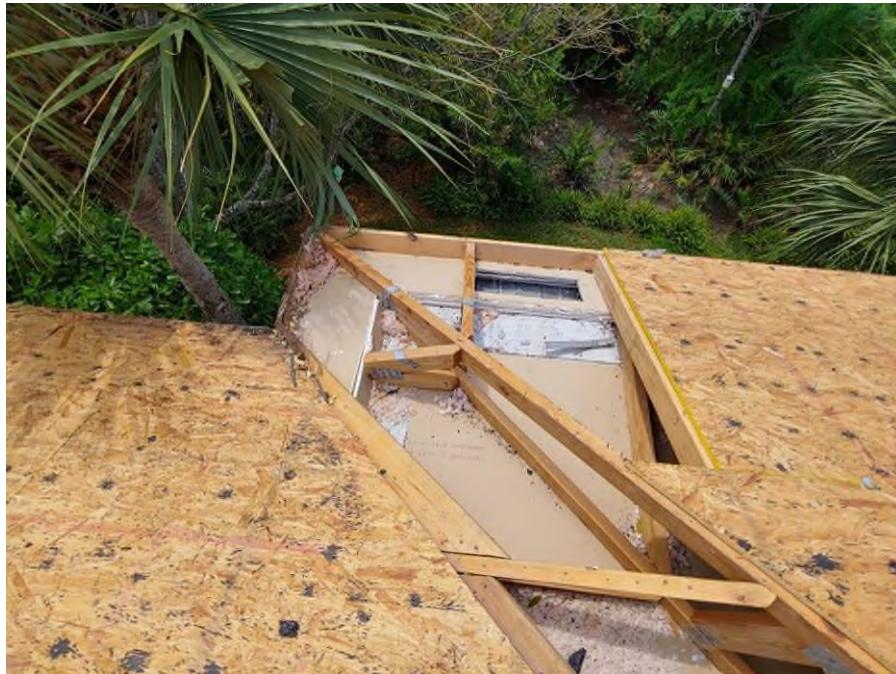
Photograph #8: Rotten fascia, truss and plywood sheathing were observed on building 21850.
