Uniform Mitigation Verification Inspection Form

RE: Palmetto Dunes Condominium
21810 Palmetto Dunes Drive
Estero, FL 33928
Roofing Restoration
KEG File #20RN-0085
Wind Mitigation
Permit # 1721790-0

| Palmetto Dunes CAI – Roofing Project | | | |

FIELD REPORT

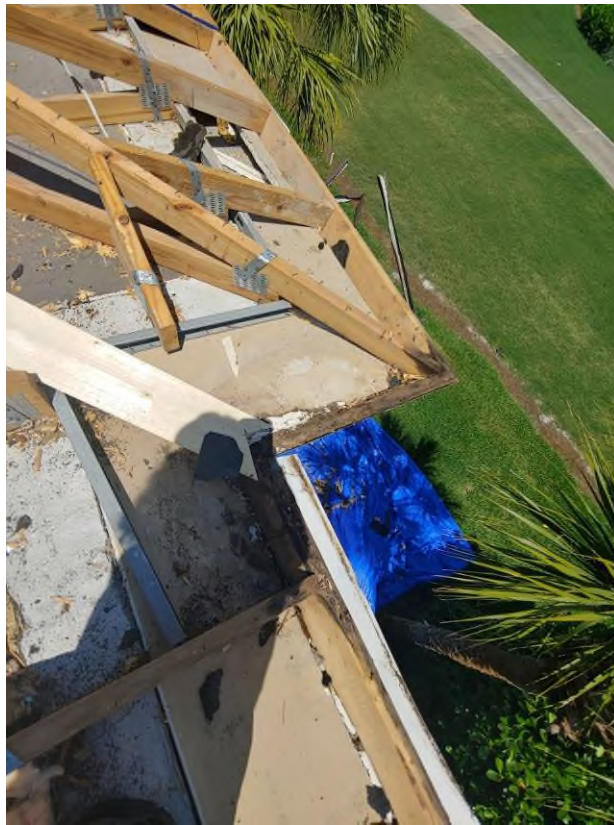
Photograph #19: Rotten fascia and truss were observed on building 21781.

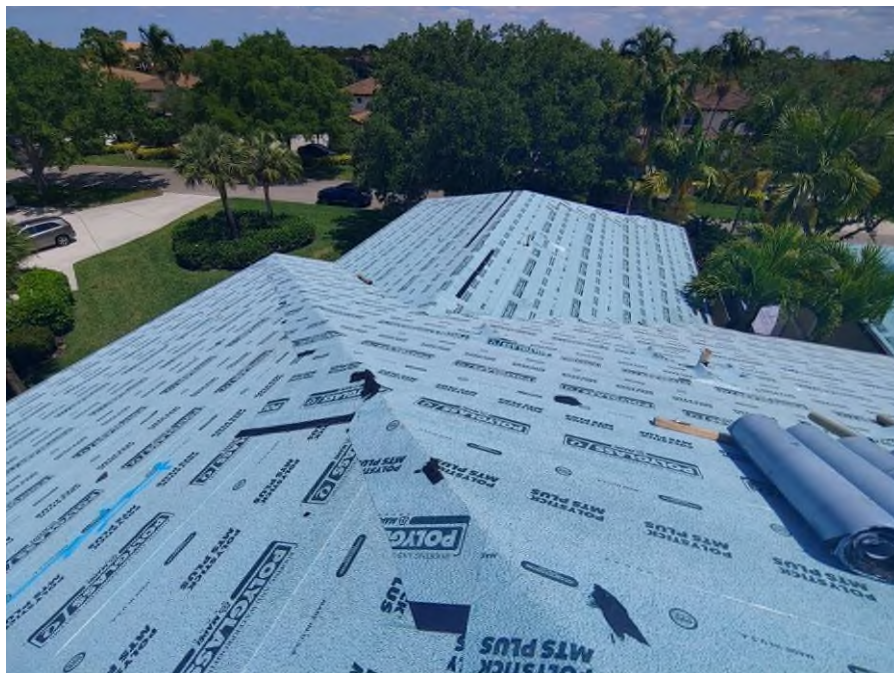
Photograph #20: Polystick MTS Plus underlayment was completed on building 21810.

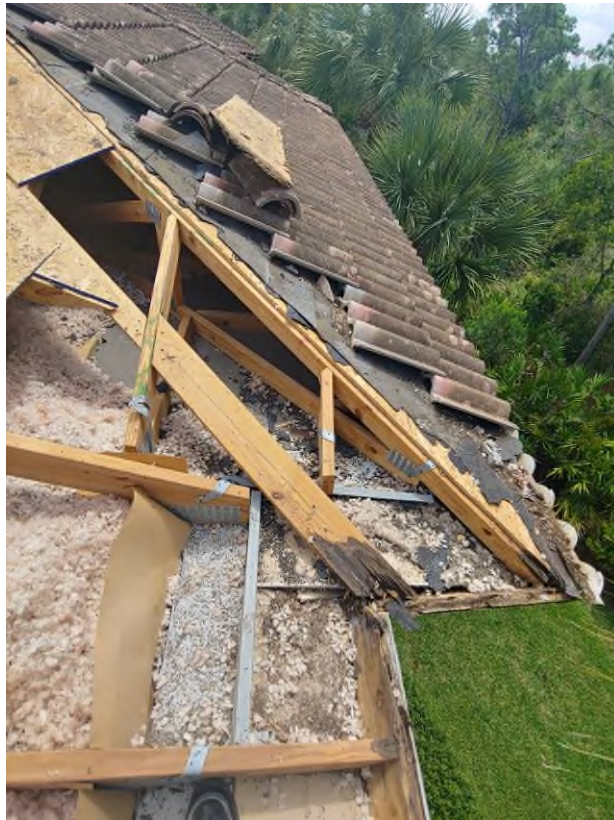
Photograph #28: Rotten fascia and truss were observed on building 21820.

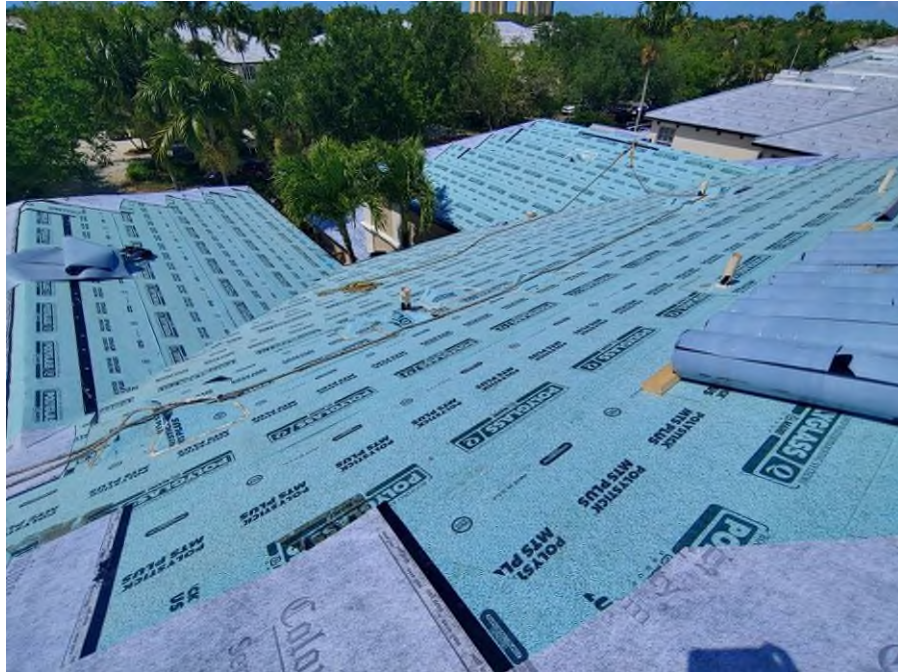
Photograph #1: Polystick MTS Plus underlayment installation was completed on building 21761.

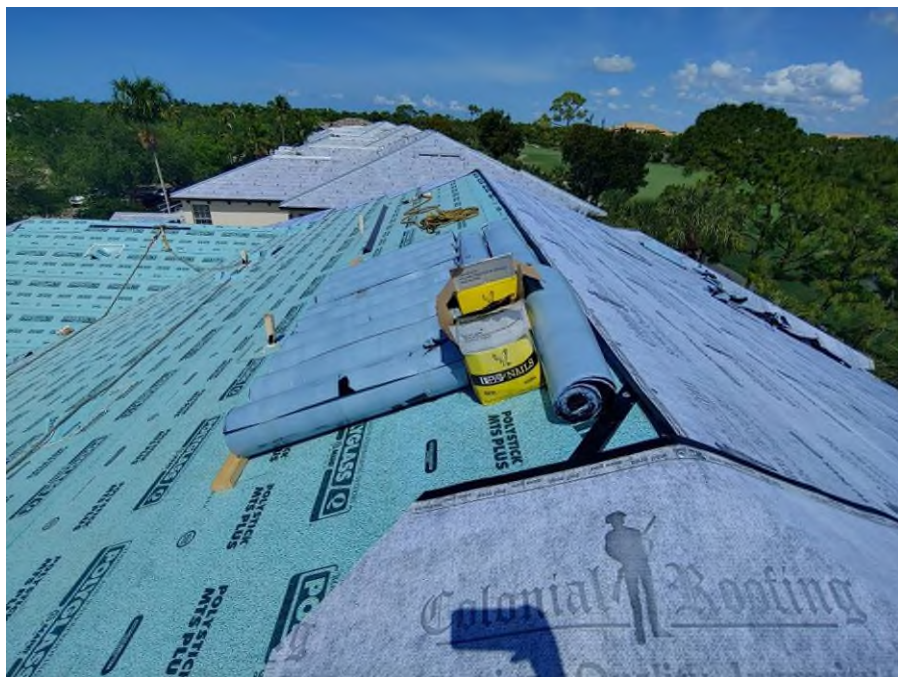
Photograph #2: Polystick MTS Plus underlayment installation was completed on building 21761.

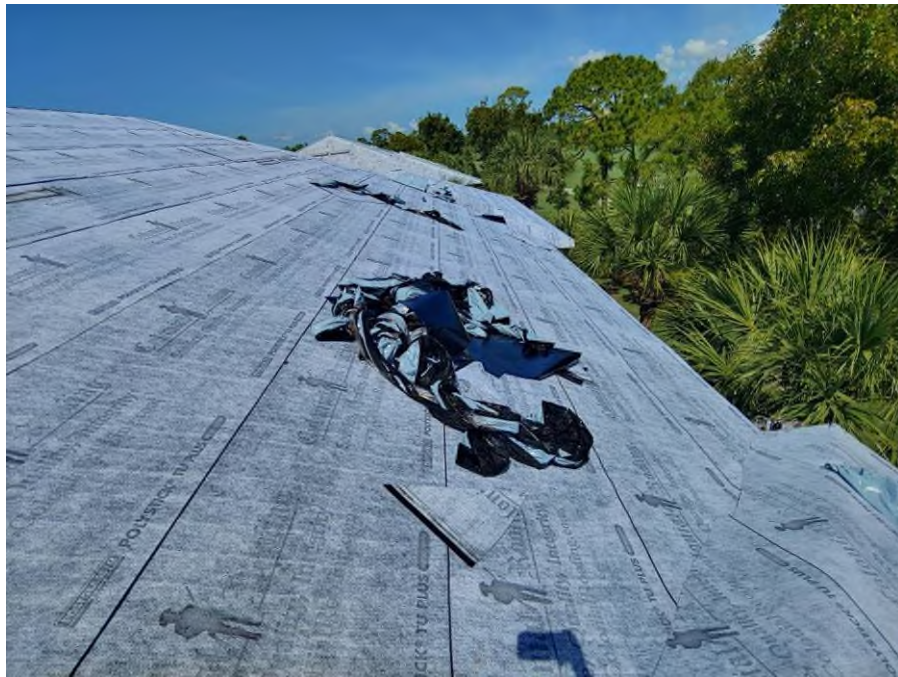
Photograph #3: Second layer of underlayment installation was in progress on building 21761.

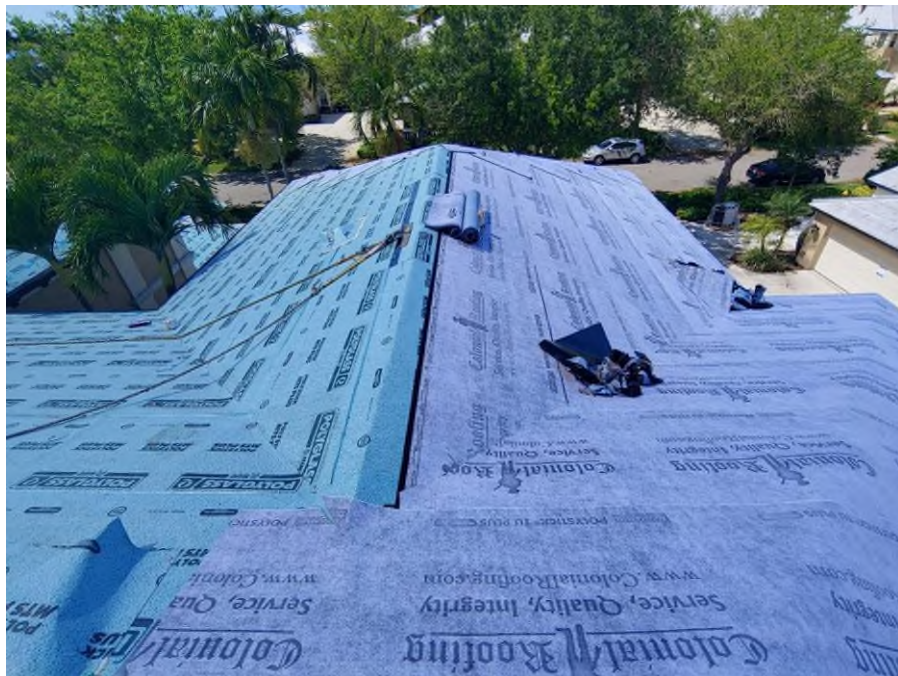
Photograph #4: Second layer of underlayment installation was in progress on building 21761.

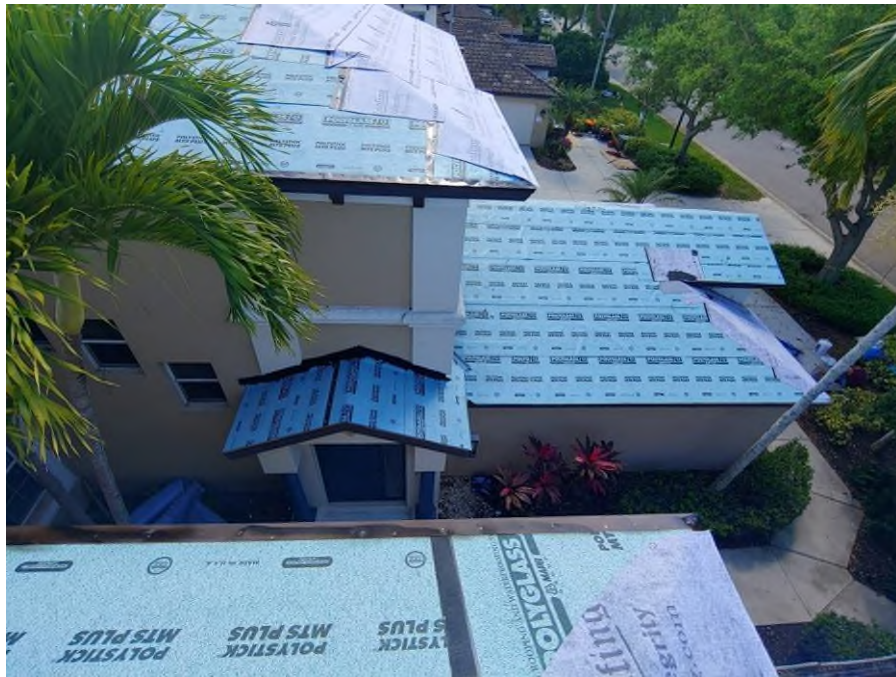
Photograph #5: Drip-edge installation was in progress on the garage roof of building 21761.

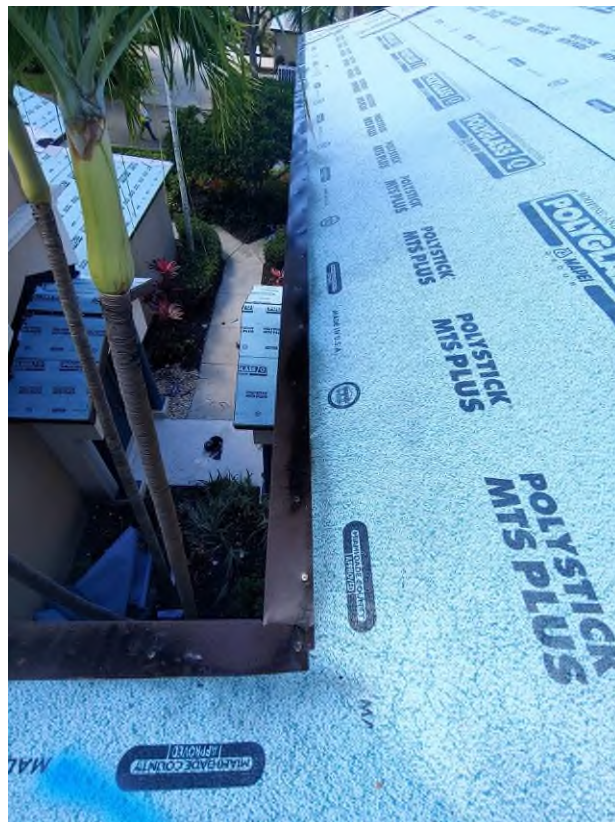
Photograph #6: Drip-edge installation was completed on the main roof of building 21761.

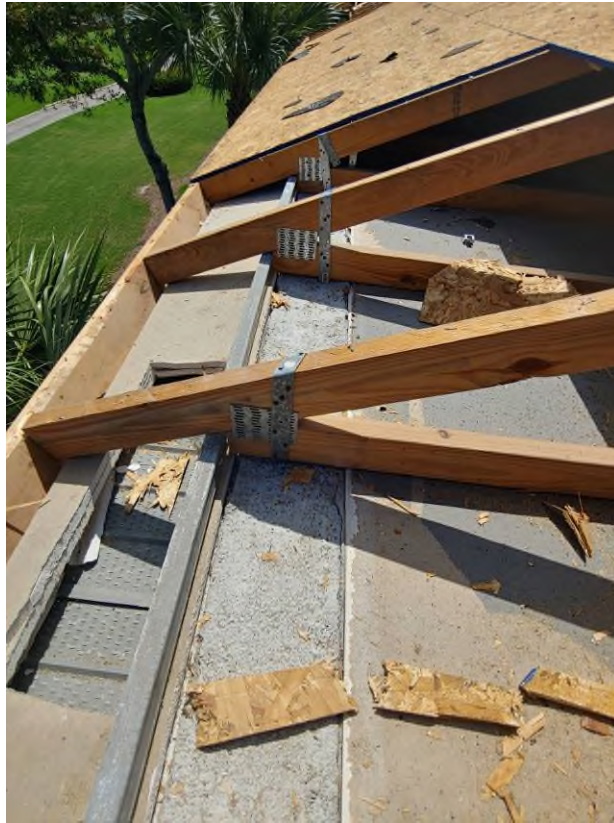
Photograph #7: Existing strap clips on the trusses have the required minimum of nails on building 21771.

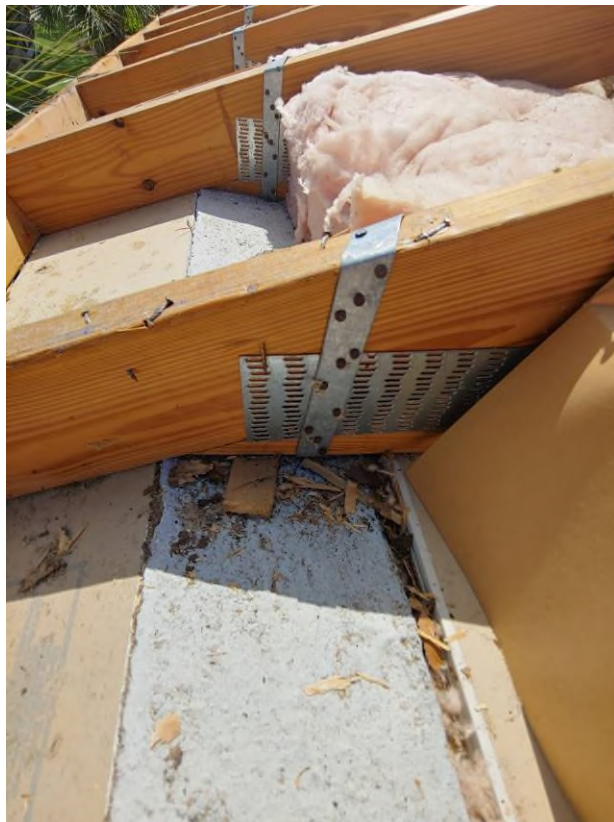
Photograph #8: Existing strap clips on the trusses have the required minimum of nails on building 21771.

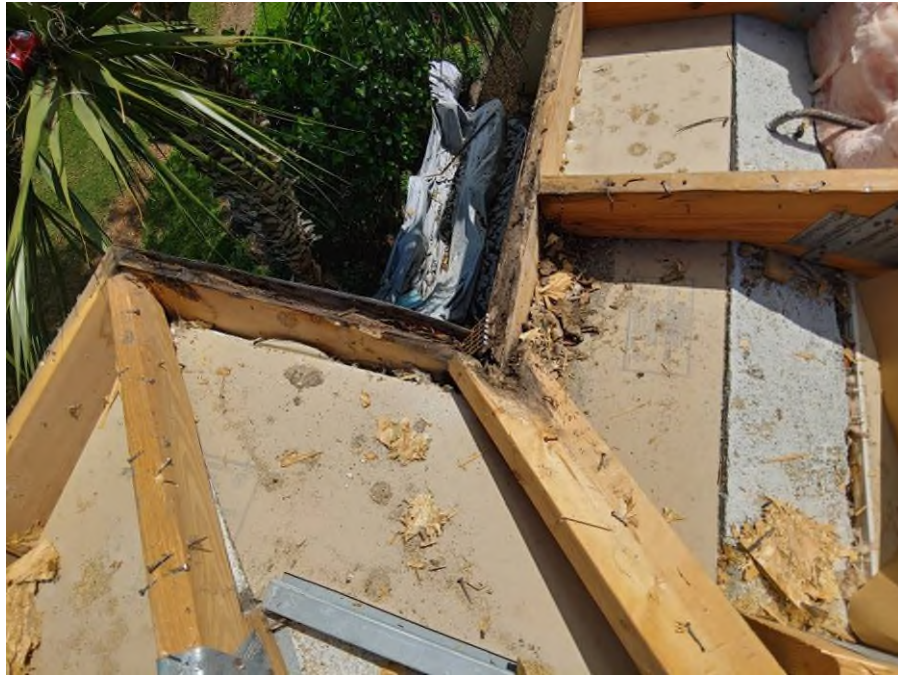
Photograph #9: Rotten fascia and truss were observed on building 21771.

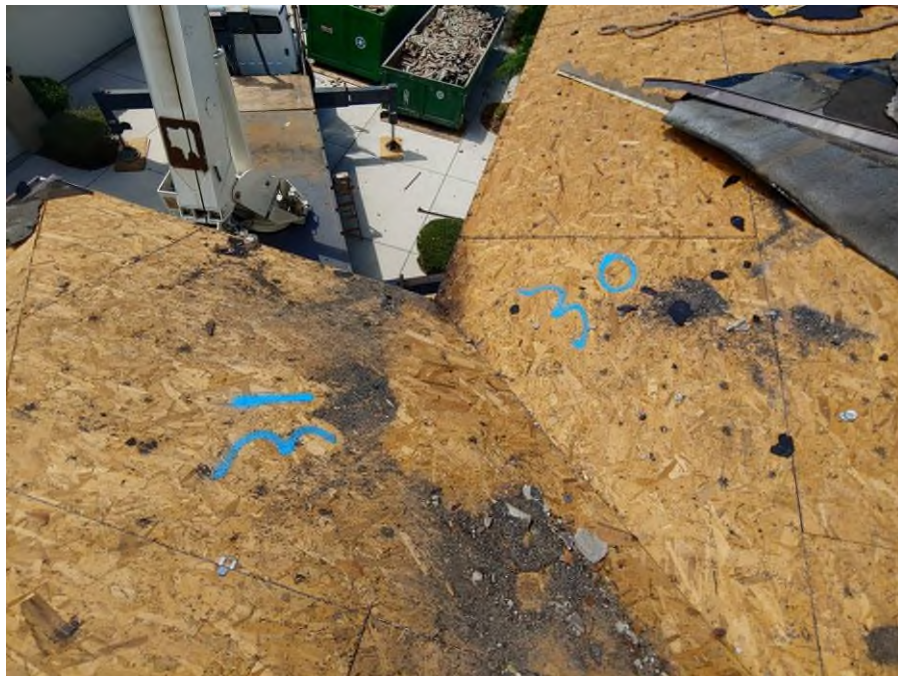
Photograph #10: Rotten plywood sheathing was observed on building 21771.

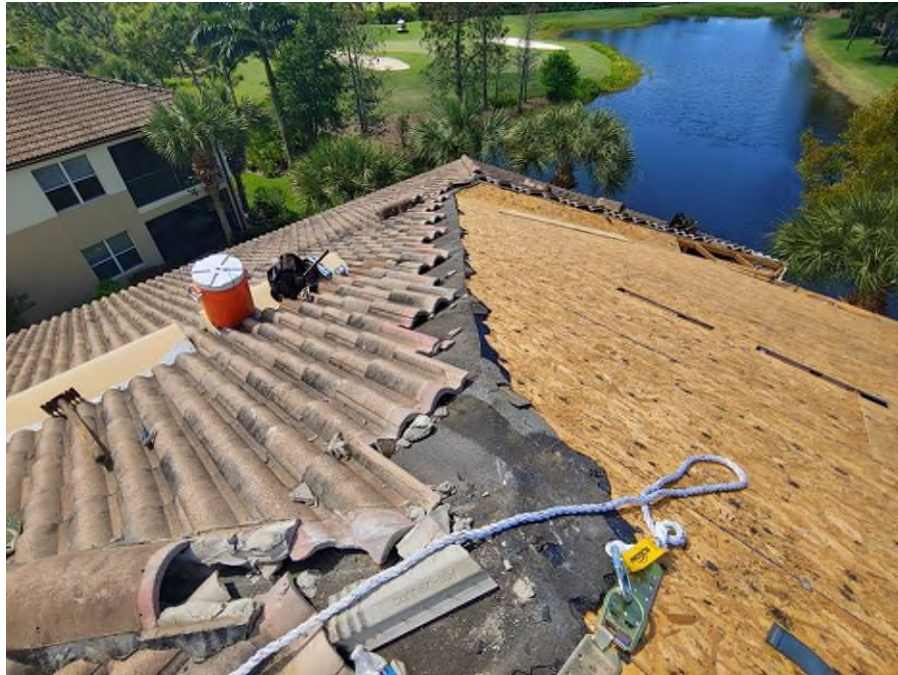
Photograph #11: Roof tile removal was in progress on 21810.

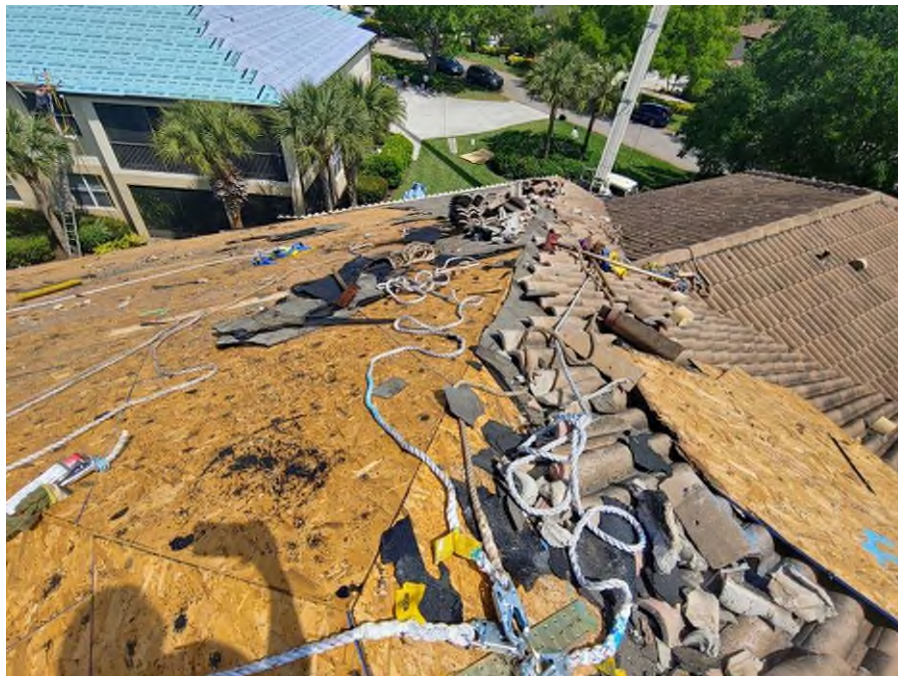
Photograph #12: Roof tile removal was in progress on 21810.

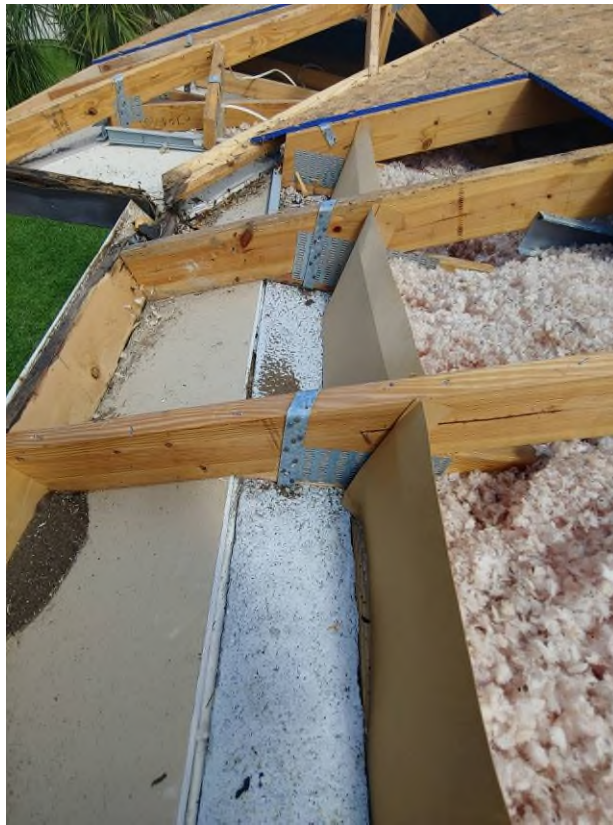
Photograph #13: Existing strap clips on the trusses have the required minimum of nails on building 21810.

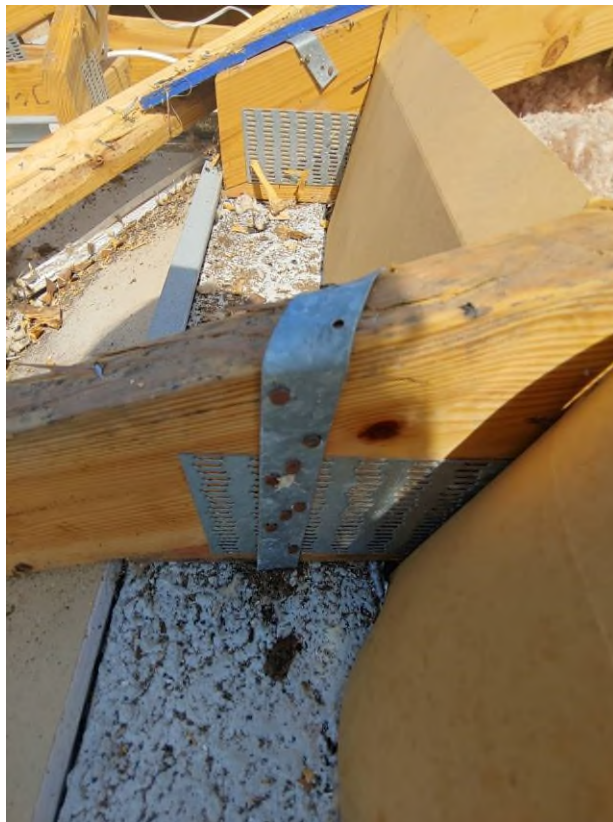
Photograph #14: Existing strap clips on the trusses have the required minimum of nails on building 21810.

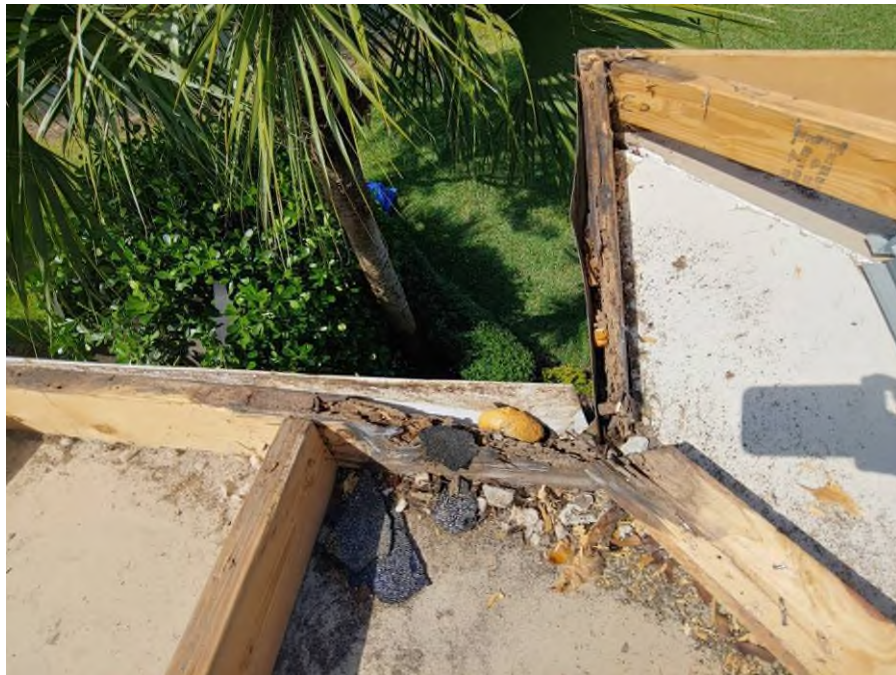
Photograph #15: Rotten fascia and truss were observed on building 21810.

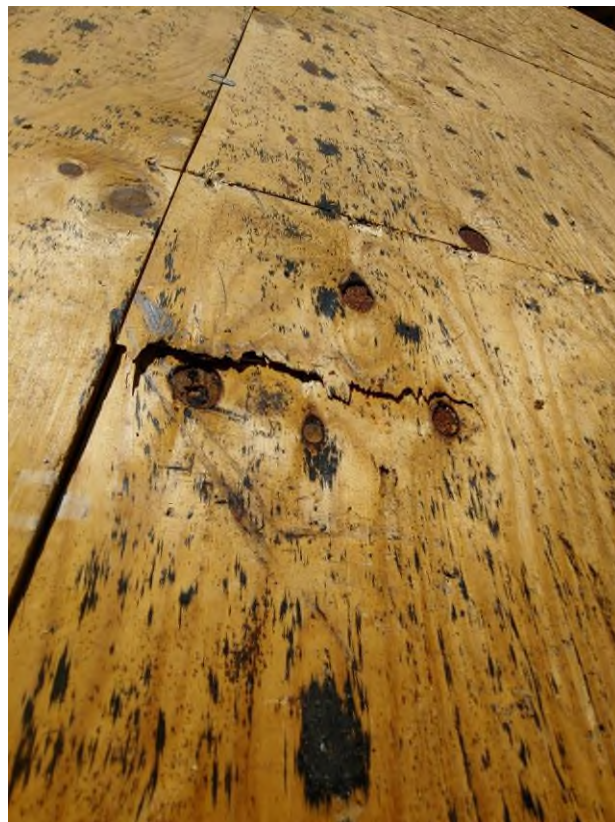
Photograph #16: Broken plywood sheathing was observed on building 21810. Contractor must replace.
