Uniform Mitigation Verification Inspection Form

RE: Palmetto Dunes Condominium
21750 Palmetto Dunes Drive
Estero, FL 33928
Roofing Restoration
KEG File #20RN-0085
Wind Mitigation
Permit # 1721363-0

DATE	March 02, 2020	JOB NO.	20RN-0085
Palmetto Dunes CAI – Roofing Project			
LOCATION	Palmetto Dunes Drive		
CONTRACTOR	EnviroStruct, LLC	Palmetto Dunes CAI	
WEATHER	Sunny	TEMP.	Time
		76° F	1:00PM
PRESENT AT SITE	Rahmin Bahar, EnviroStruct (ES) Teresita Nazario-Acosta, Karins Engineering Group (KEG)

REPORT: FR # 10

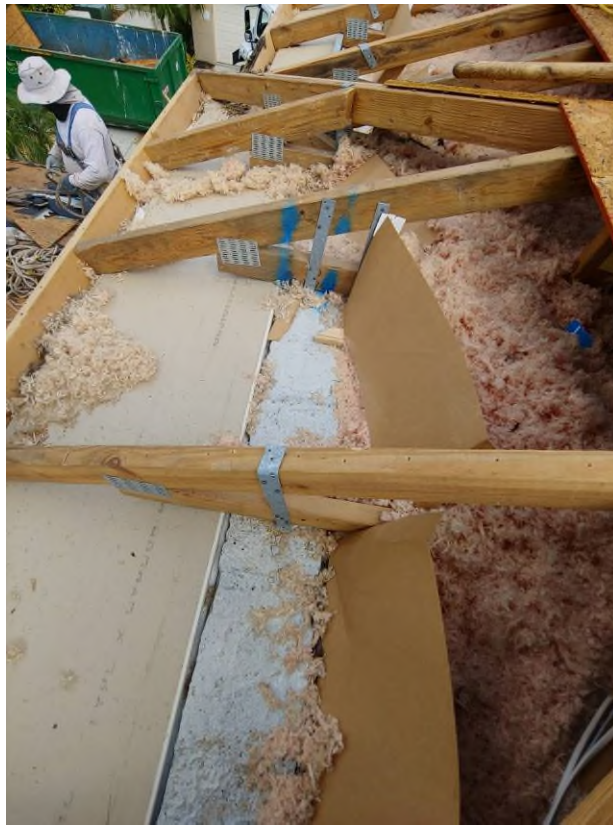
Photograph #1: Existing strap clips on the trusses have the required minimum quantity of nails on building 7870.

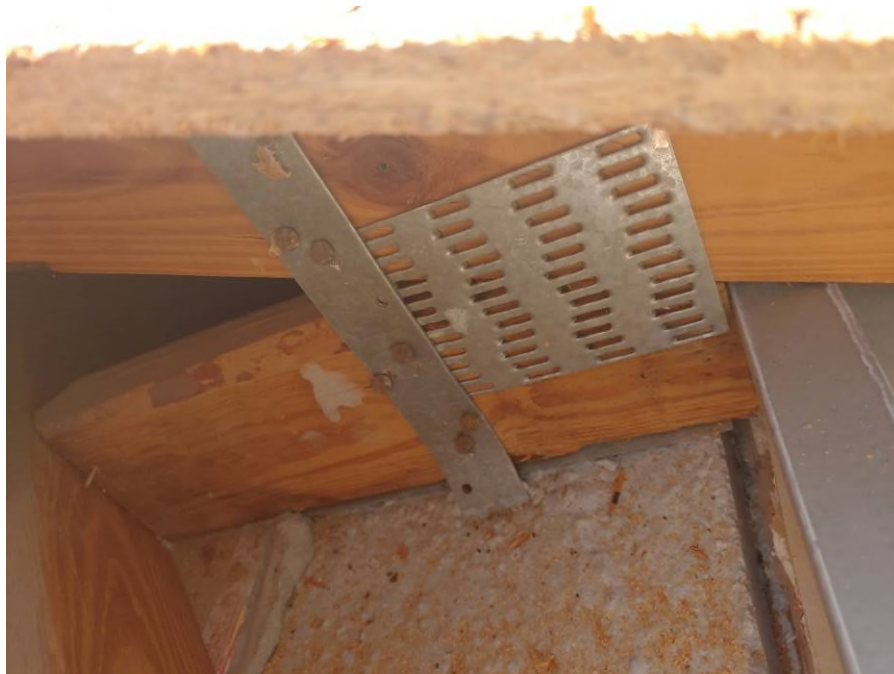
Photograph #2: Existing strap clips on the trusses have the required minimum quantity of nails on building 7870.

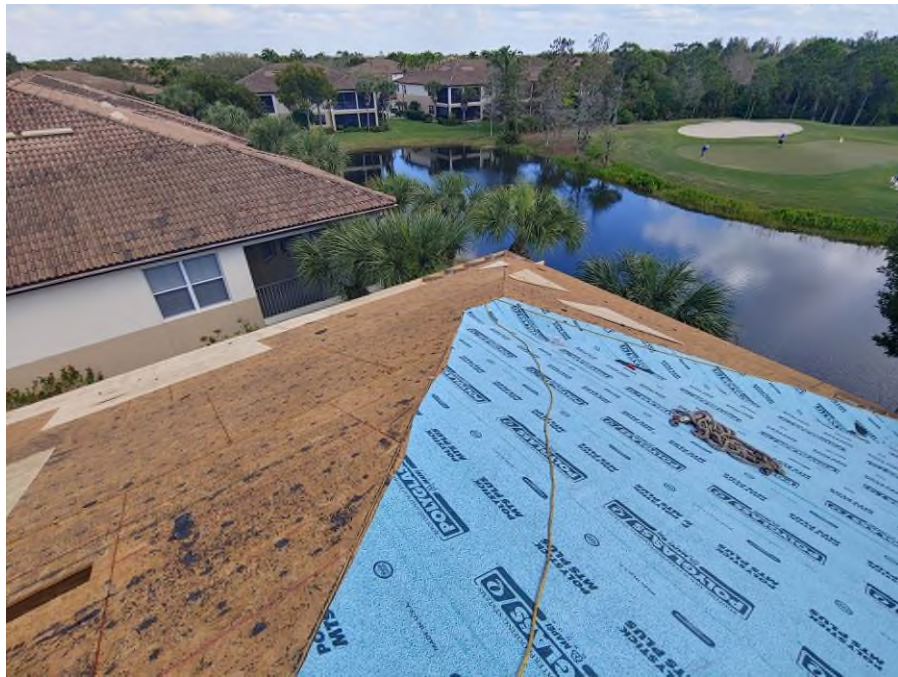
Photograph #3: Polystick MTS Plus underlayment installation was in progress on building 7870.

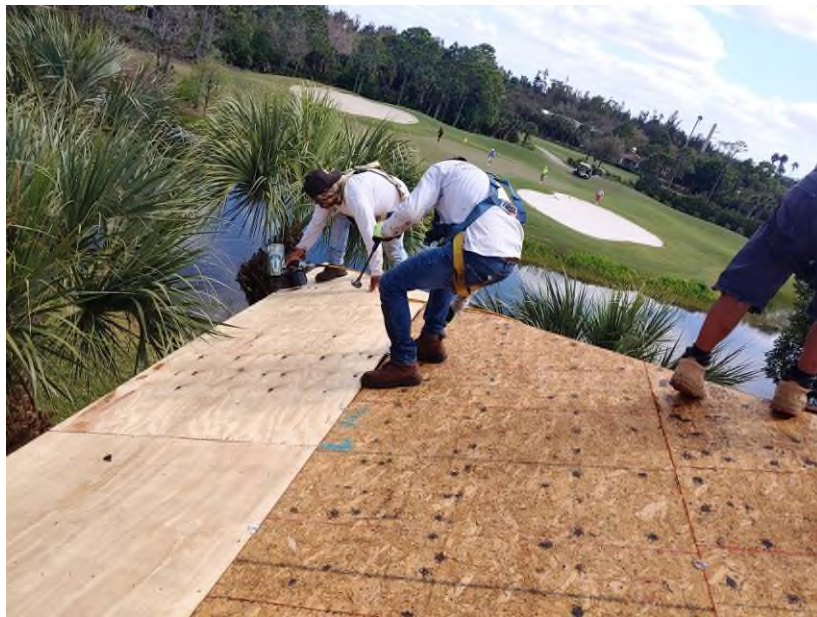
Photograph #4: Re-nail pattern at the plywood sheathing was in progress on buildings 7870.

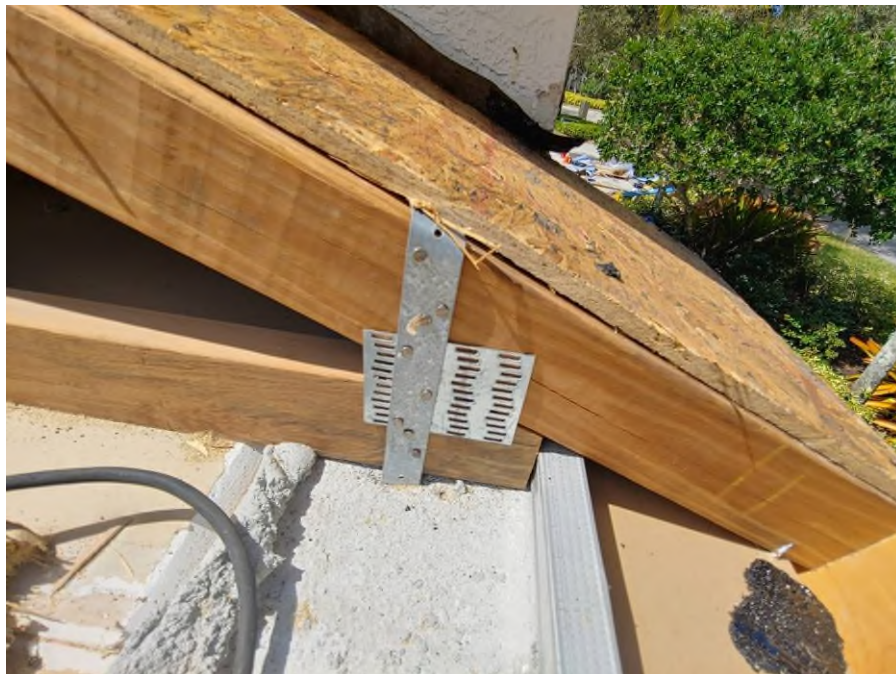
Photograph #8: Existing strap clips on the trusses have the required minimum quantity of nails on building 21740

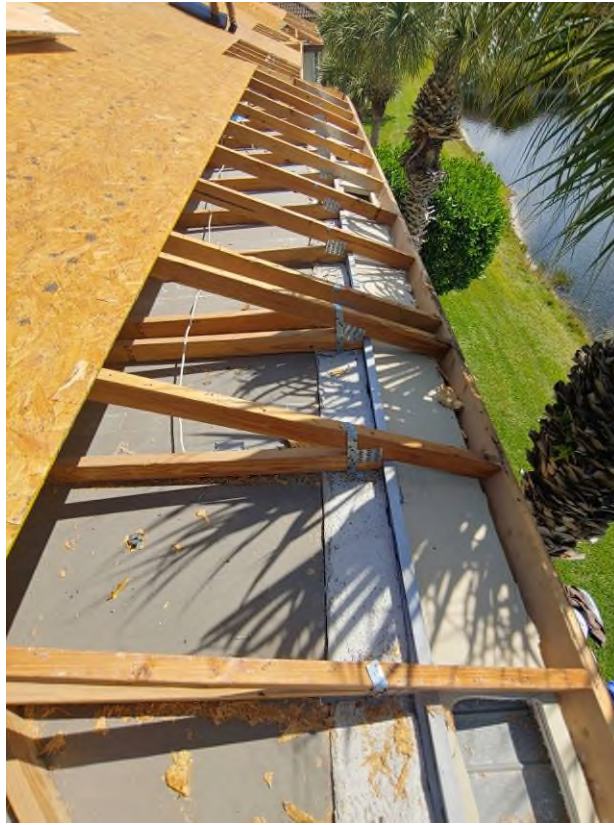
Photograph #11: Existing strap clips on the trusses have the required minimum quantity of nails on building 21750.

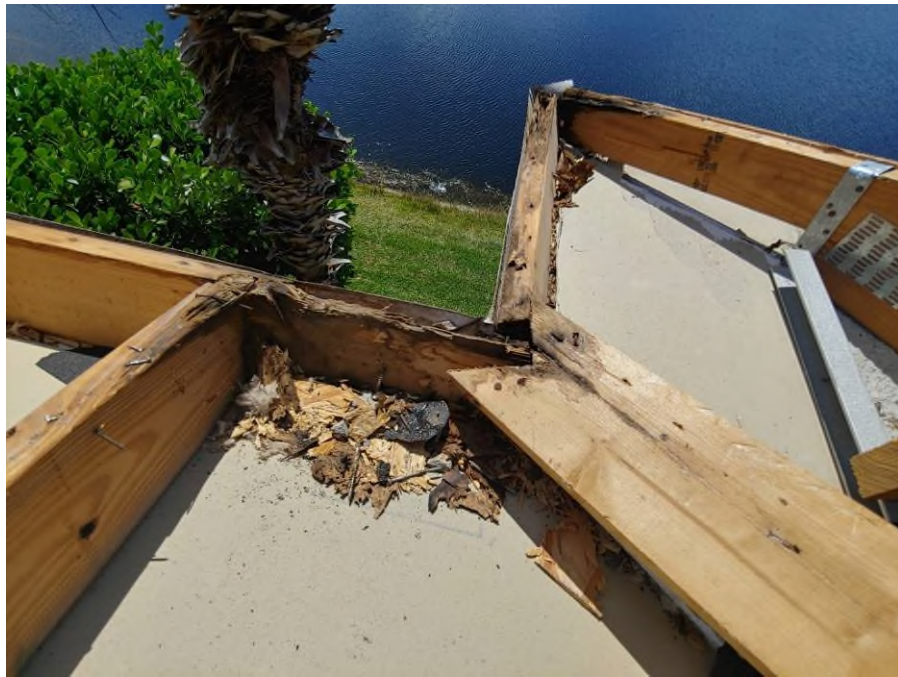
Photograph #13: Rotten fascia and truss were observed on building 21750.

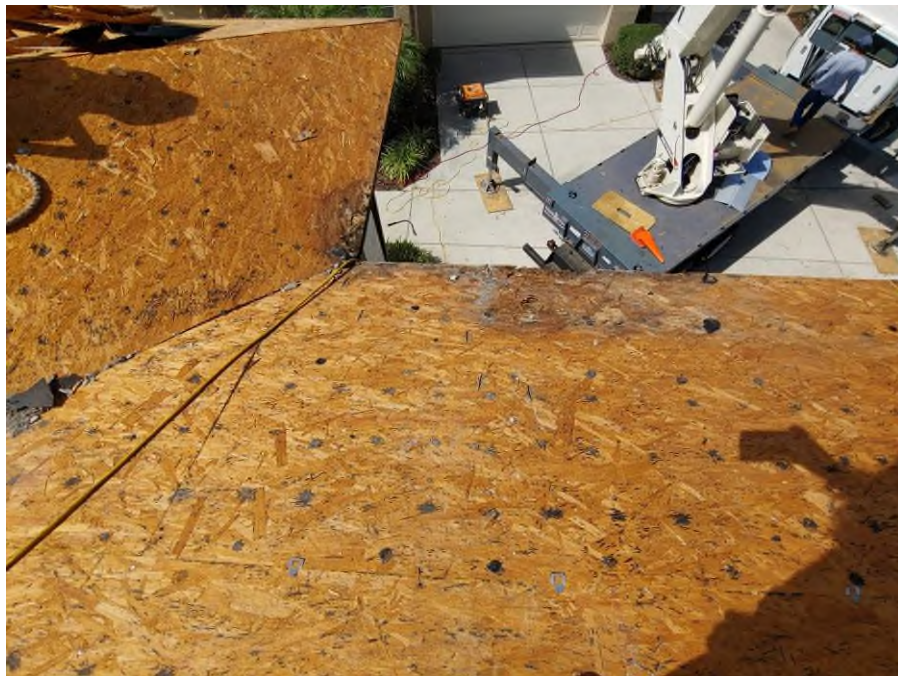
Photograph #14: Rotten plywood sheathing was observed on building 21750.
