Uniform Mitigation Verification Inspection Form

Inspection Date: 5-6-2020		
Owner Information		
Owner Name: Palmetto Dunes Pelical Sound Condominium Association Inc.		Contact Person:
Address: 21731 Palmetto Dunes Drive Units 101,102,201,202		Home Phone:
City: Estero	Zip: 33928	Work Phone:
County: Lee		Cell Phone:
Insurance Company:		Policy #:
Year of Home: 2001	# of Stories: 2	Email:

DATE	March 30, 2020	JOB NO.	20RN-0085
Palmetto Dunes CAI – Roofing Project			
LOCATION	Palmetto Dunes Drive		
CONTRACTOR	EnviroStruct, LLC	Palmetto Dunes CAI	
WEATHER	Sunny	TEMP. 88° F	Time 2:30PM
PRESENT AT SITE	Rahmin Bahar, EnviroStruct (ES) Teresita Nazario-Acosta, Karins Engineering Group (KEG)

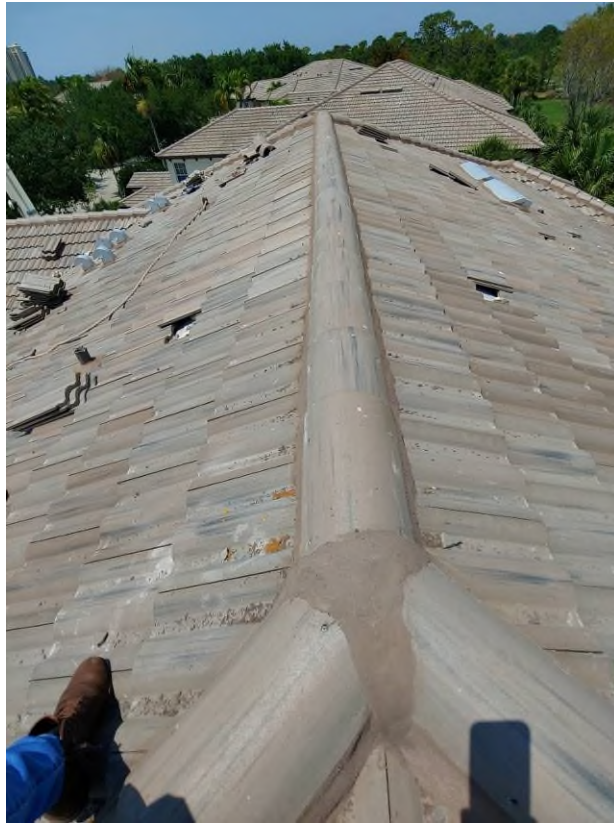
Photograph #1: Mortar adhesive application was in progress on building 21731.

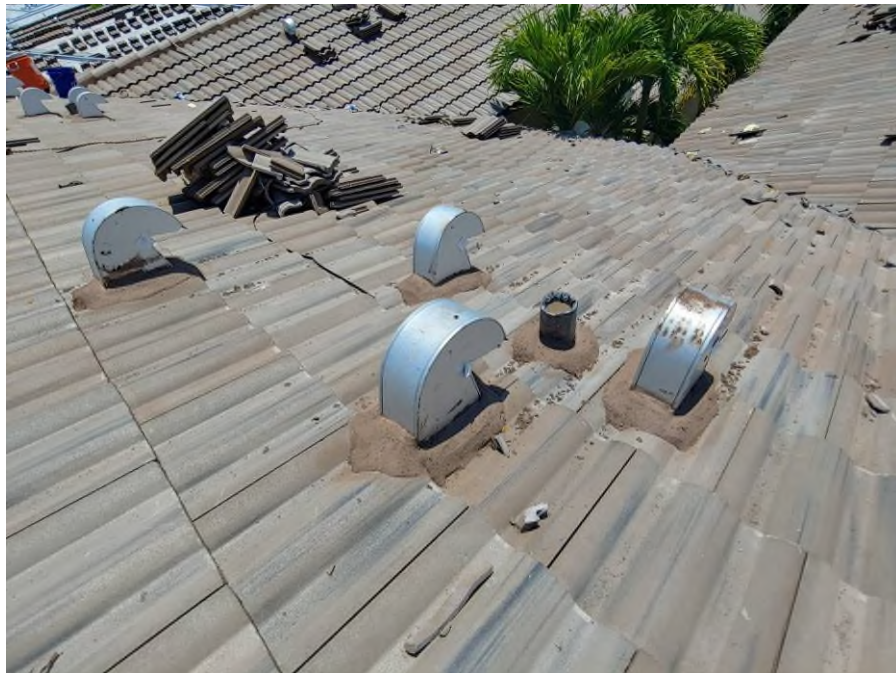
Photograph #2: Mortar adhesive application was in progress on building 21731.

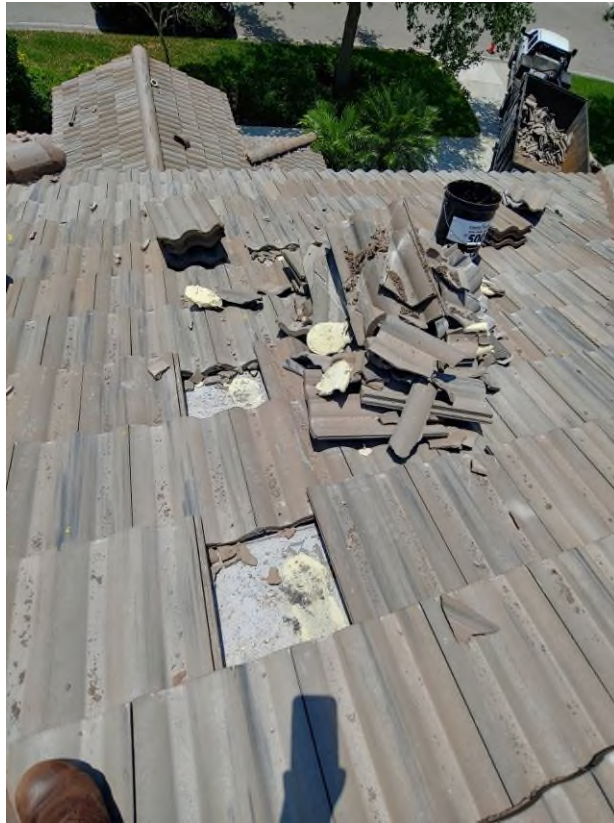
Photograph #3: Broken field tile replacement was in progress on building 21731.

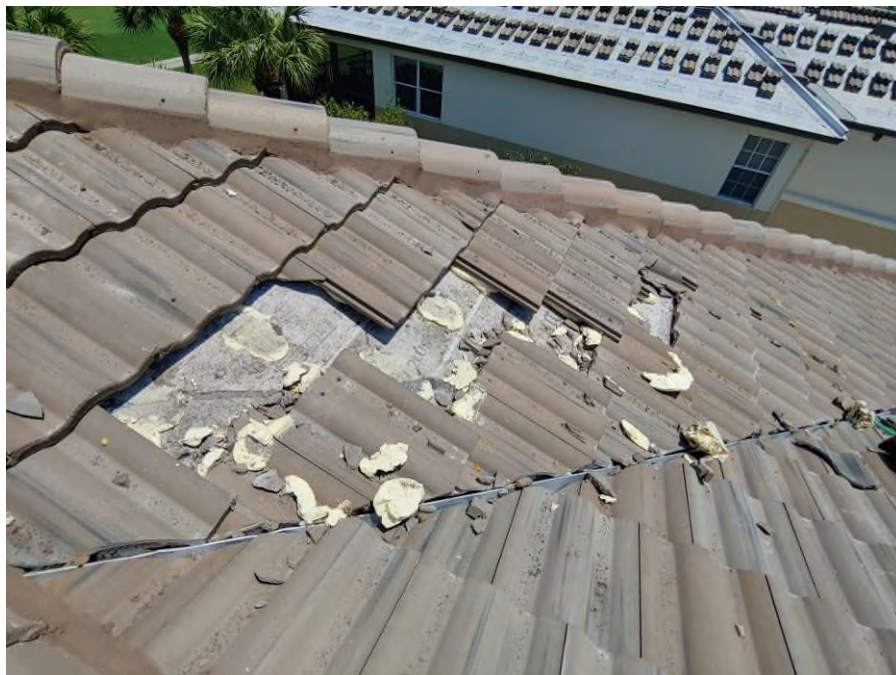
Photograph #4: Broken field tile replacement was in progress on building 21731.

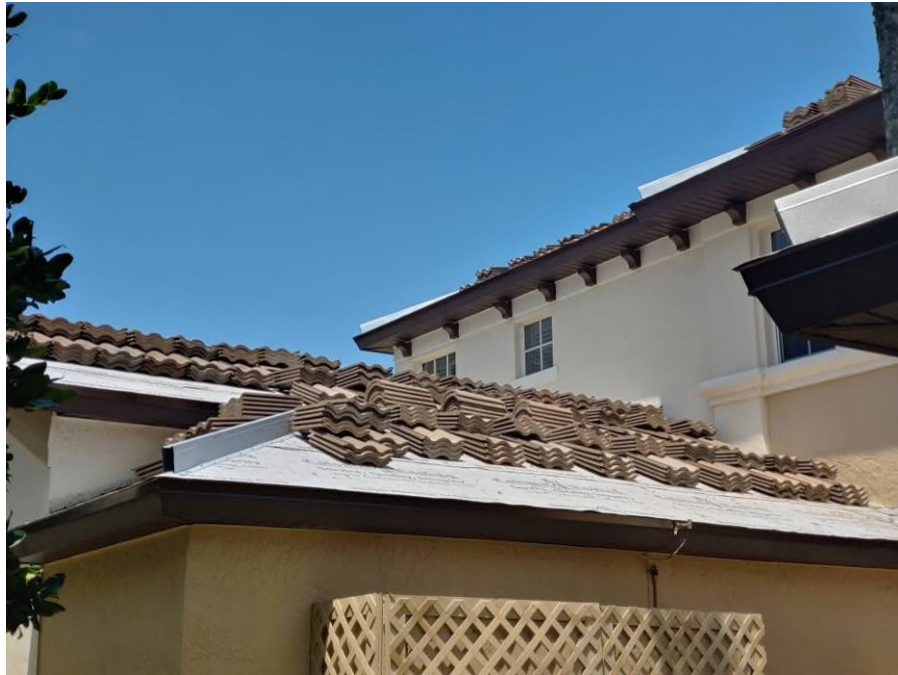
Photograph #5: Roof tiles were set in place for installation on buildings 21741.

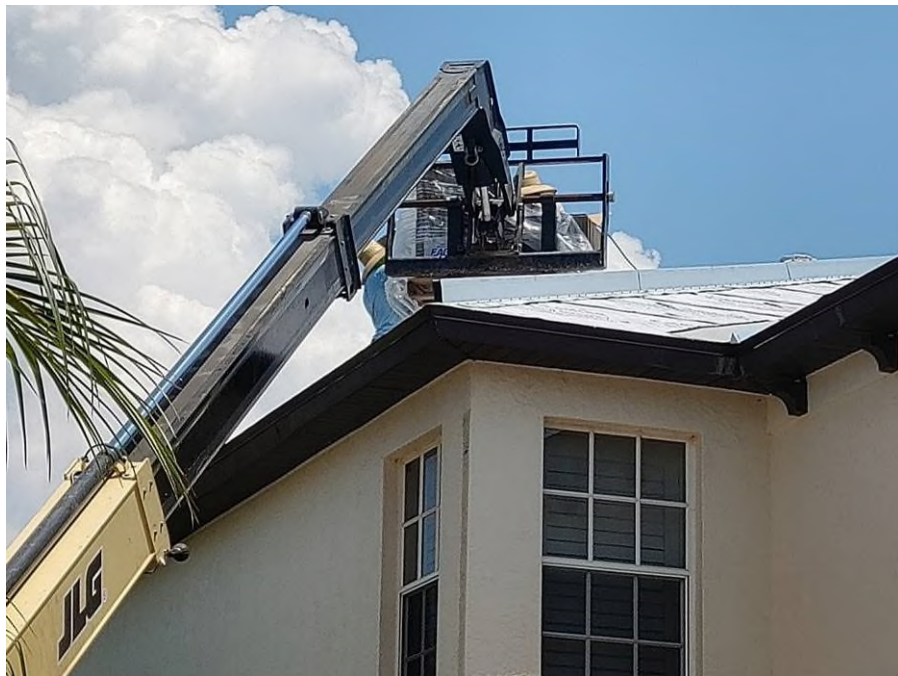
Photograph #6: Roof tiles were set in place for installation on buildings 21751.

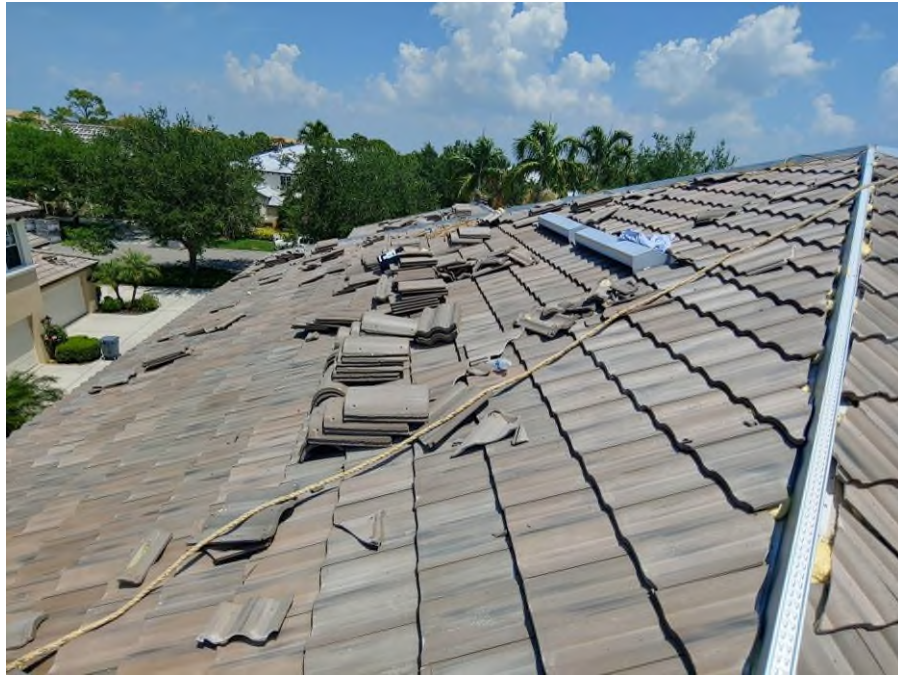
Photograph #7: Roof field tiles with polyurethane foam adhesive were in progress on building 21760.

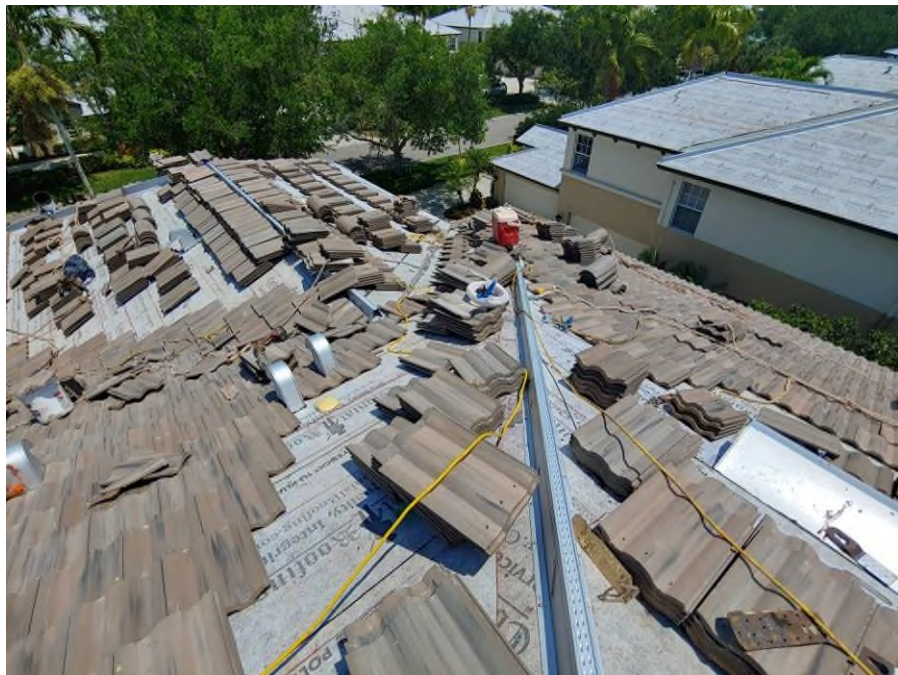
Photograph #8: Roof field tiles with polyurethane foam adhesive were in progress on building 21760.

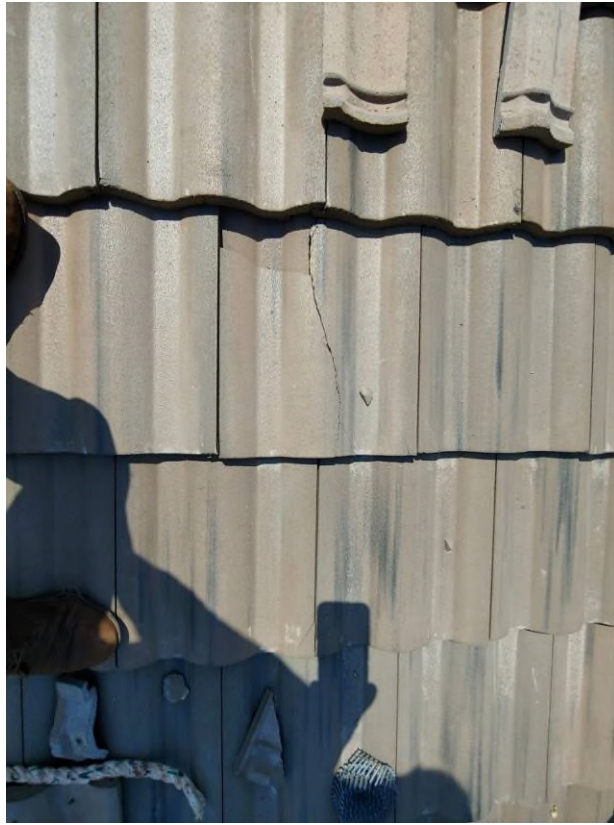
Photograph #9: Broken field tile replacement must be addressed on building 21760.

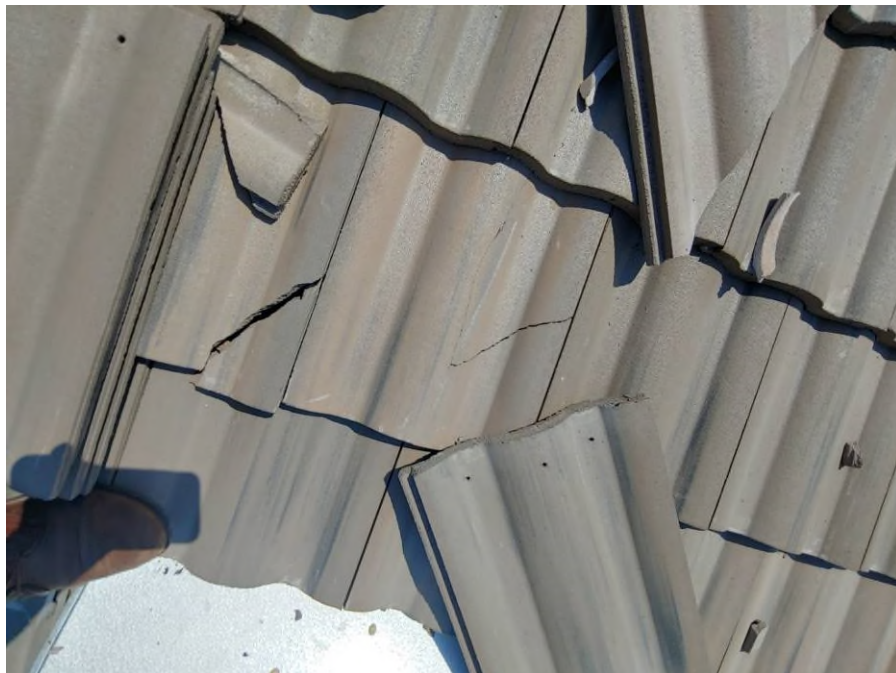
Photograph #10: Broken field tile replacement must be addressed on building 21760.

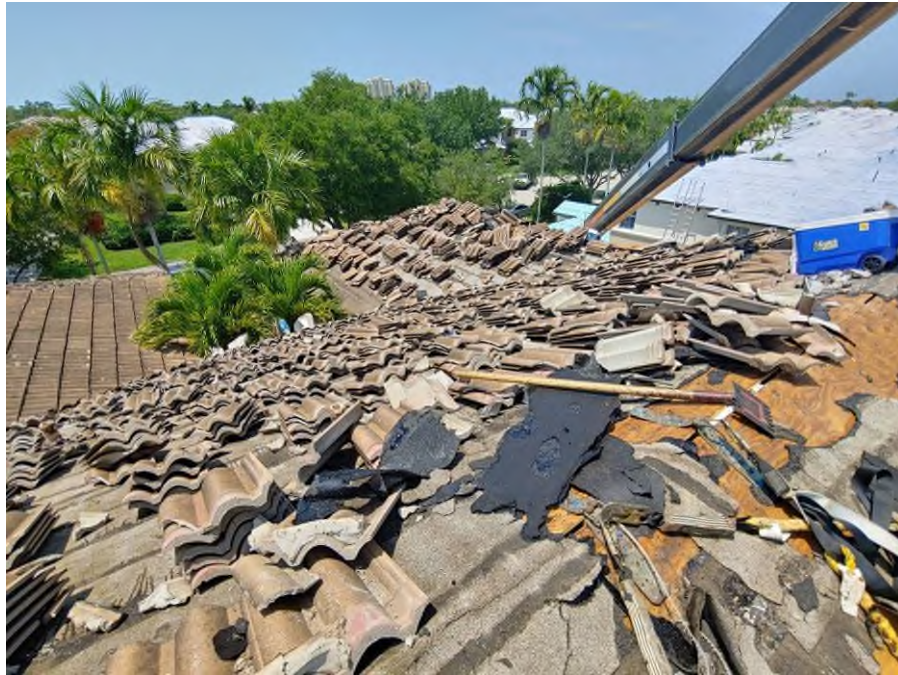
Photograph #11: Roof tile removal was in progress on building 21811.

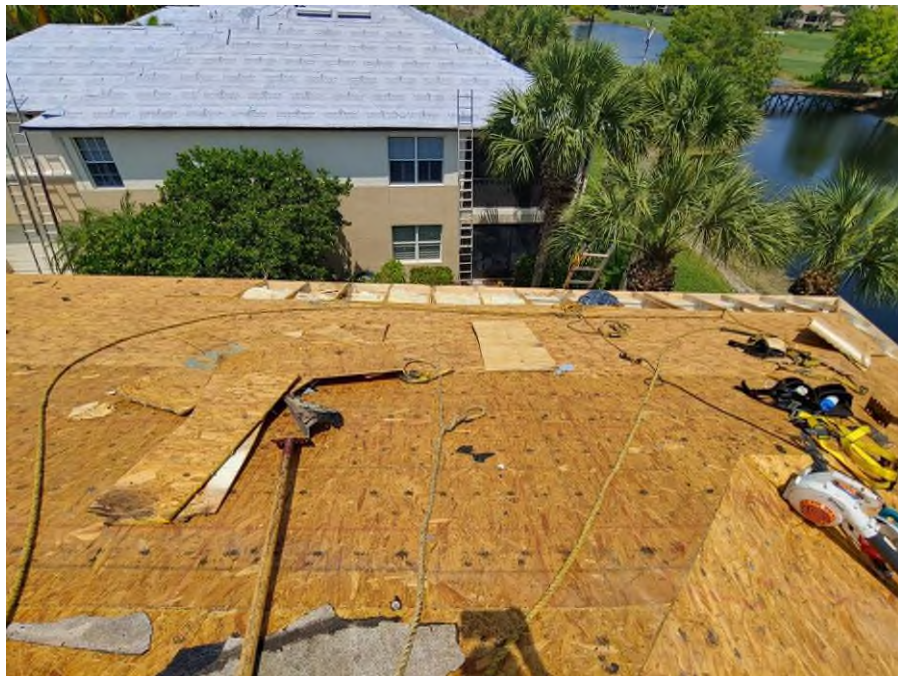
Photograph #12: Roof tile removal was in progress on building 21811.

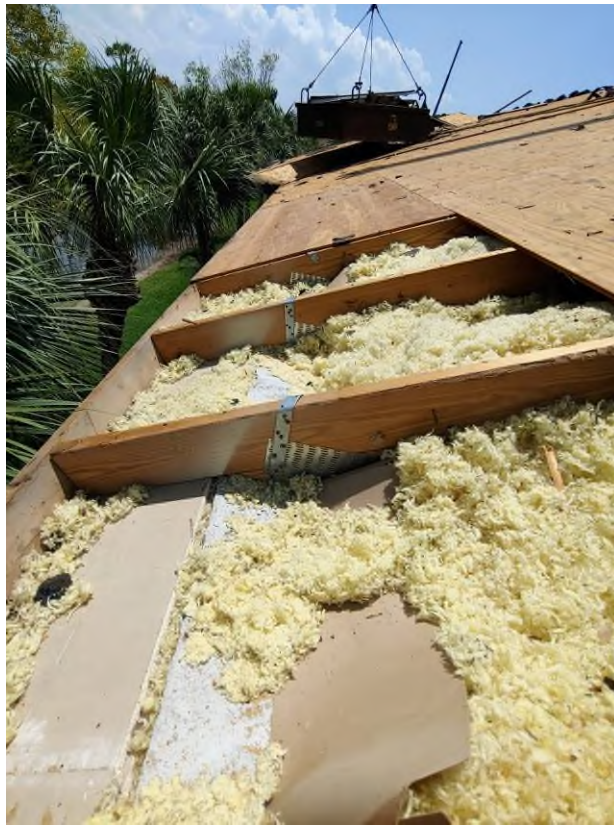
Photograph #13: Existing strap clips on the trusses have the required minimum of 5 nails on building 21811.

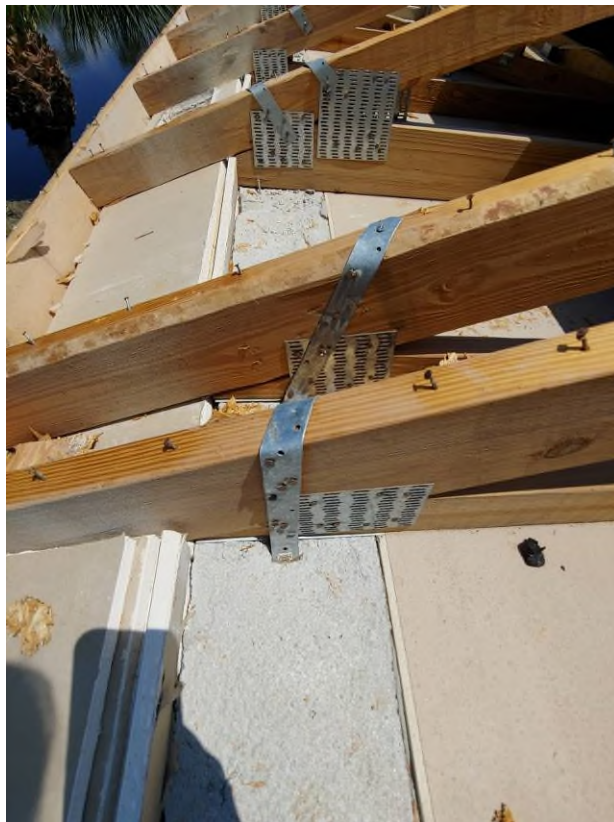
Photograph #14: Existing strap clips on the trusses have the required minimum of 5 nails on building 21811.

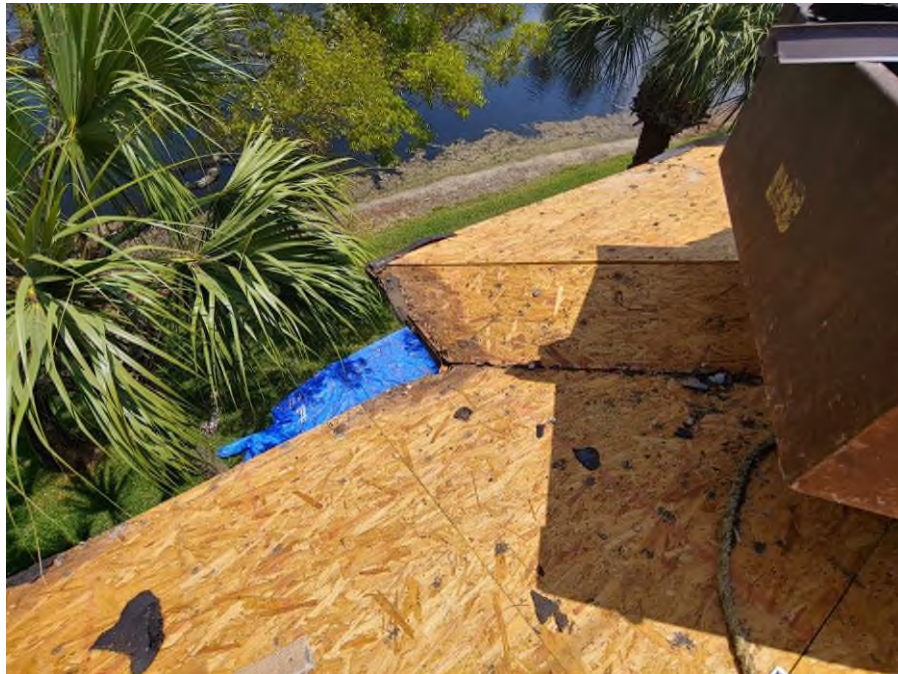
Photograph #16: Rotten fascia, trusses and plywood sheathing were observed on building 21811.

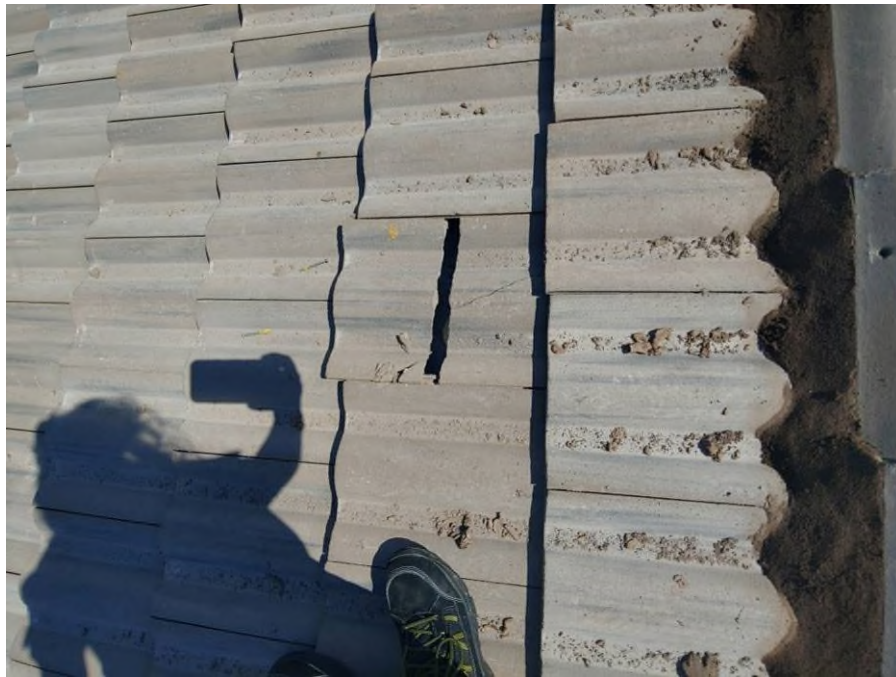
Photograph #7: Broken field tile replacement must be addressed on building 21711.

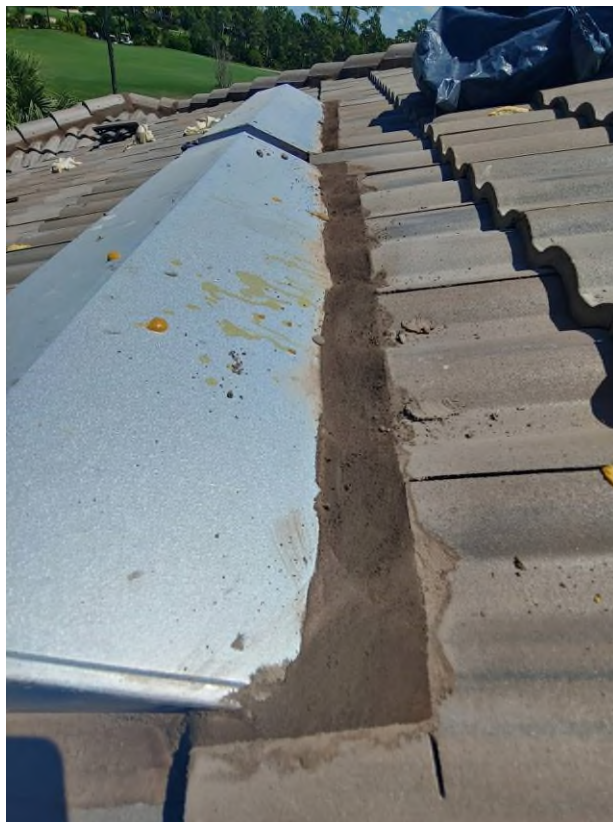
Photograph #8: Mortar adhesive application was in progress on building 21711.

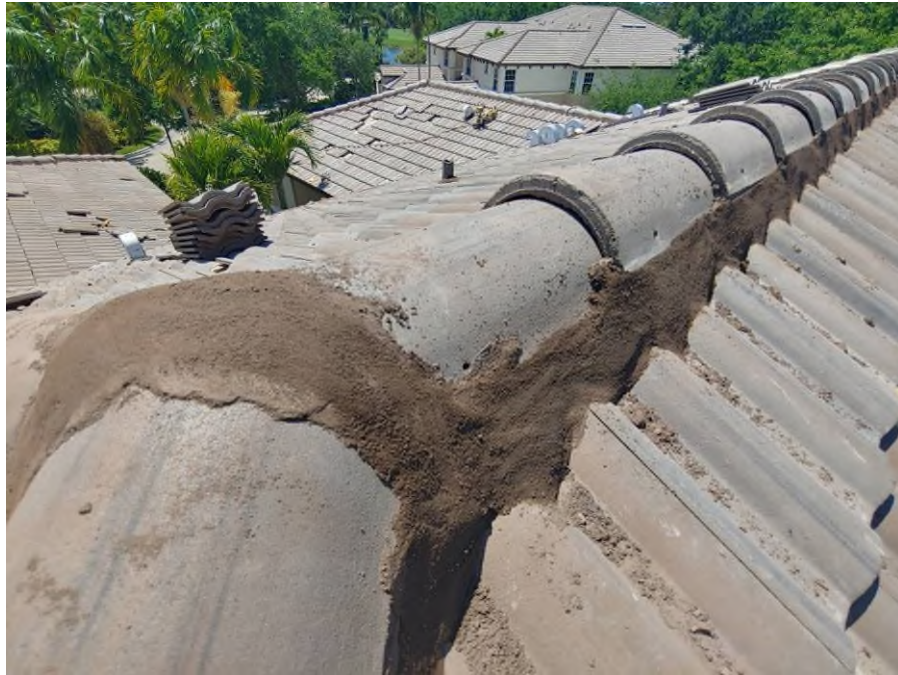
Photograph #9: Mortar adhesive application was in progress on building 21711.

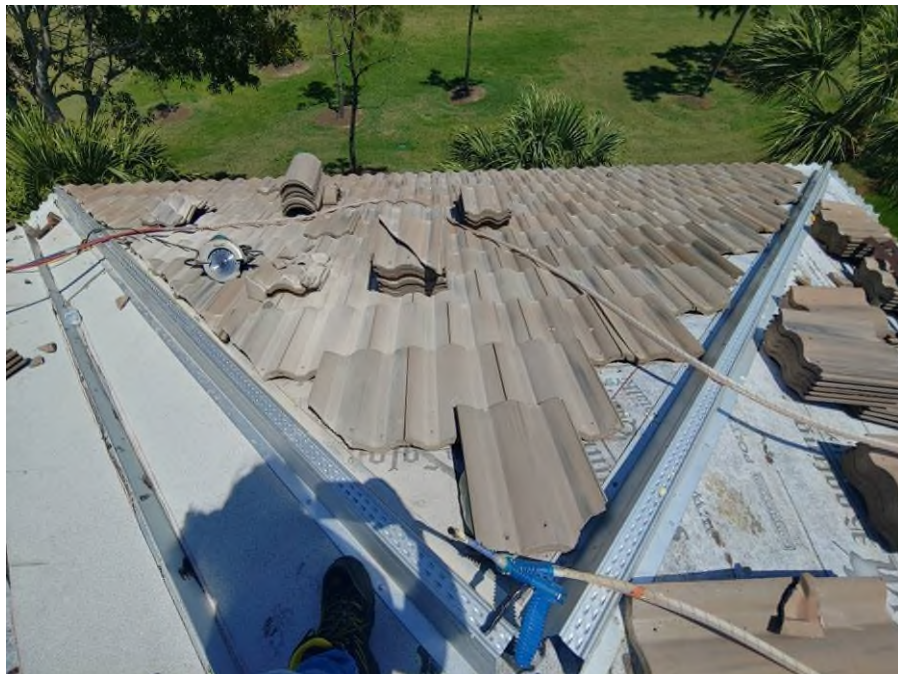
Photograph #10: Roof field, ridge and hip tile installations with polyurethane foam adhesive were in progress on building 21721.

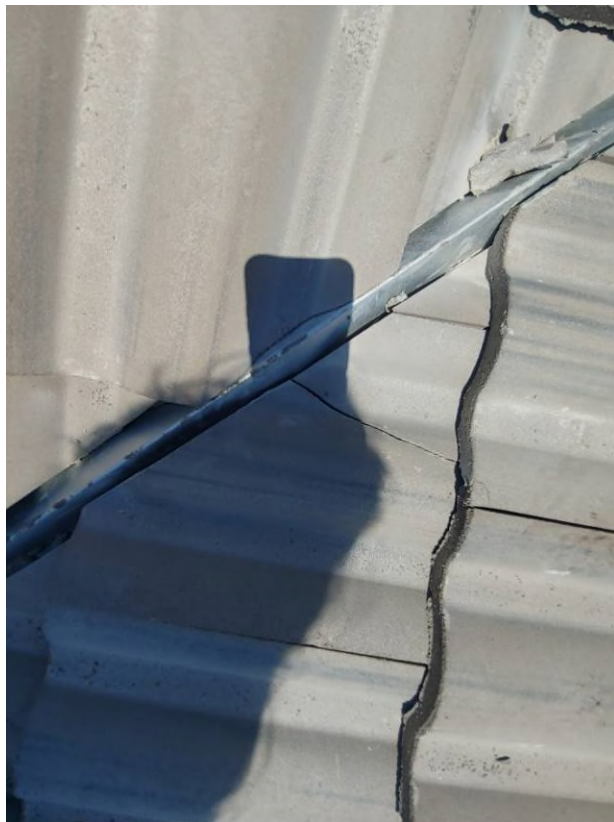
Photograph #12: Broken field tile replacement must be addressed on building 21721.

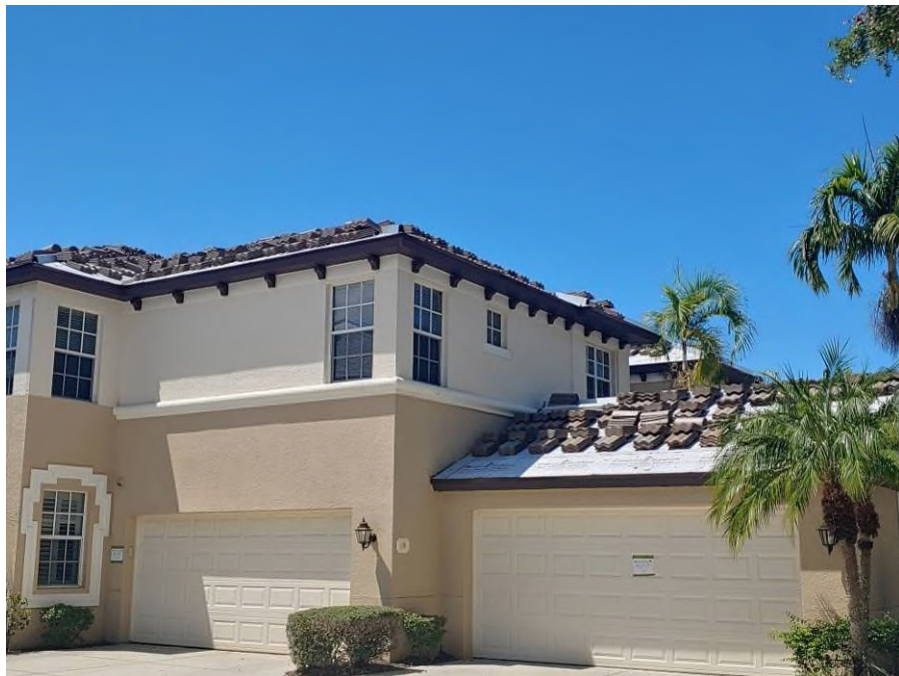
Photograph #14: Roof tiles were set into place for installation on building 21740.

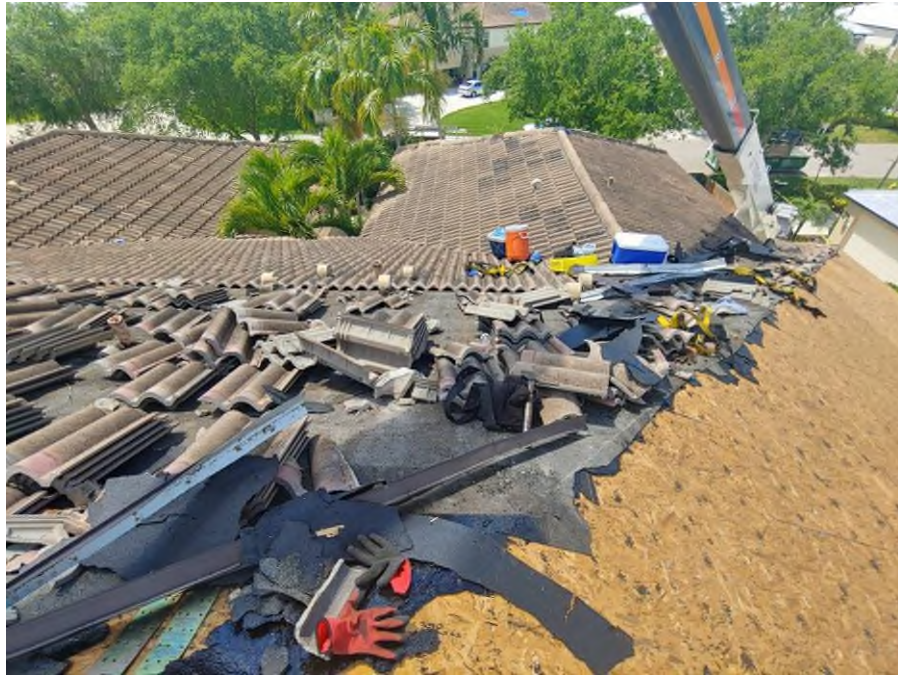
Photograph #15: Roof tile removal was in progress on building 21781.

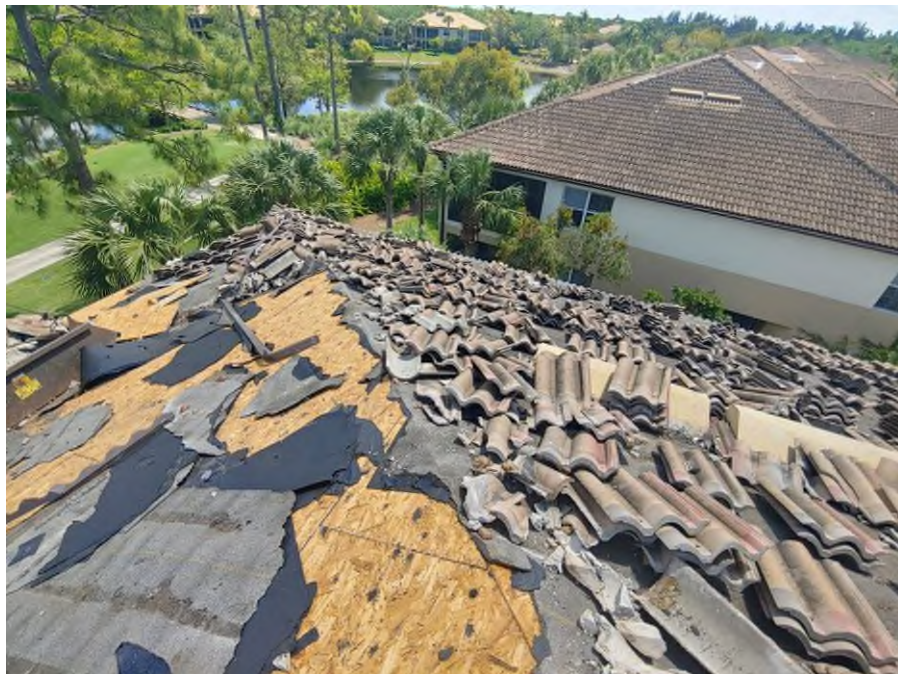
Photograph #16: Roof tile removal was in progress on building 21781.

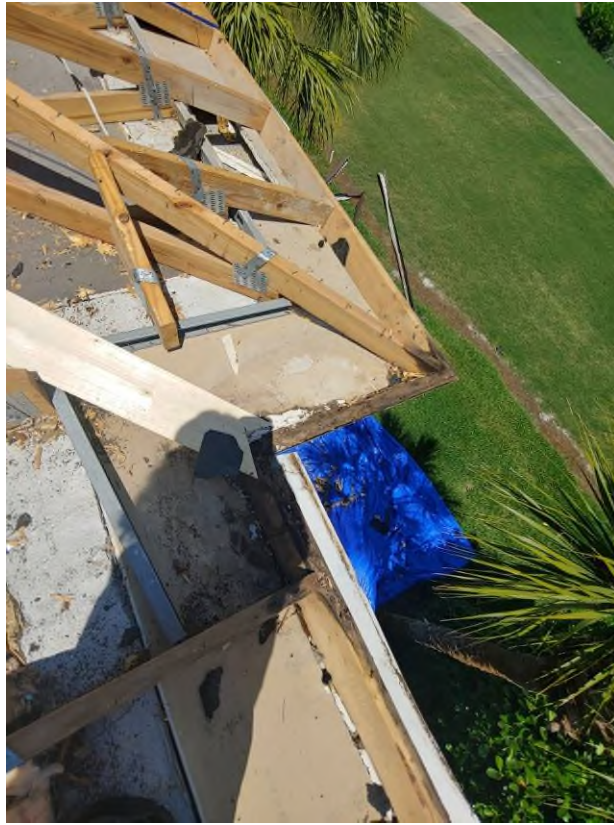
Photograph #19: Rotten fascia and truss were observed on building 21781.

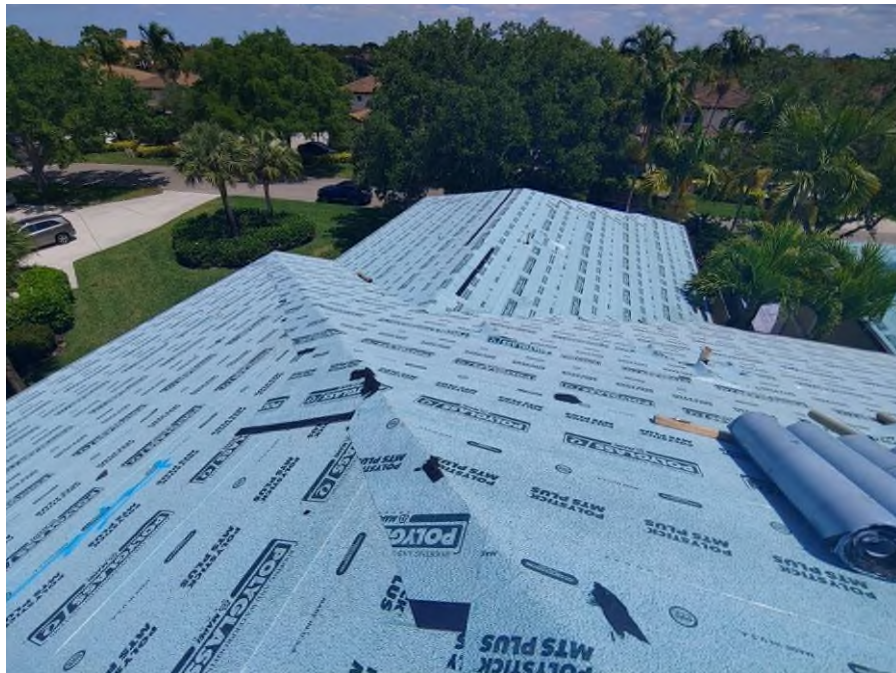
Photograph #20: Polystick MTS Plus underlayment was completed on building 21810.

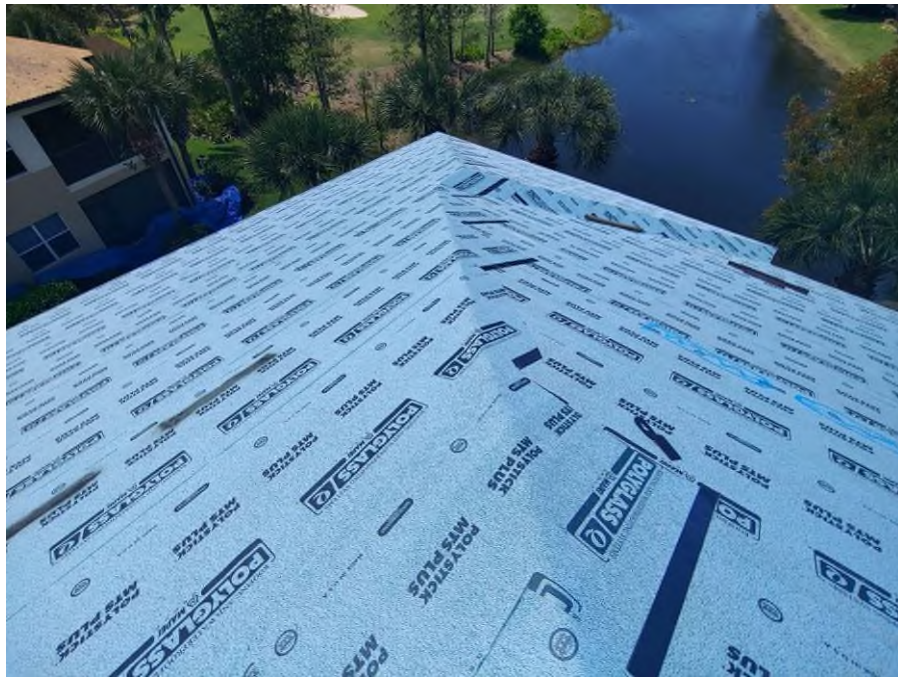
Photograph #21: Polystick MTS Plus underlayment was completed on building 21810.

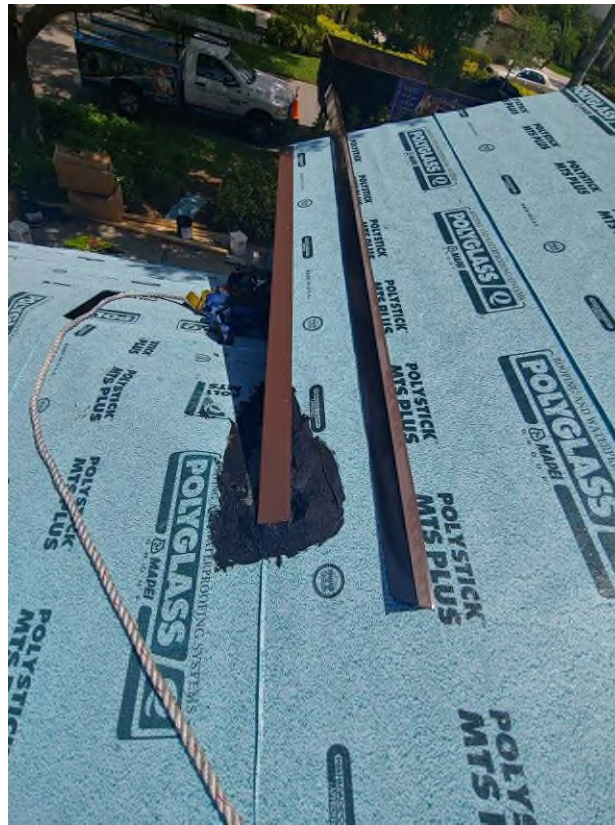
Photograph #23: Drip-edge installation was in progress on building 21810.

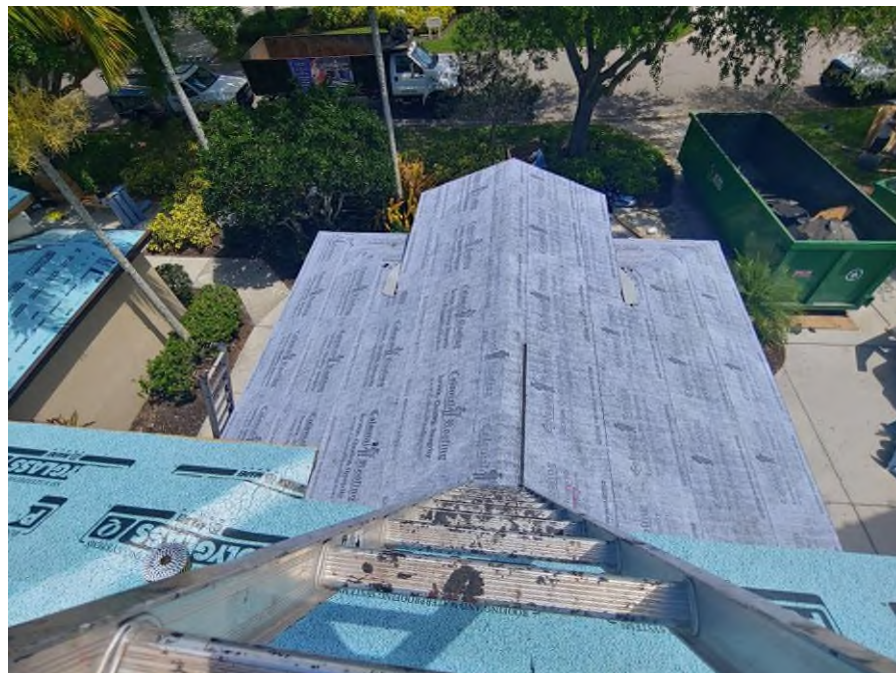
Photograph #24: Second layer of underlayment began on building 21810.

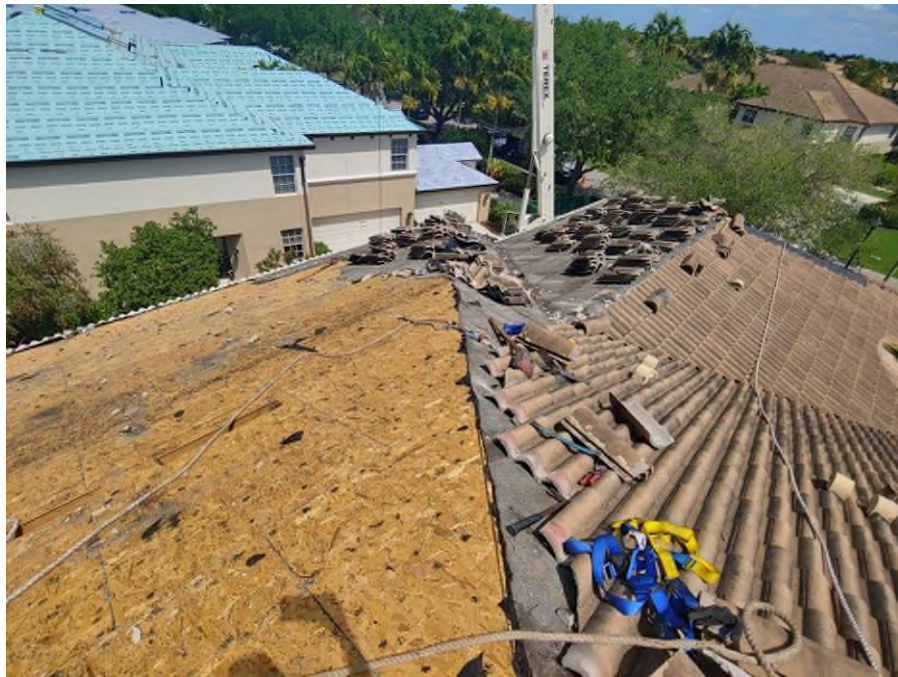
Photograph #25: Roof tile removal was in progress on building 21820.

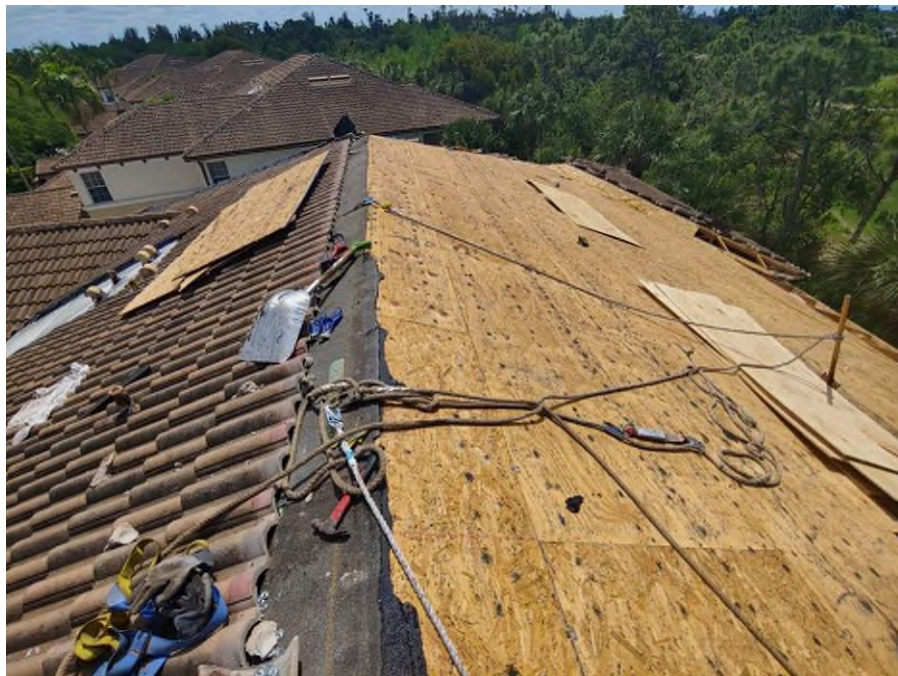
Photograph #26: Roof tile removal was in progress on building 21820.

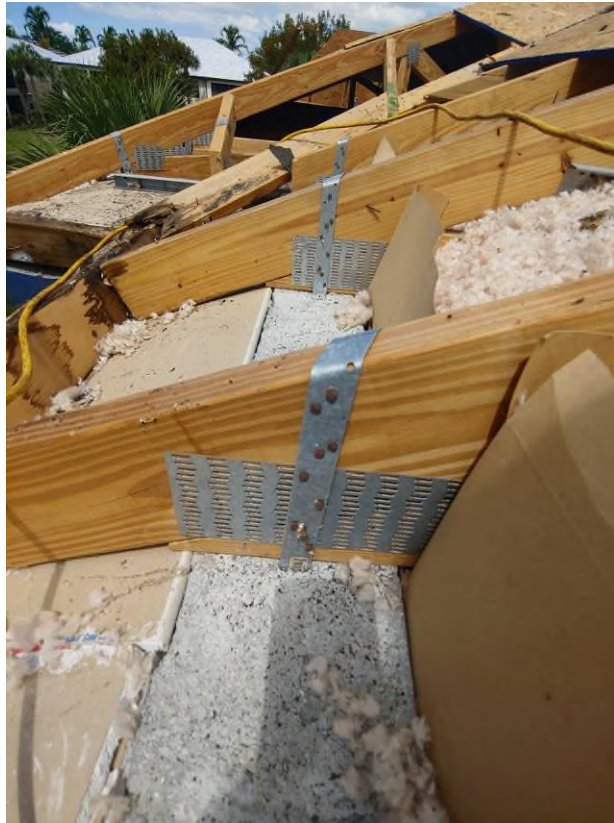
Photograph #27: Existing strap clips on the trusses have the required minimum of nails on building 21820.

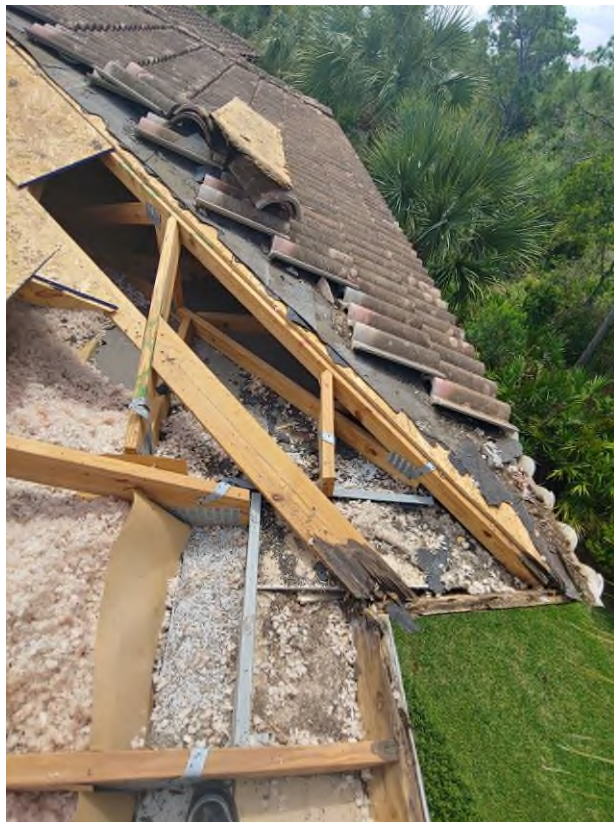
Photograph #28: Rotten fascia and truss were observed on building 21820.

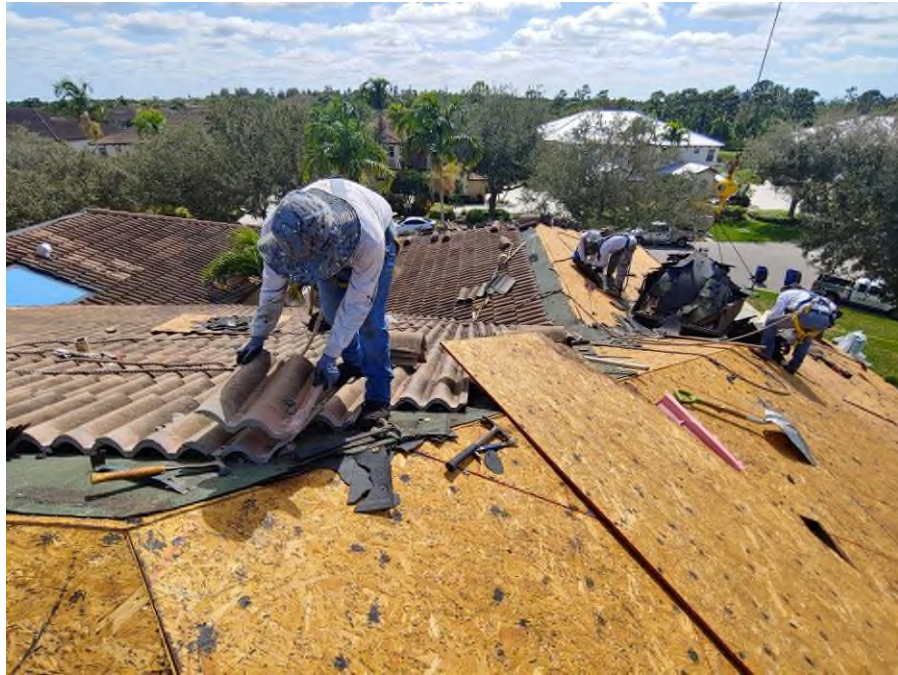
Photograph #1: Roof tile removal was in progress on building 7861.

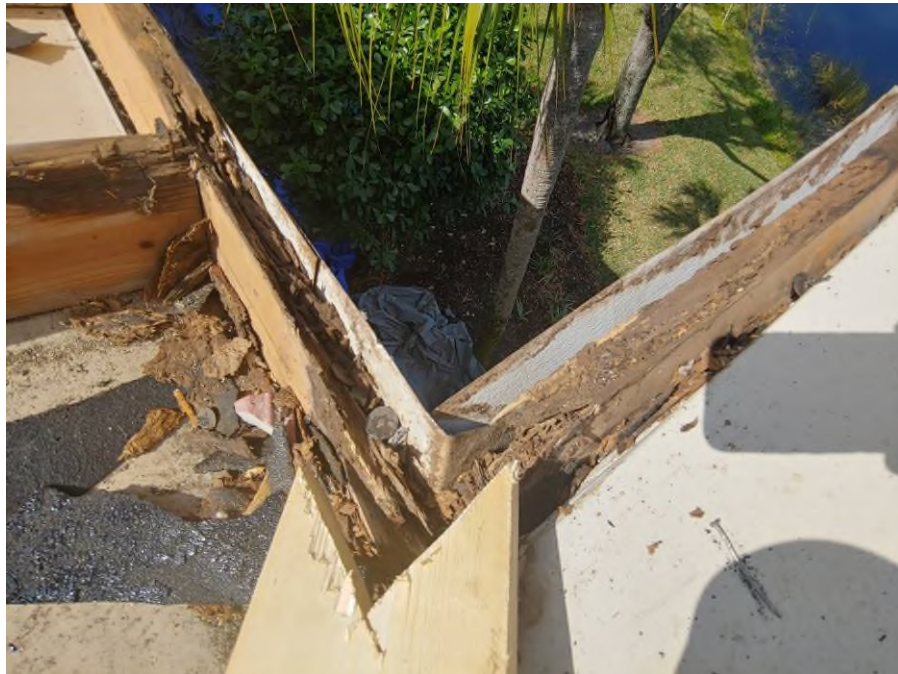
Photograph #2: Rotten wood fascia was observed on building 7861.

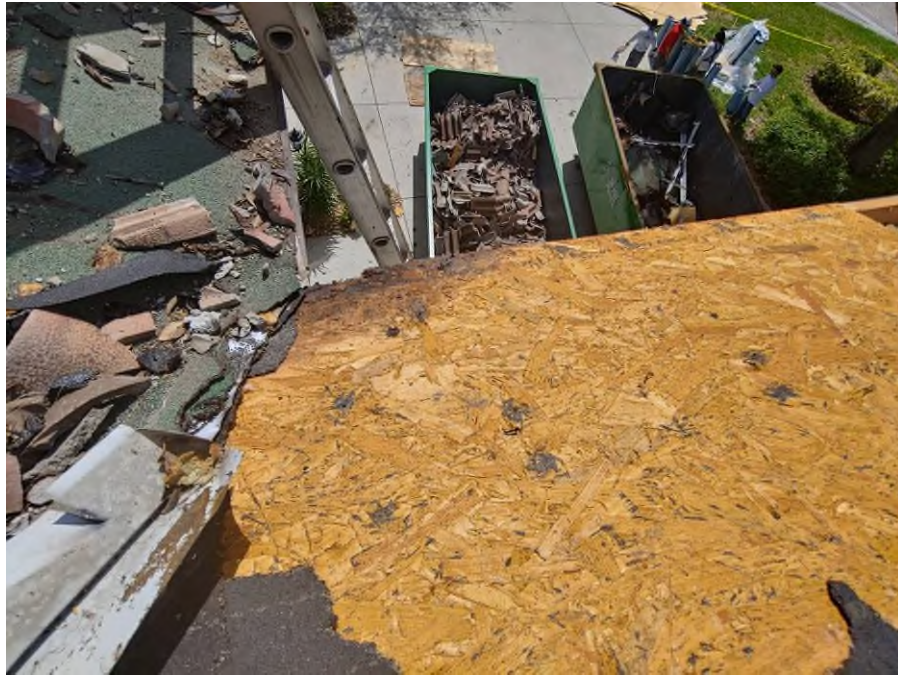
Photograph #3: Rotten plywood sheathing was observed on building 7861.

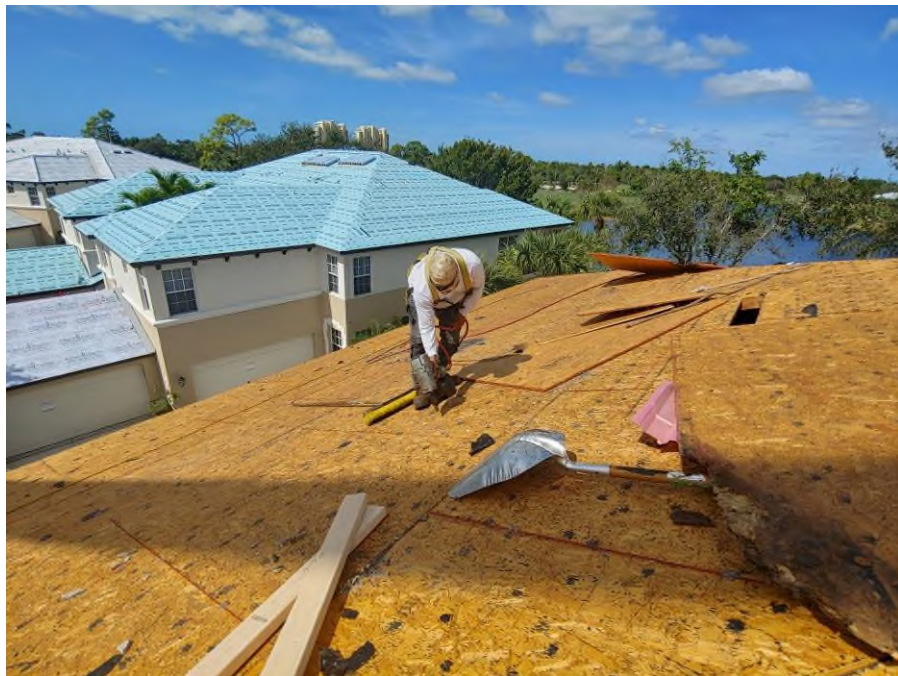
Photograph #4: Re-nail pattern at plywood sheathing was in progress on building 7861.

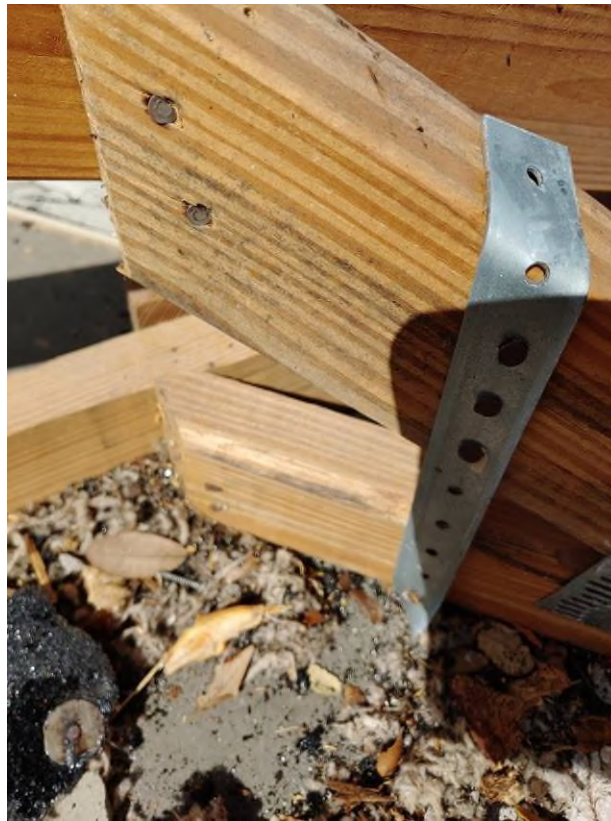
Photograph #5: KEG observed a lack of nails on a few existing straps on building 7861. N8D nails were installed during the site visit to comply with the Florida building code.

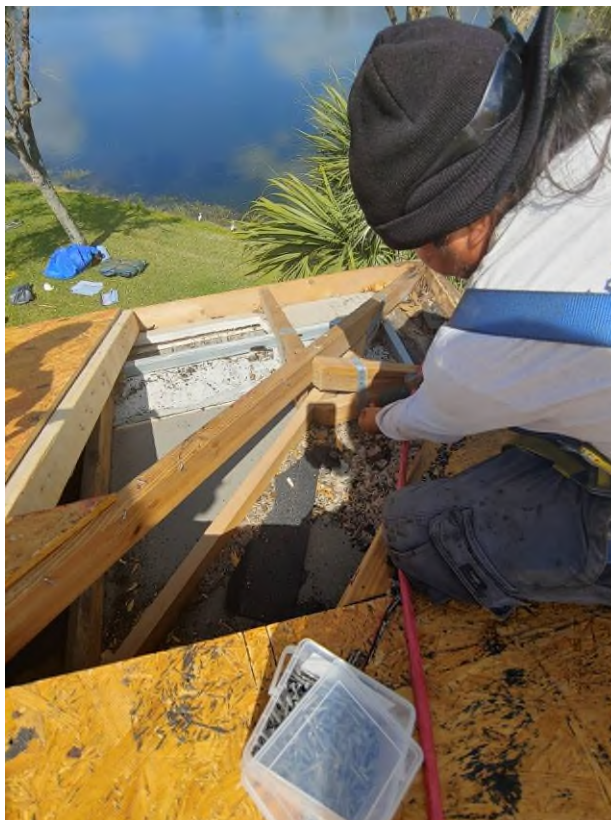
Photograph #6: KEG observed a lack of nails on a few existing straps on building 7861. N8D nails were installed during the site visit to comply with the Florida building code.
