Uniform Mitigation Verification Inspection Form

Inspection Date: 5-6-2020		
Owner Information		
Owner Name: Palmetto Dunes Pelical Sound Condominium Association Inc.		Contact Person:
Address: 21731 Palmetto Dunes Drive Units 101,102,201,202		Home Phone:
City: Estero	Zip: 33928	Work Phone:
County: Lee		Cell Phone:
Insurance Company:		Policy #:
Year of Home: 2001	# of Stories: 2	Email:

DATE	March 30, 2020	JOB NO.	20RN-0085
Palmetto Dunes CAI – Roofing Project			
LOCATION	Palmetto Dunes Drive		
CONTRACTOR	EnviroStruct, LLC	Palmetto Dunes CAI	
WEATHER	Sunny	TEMP. 88° F	Time 2:30PM
PRESENT AT SITE	Rahmin Bahar, EnviroStruct (ES) Teresita Nazario-Acosta, Karins Engineering Group (KEG)

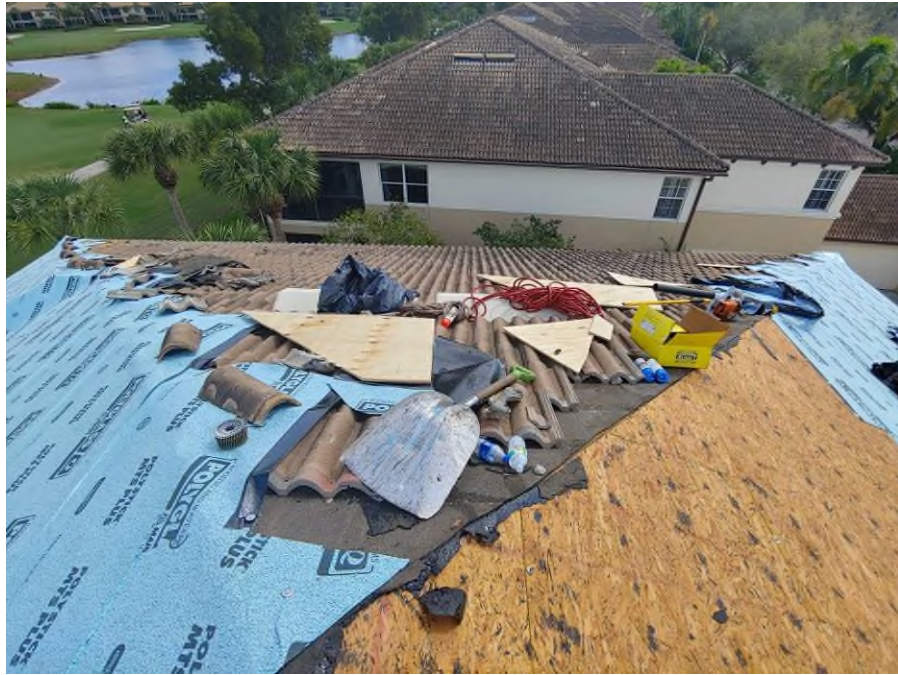
Photograph #7: Roof tile removal was in progress on building 21731.

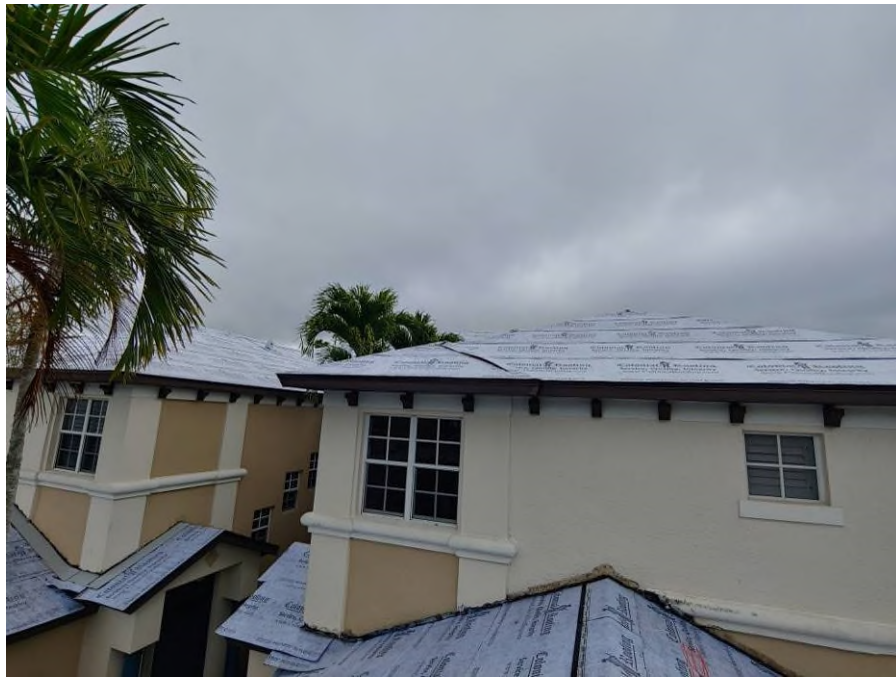
Photograph #5: Second layer of underlayment installation was in progress on building 7860.

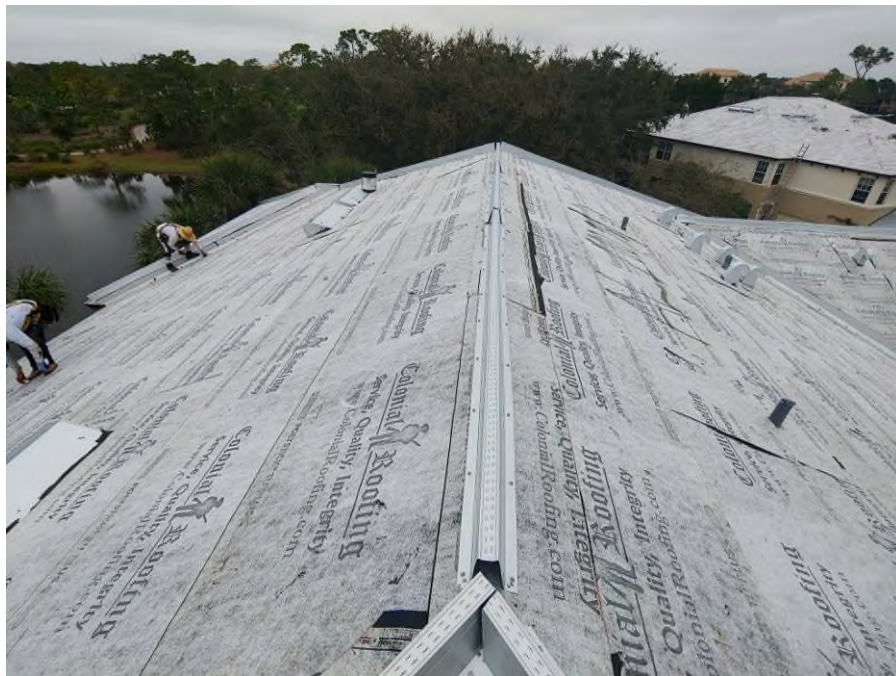
Photograph #6: V-crimp metal valley flashing, and hip/ridge metal channel installations were in progress on building 21700.

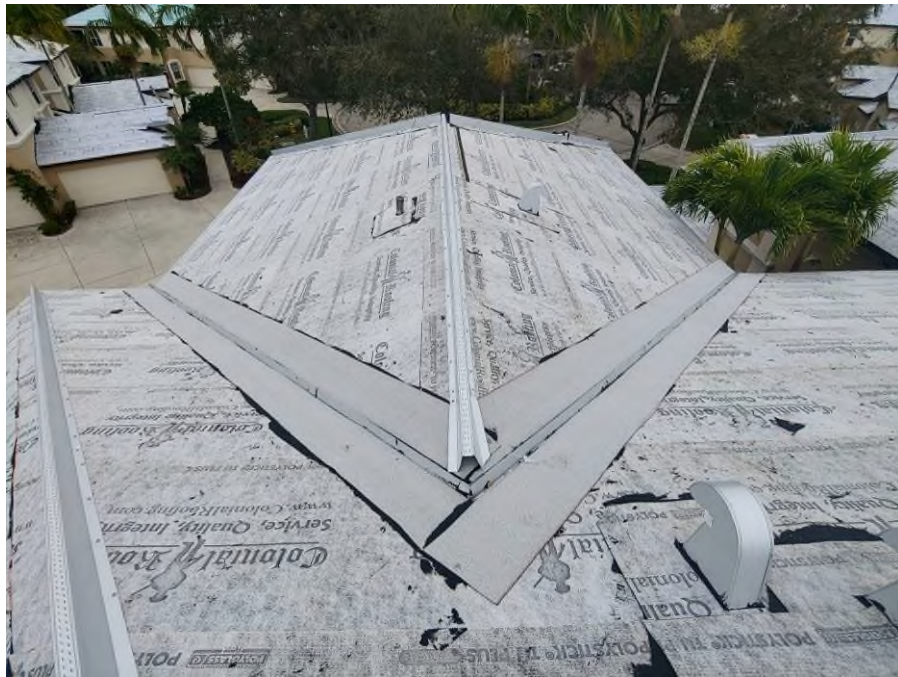
Photograph #7: V-crimp metal valley flashing, and hip/ridge metal channel installations were in progress on building 21700.

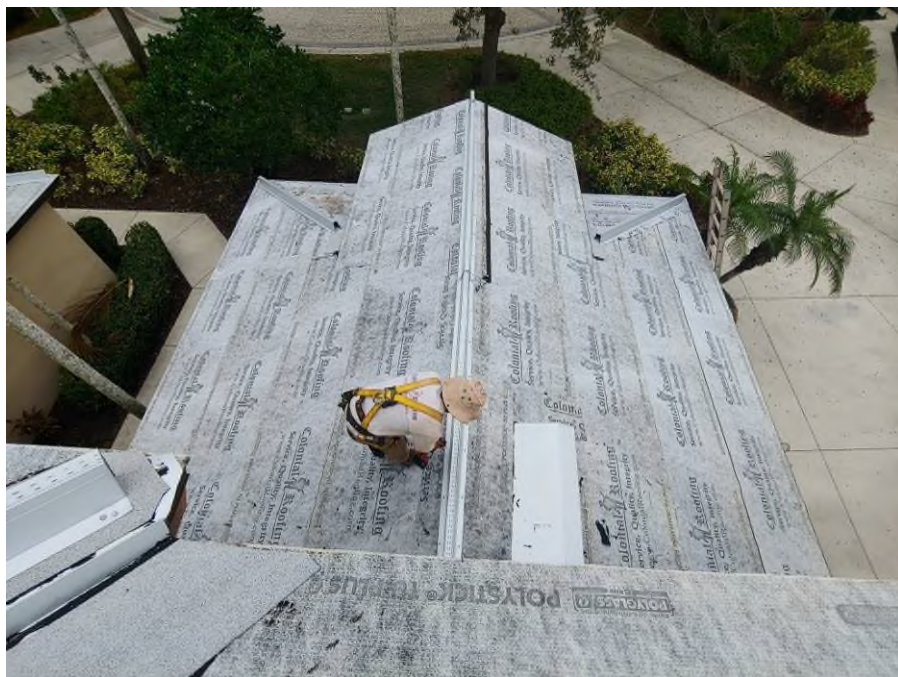
Photograph #8: V-crimp metal valley flashing, and hip/ridge metal channel installations were in progress on building 21700.

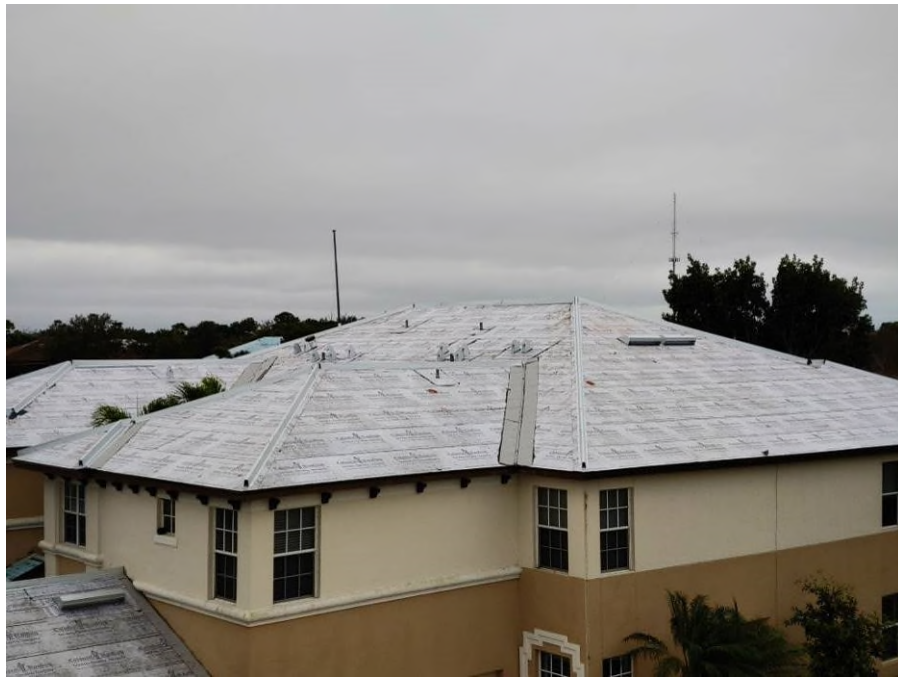
Photograph #9: V-crimp metal valley flashing, and hip/ridge metal channel installations were in progress on building 21710.

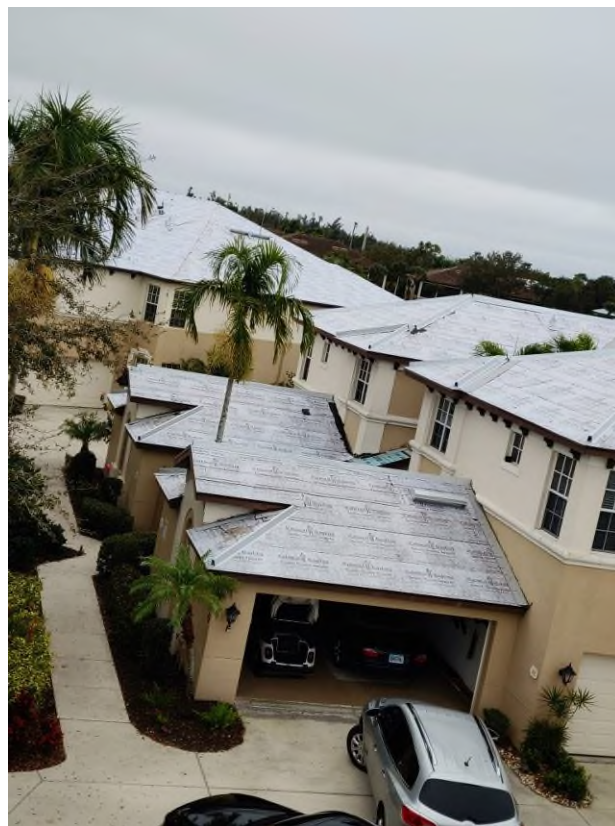
Photograph #10: Second layer of underlayment installation was in progress on building 21710.

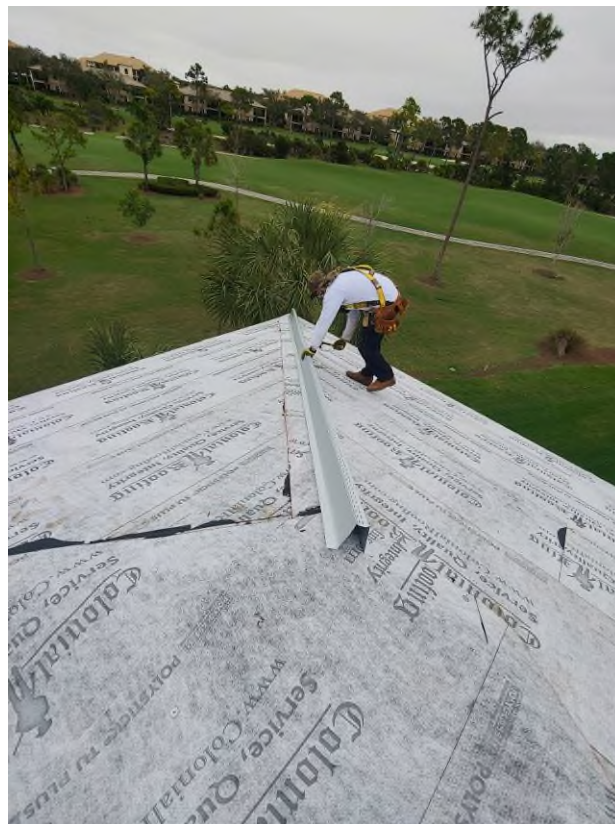
Photograph #12: V-crimp metal valley flashing, and hip/ridge metal channel installations were in progress on building 21711.

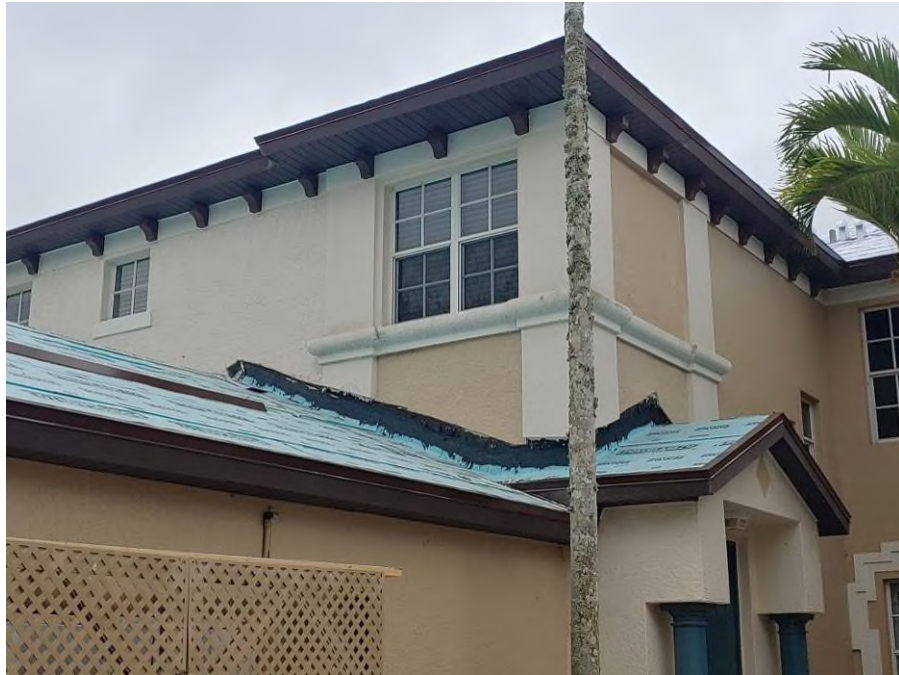
Photograph #15: Drip-edge flashing installation was in progress on building 21720.

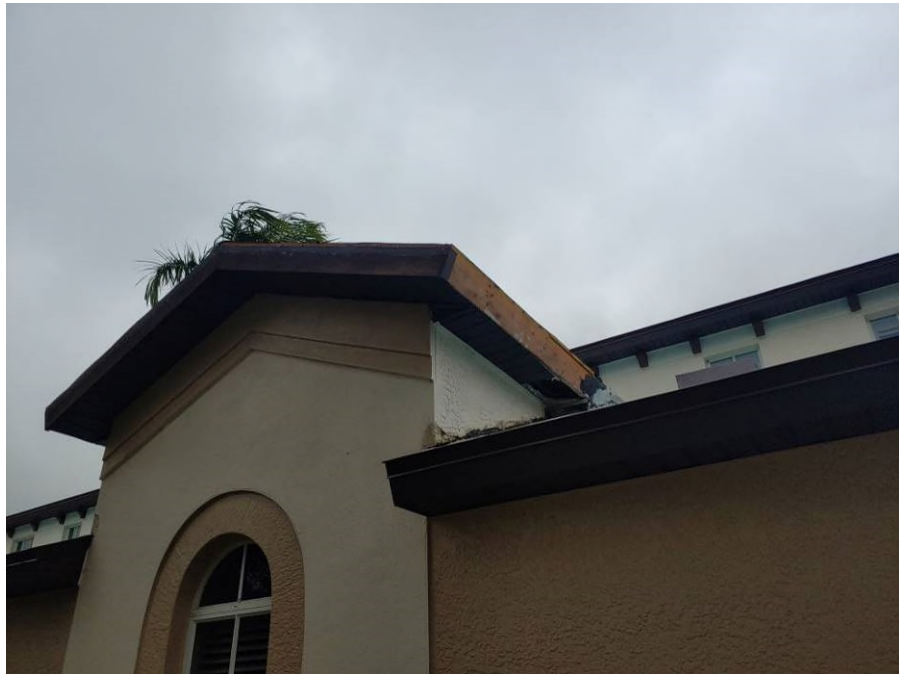
Photograph #16: Fascia repair was in progress on building 21720.

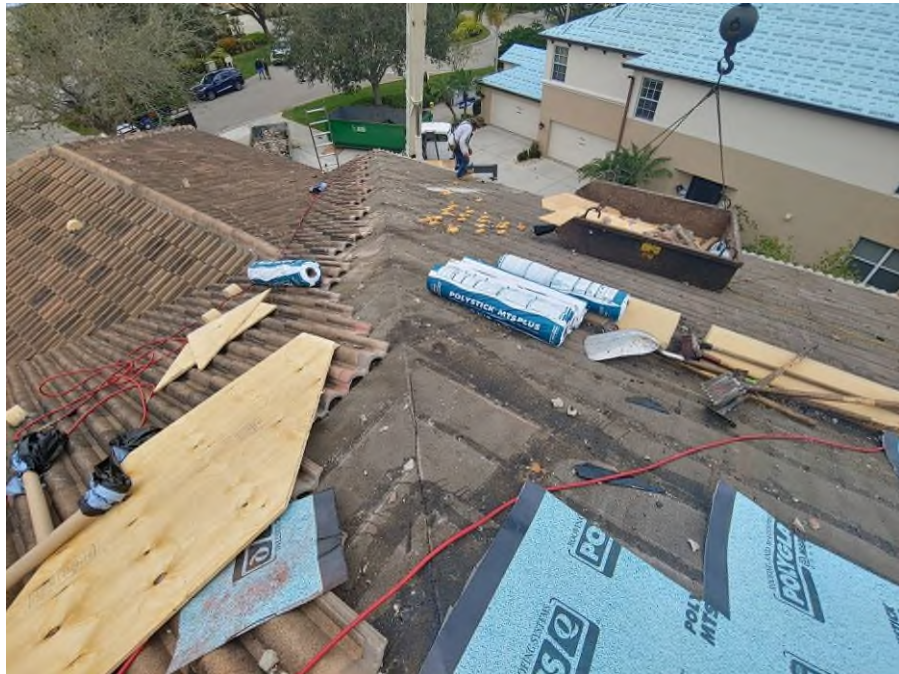
Photograph #20: Roof tile removal was in progress on building 21731.

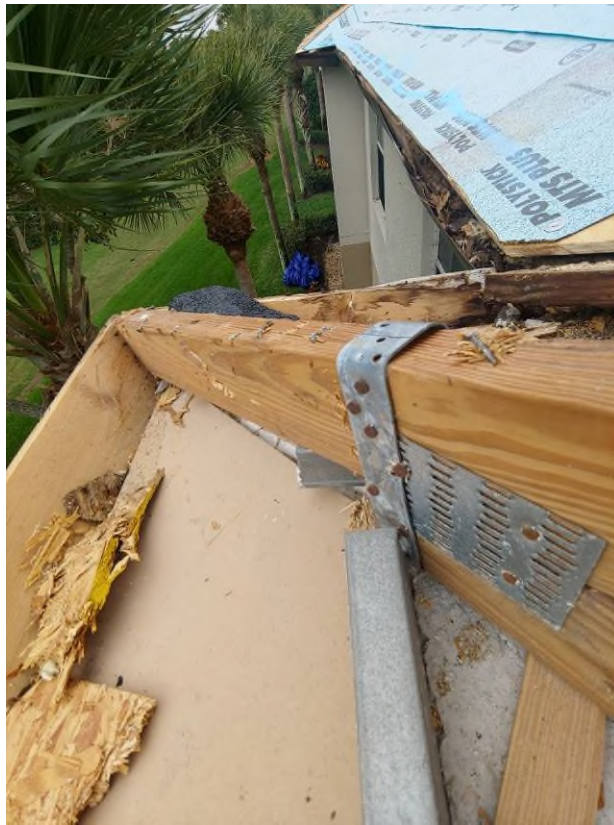
Photograph #21: Existing strap clips on trusses have the required minimum quantity of nails on building 21731. Installation of new hurricane truss anchor straps (HGAM10) is not required.

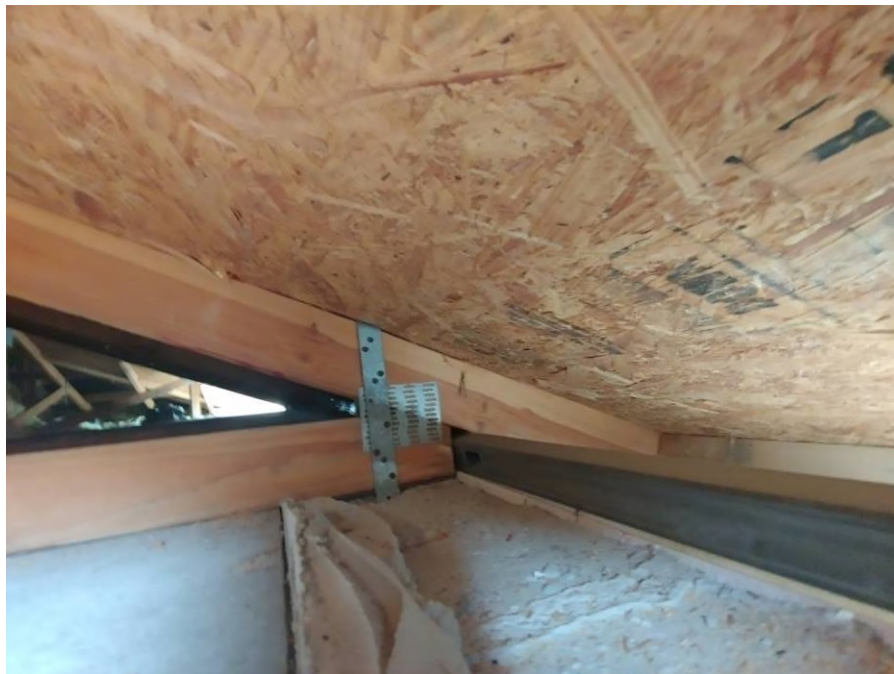
Photograph #22: Existing strap clips on trusses have the required minimum quantity of nails on building 21731. Installation of new hurricane truss anchor straps (HGAM10) is not required.
