Uniform Mitigation Verification Inspection Form

Maintain a copy of this form and any documentation provided with the insurance policy

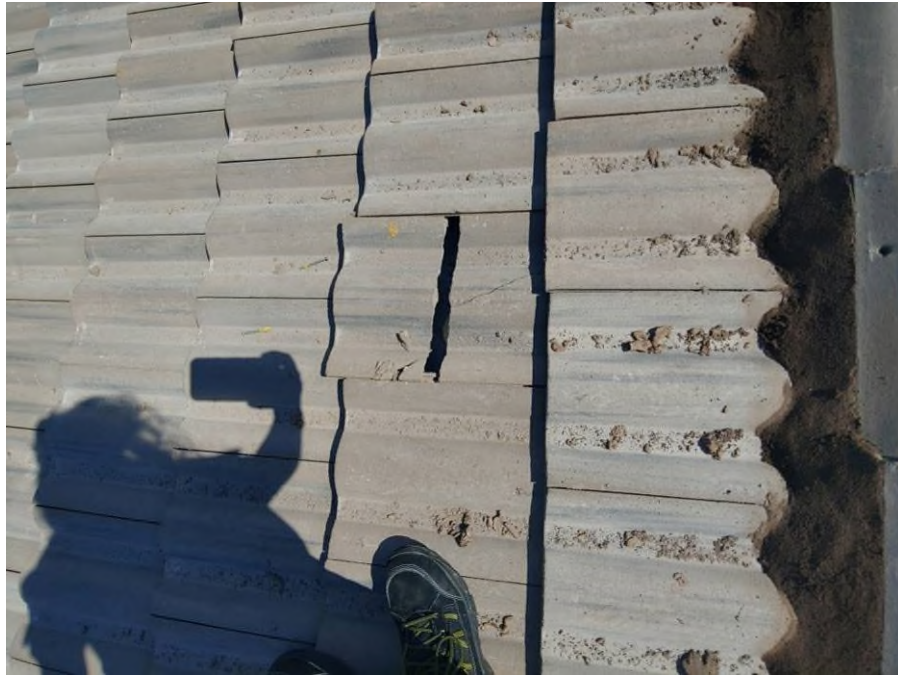
Photograph #7: Broken field tile replacement must be addressed on building 21711.

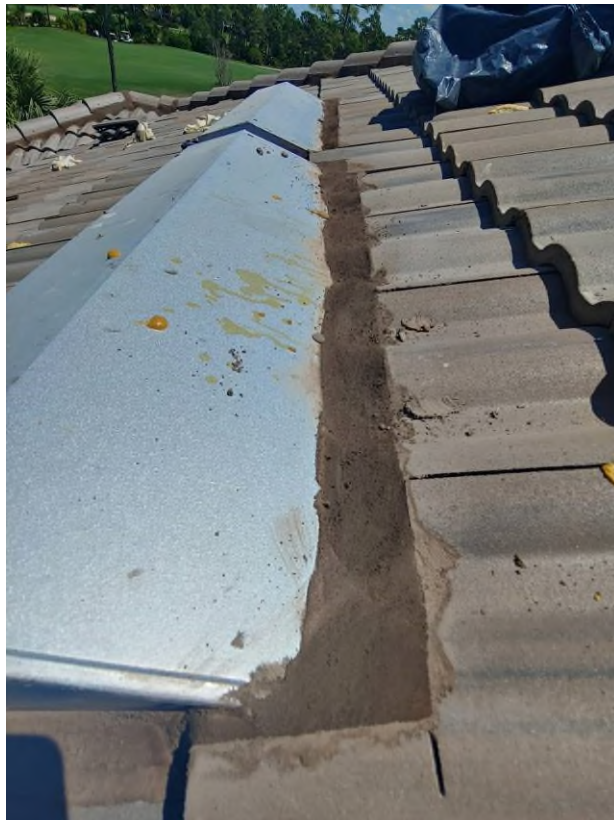
Photograph #8: Mortar adhesive application was in progress on building 21711.

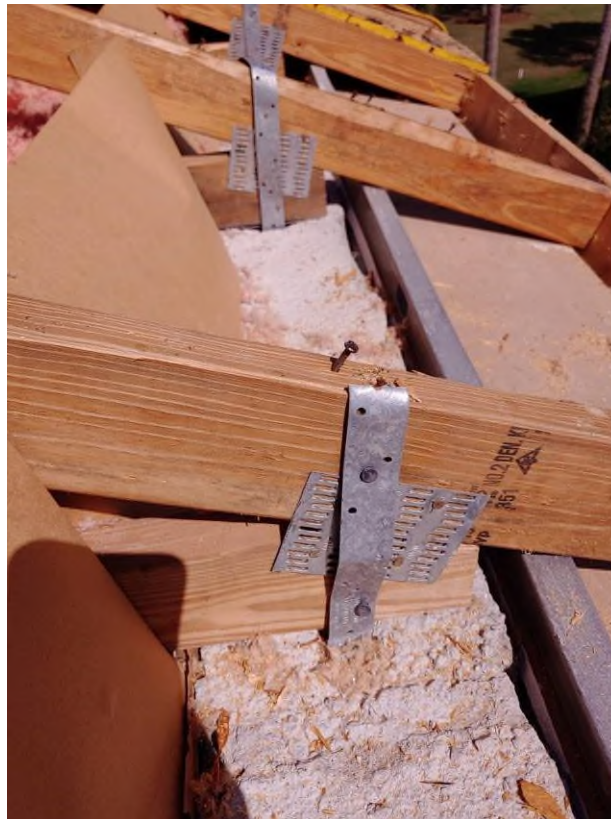
Photograph #7: KEG observed a lack of nails on a few existing straps on building 21721. N8d nails were installed during the site visit to comply with the Florida Building Code.

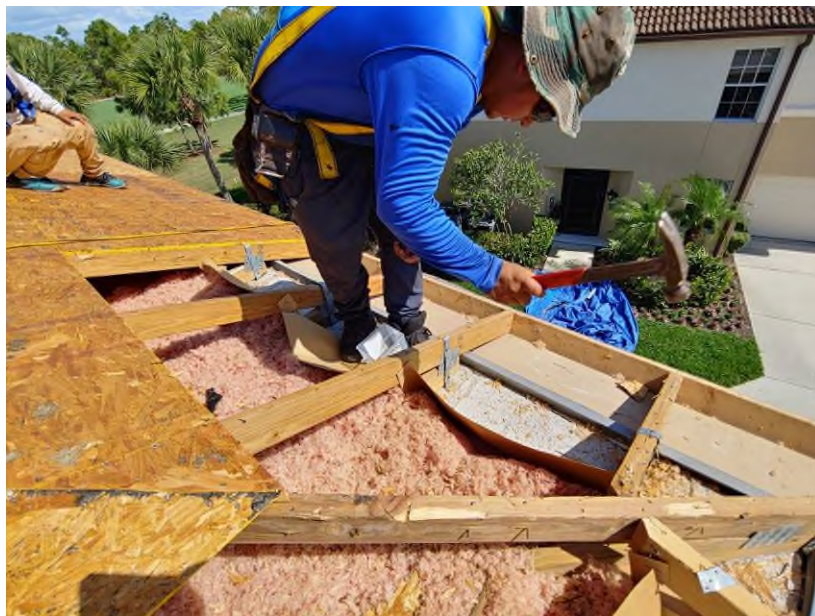
Photograph #8: KEG observed a lack of nails on a few existing straps on building 21721. N8d nails were installed during the site visit to comply with the Florida Building Code.
