# Uniform Mitigation Verification Inspection Form

**RE: Palmetto Dunes Condominium**  
**21720 Palmetto Dunes Drive**  
**Estero, FL 33928**  
**Roofing Restoration**  
**KEG File #20RN-0085**  
**Wind Mitigation**  
**Permit # 1721301-0**

DATE	February 21, 2020	JOB NO.	20RN-0085
Palmetto Dunes CAI – Roofing Project			
LOCATION	Palmetto Dunes Drive		
CONTRACTOR	EnviroStruct, LLC	Palmetto Dunes CAI	
WEATHER	Cloudy	TEMP.	Time
		65° F	12:00PM
PRESENT AT SITE	Rahmin Bahar, EnviroStruct (ES) Teresita Nazario-Acosta, Karins Engineering Group (KEG)

REPORT: FR # 7

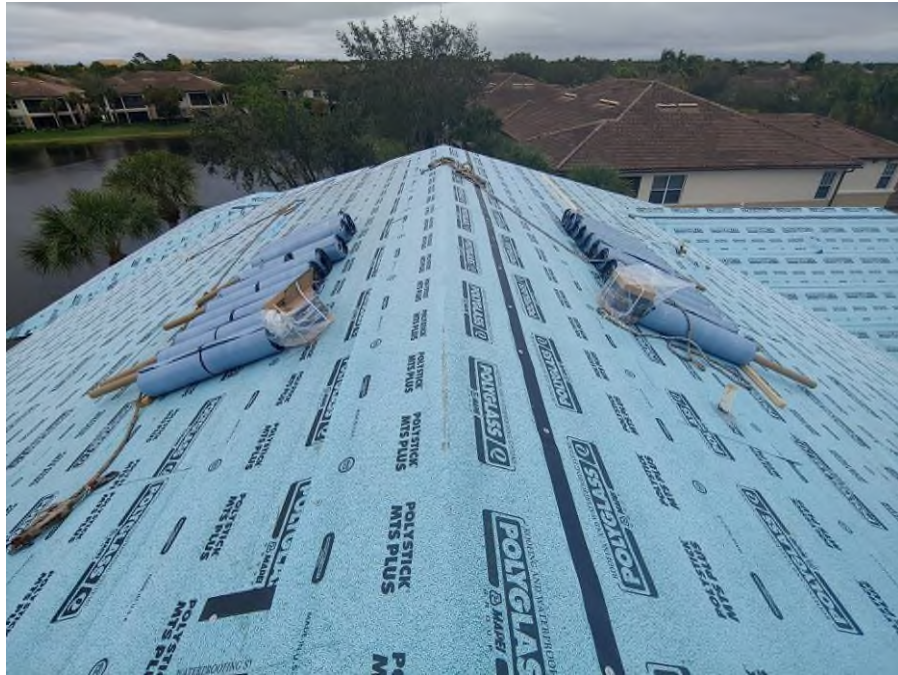
**Photograph #1: Polystick MTS Plus underlayment installation was in progress on building 7851.**

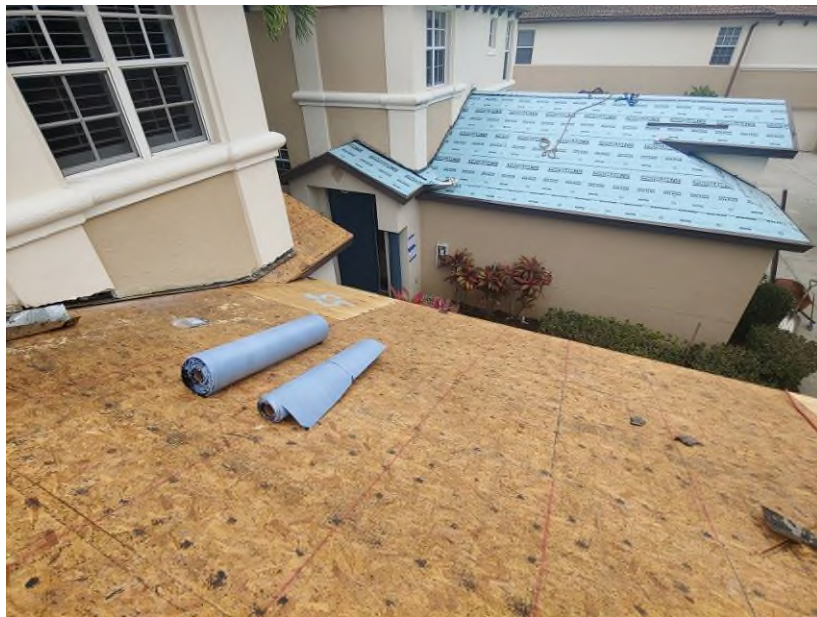
**Photograph #2: Polystick MTS Plus underlayment installation was in progress on building 7851.**

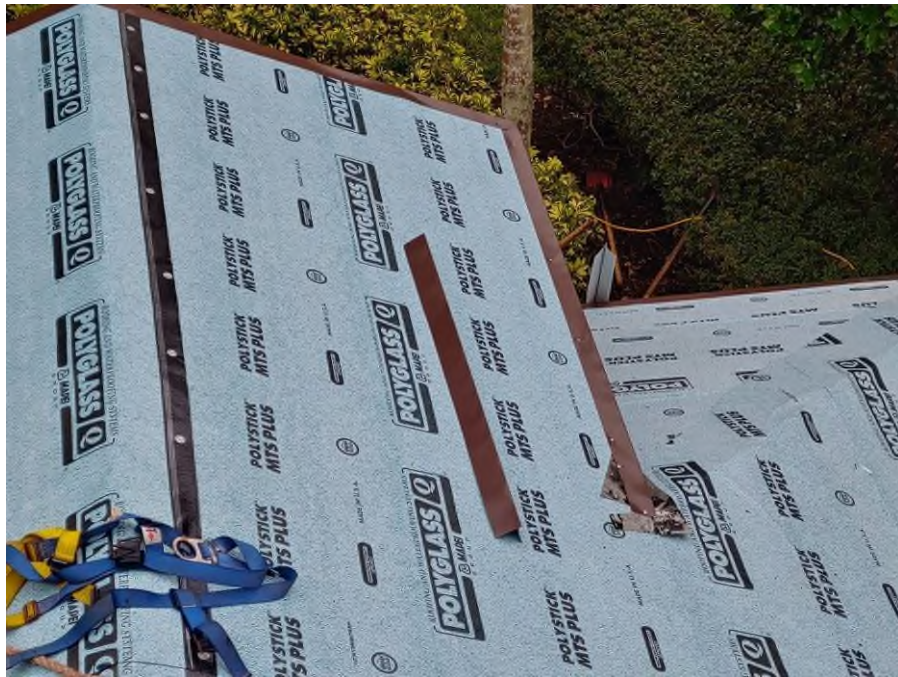
Photograph #3: Drip-edge flashing installation was in progress on building 7851.

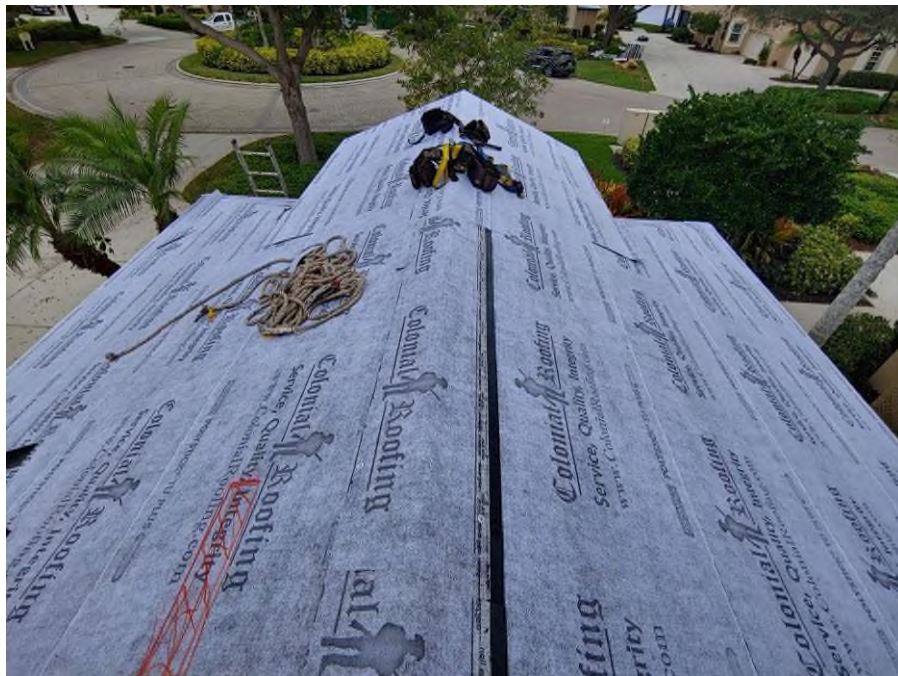
Photograph #4: Second layer of underlayment installation was in progress on building 7860.

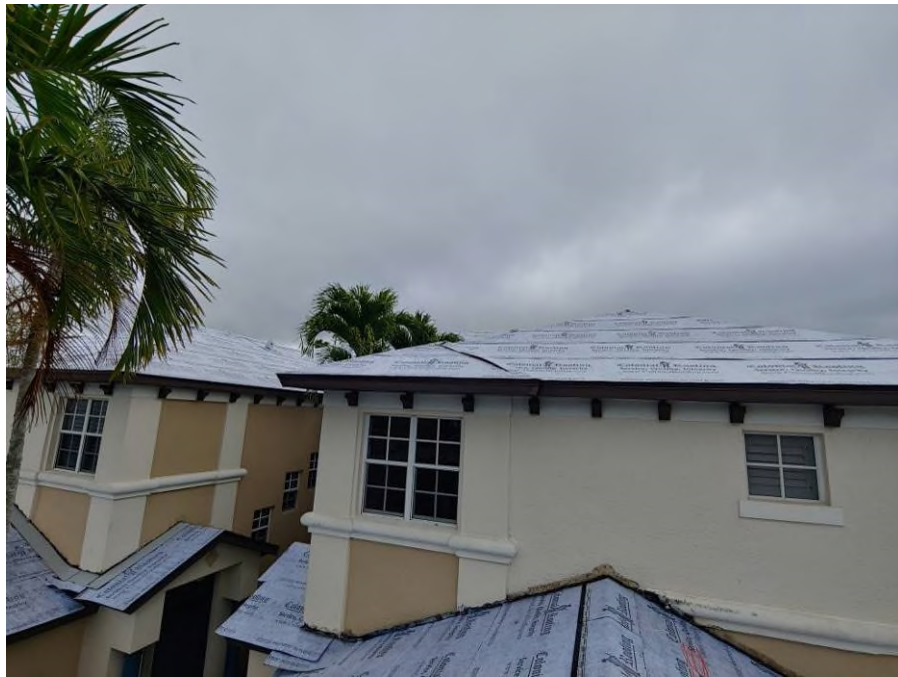
**Photograph #5: Second layer of underlayment installation was in progress on building 7860.**

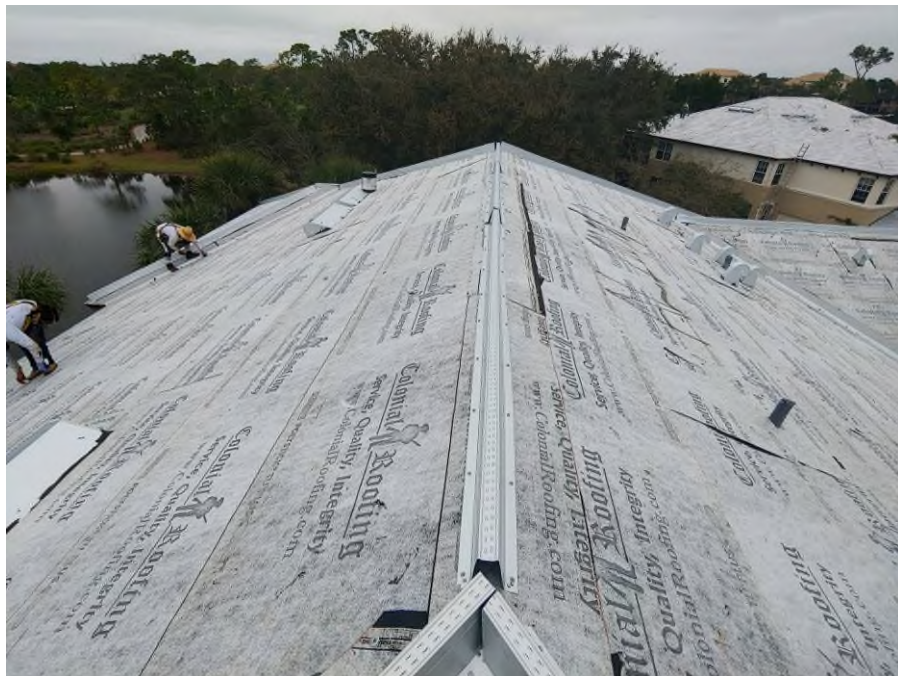
**Photograph #6: V-crimp metal valley flashing, and hip/ridge metal channel installations were in progress on building 21700.**

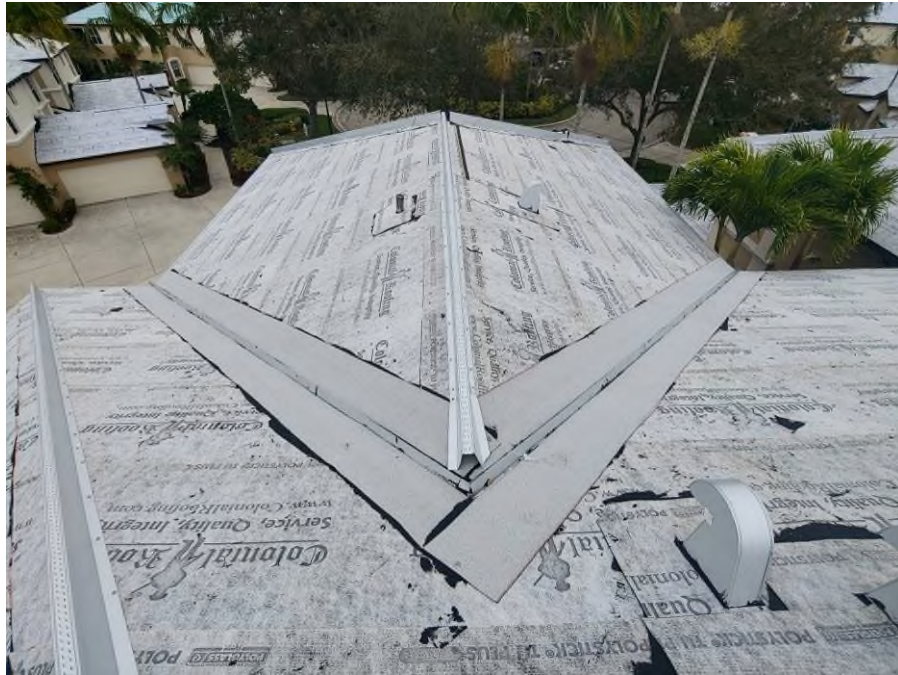
**Photograph #7: V-crimp metal valley flashing, and hip/ridge metal channel installations were in progress on building 21700.**

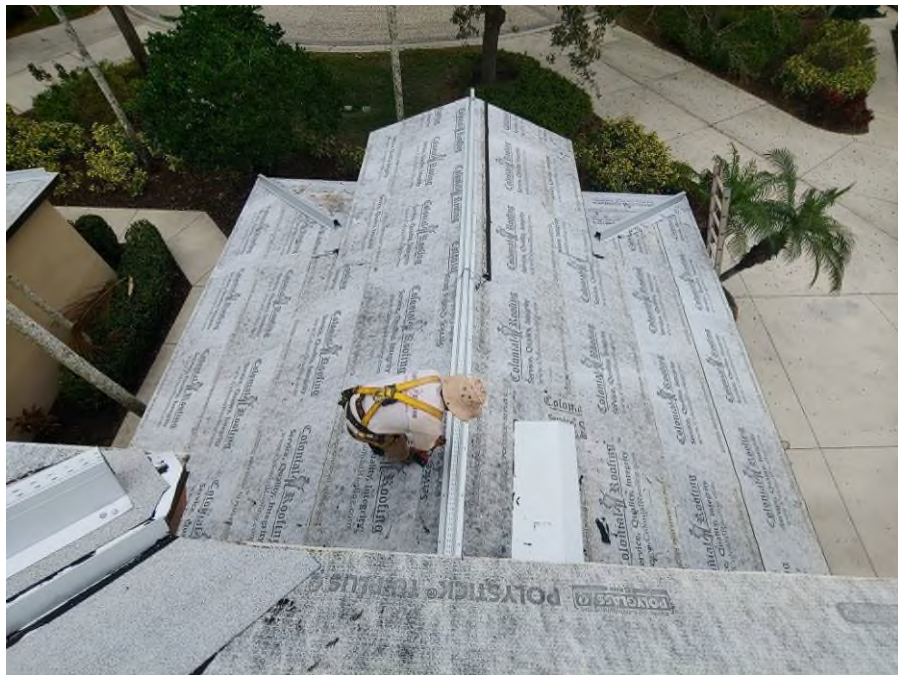
**Photograph #8: V-crimp metal valley flashing, and hip/ridge metal channel installations were in progress on building 21700.**

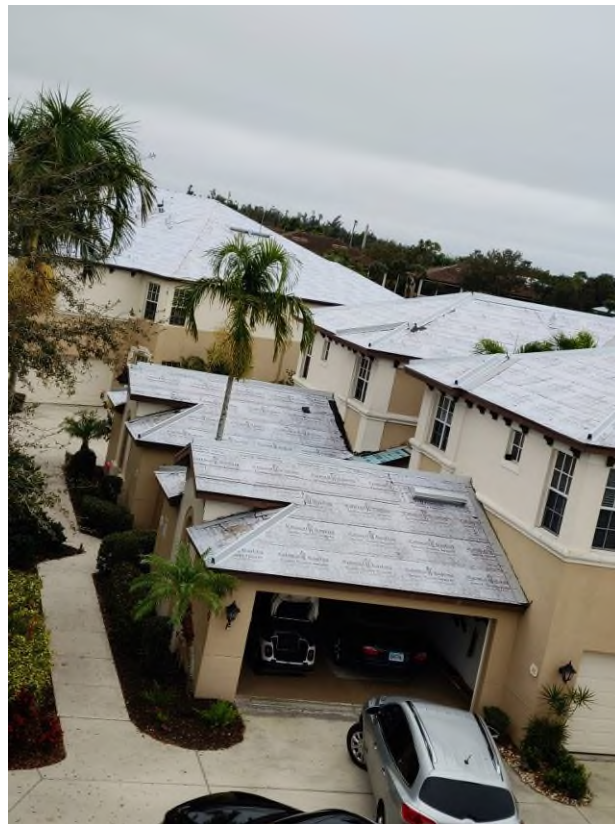
**Photograph #10: Second layer of underlayment installation was in progress on building 21710.**

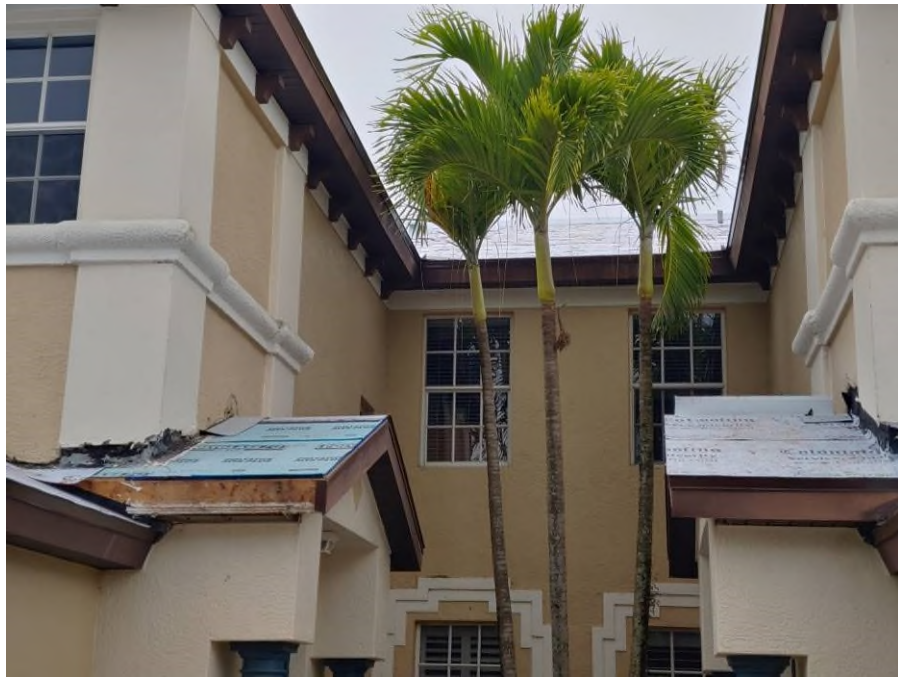
**Photograph #11: Fascia repair was in progress on building 21710.**

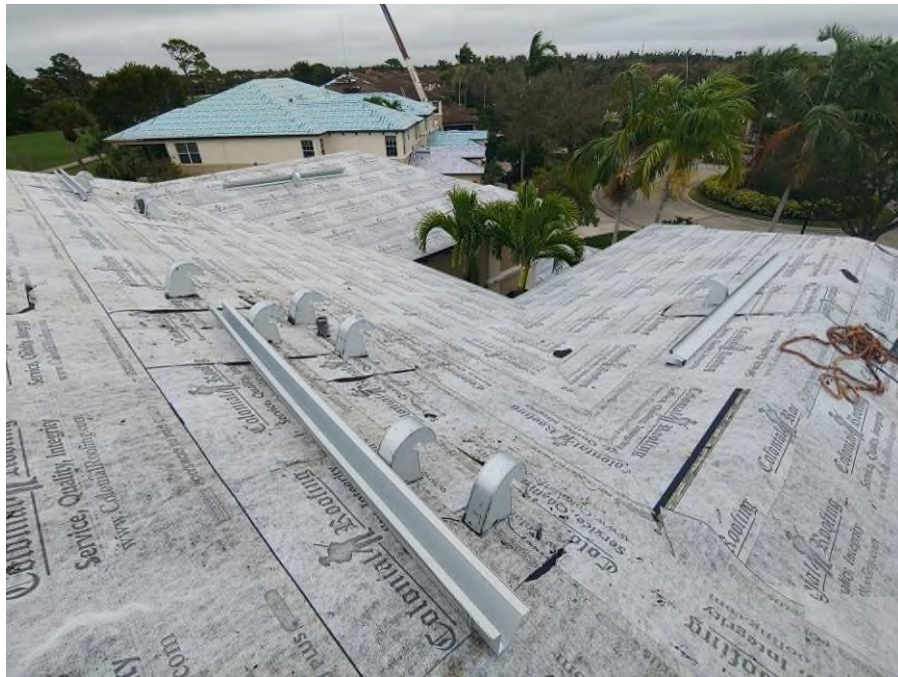
**Photograph #13: V-crimp metal valley flashing, and hip/ridge metal channel installations were in progress on building 21711.**

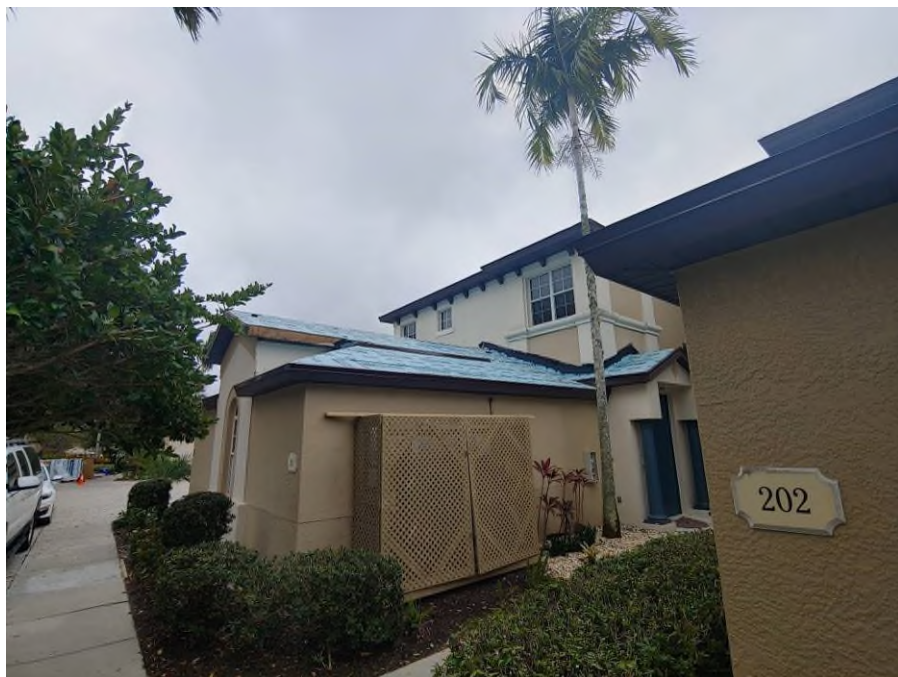
**Photograph #14: Second layer of underlayment installation was in progress on building 21720.**

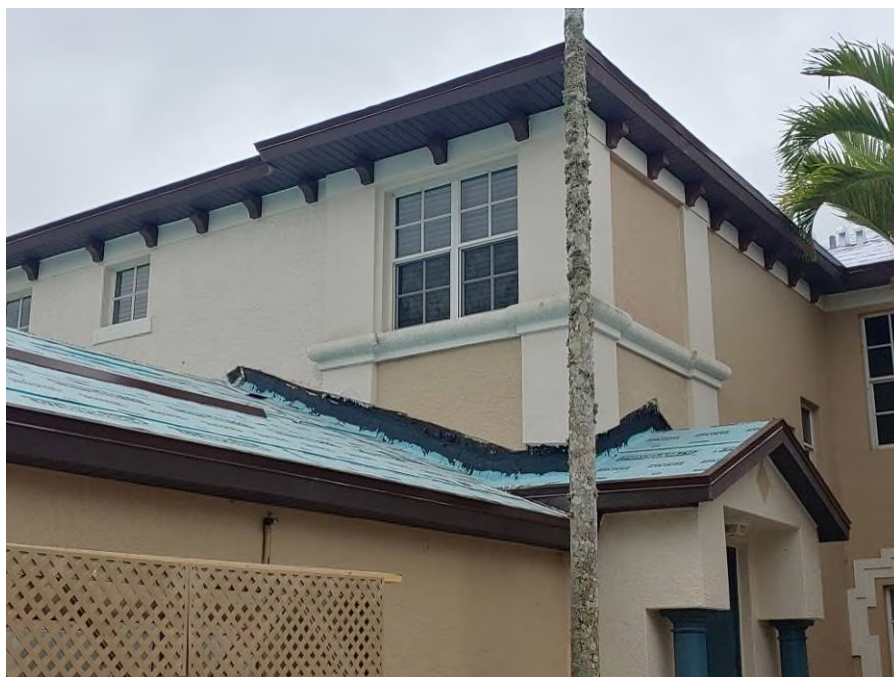
**Photograph #15: Drip-edge flashing installation was in progress on building 21720.**

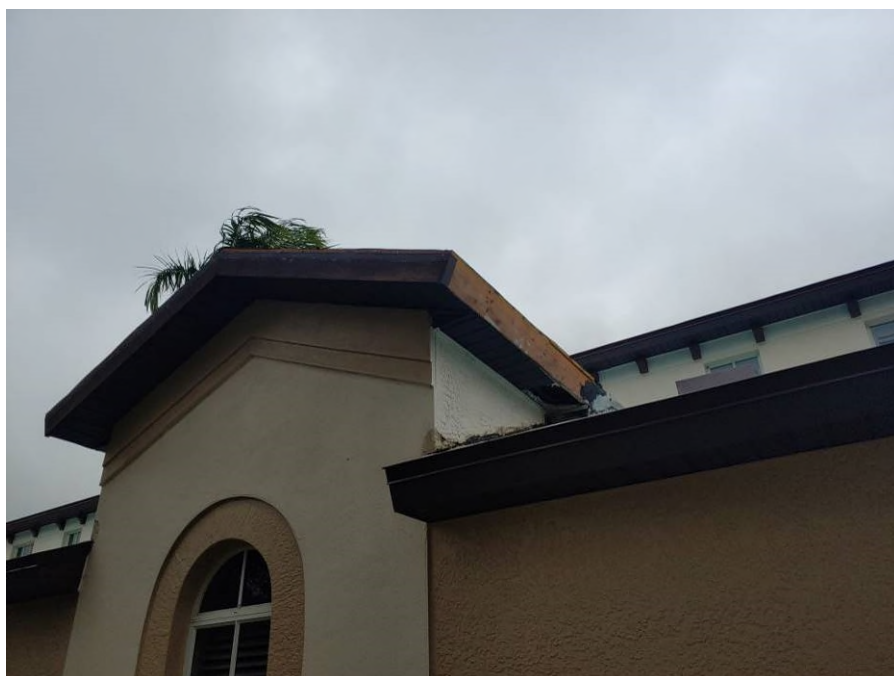
**Photograph #16: Fascia repair was in progress on building 21720.**

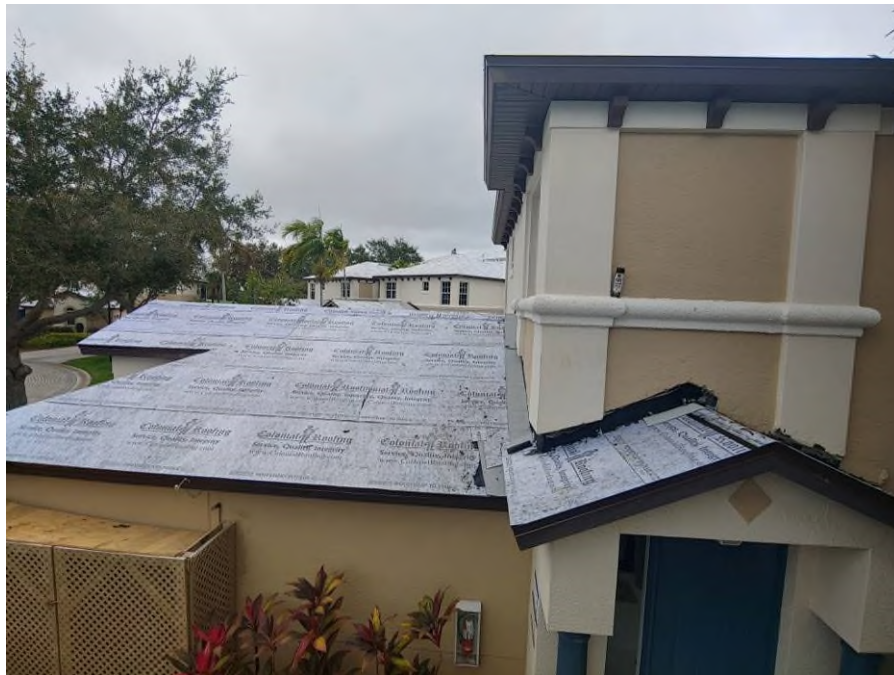
**Photograph #17: Second layer of underlayment installation was in progress on building 21721.**

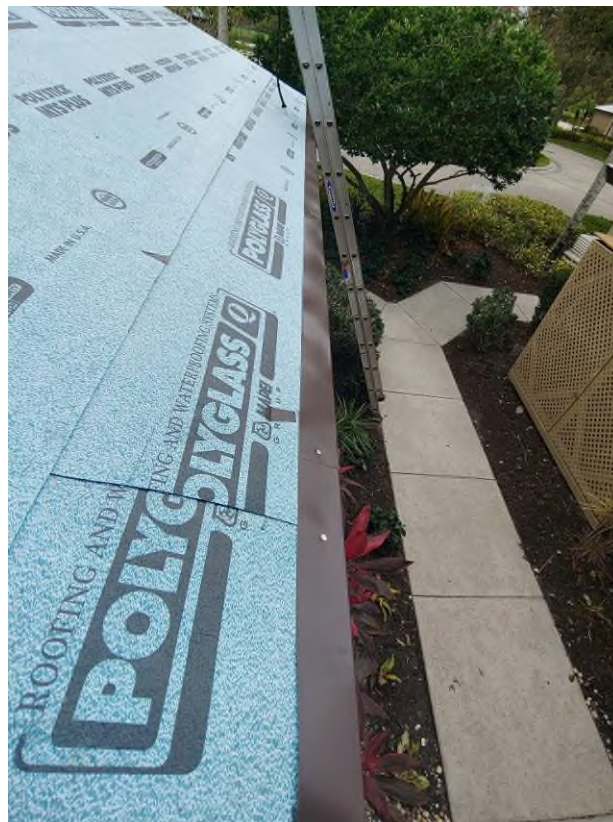
**Photograph #18: Drip-edge flashing installation was in progress on building 21721.**

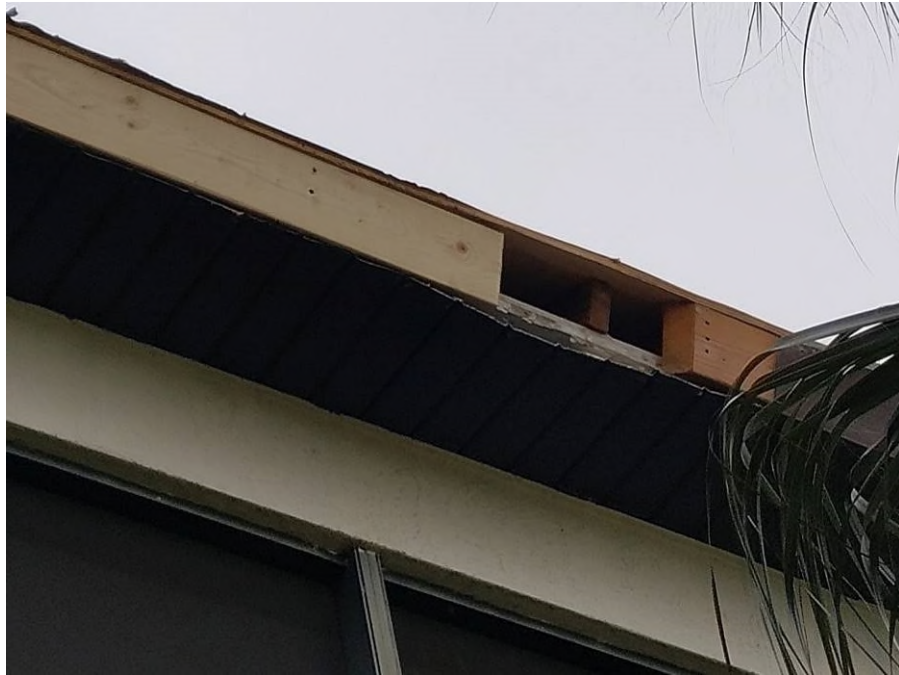
**Photograph #19: Fascia repair was in progress on building 21721.**

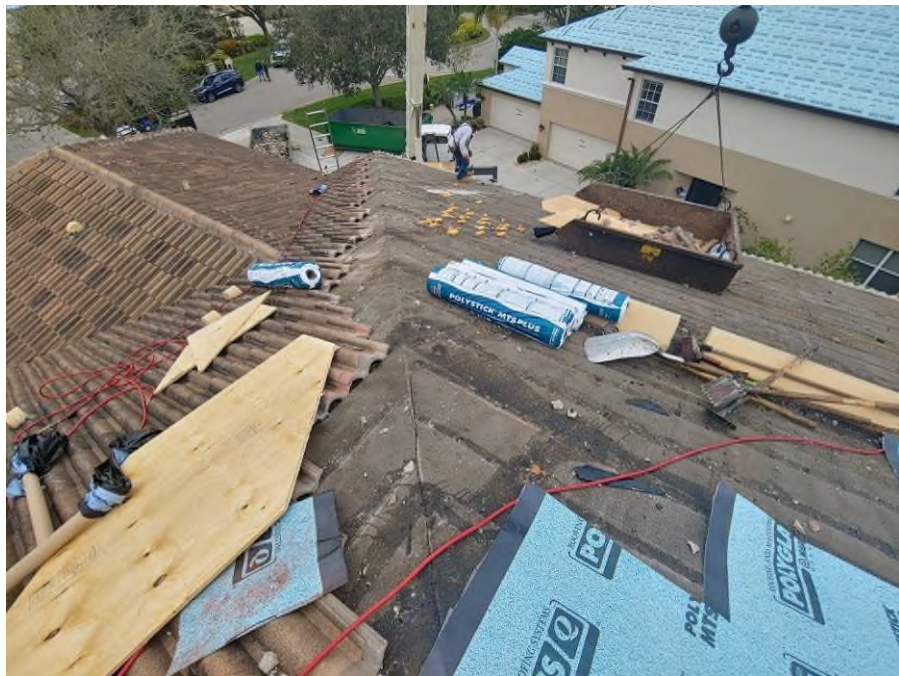
**Photograph #20: Roof tile removal was in progress on building 21731.**

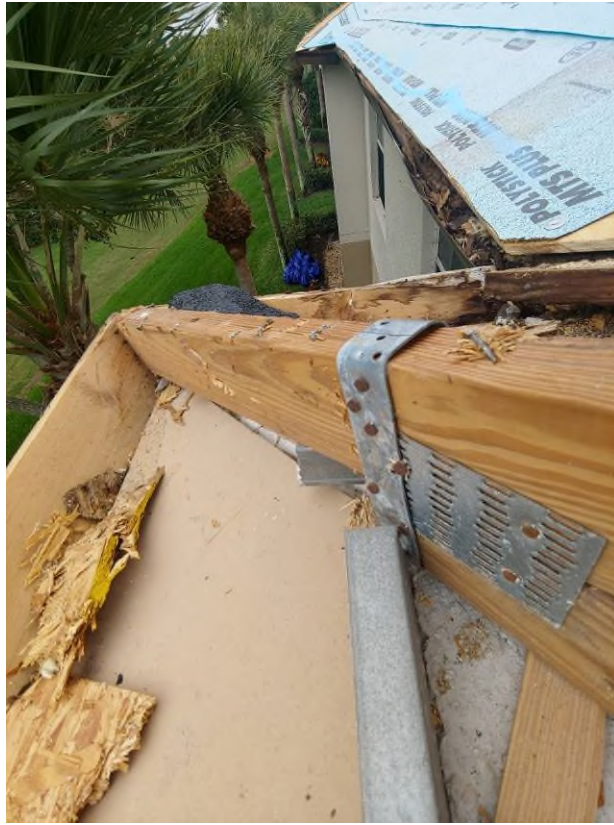
**Photograph #21: Existing strap clips on trusses have the required minimum quantity of nails on building 21731. Installation of new hurricane truss anchor straps (HGAM10) is not required.**

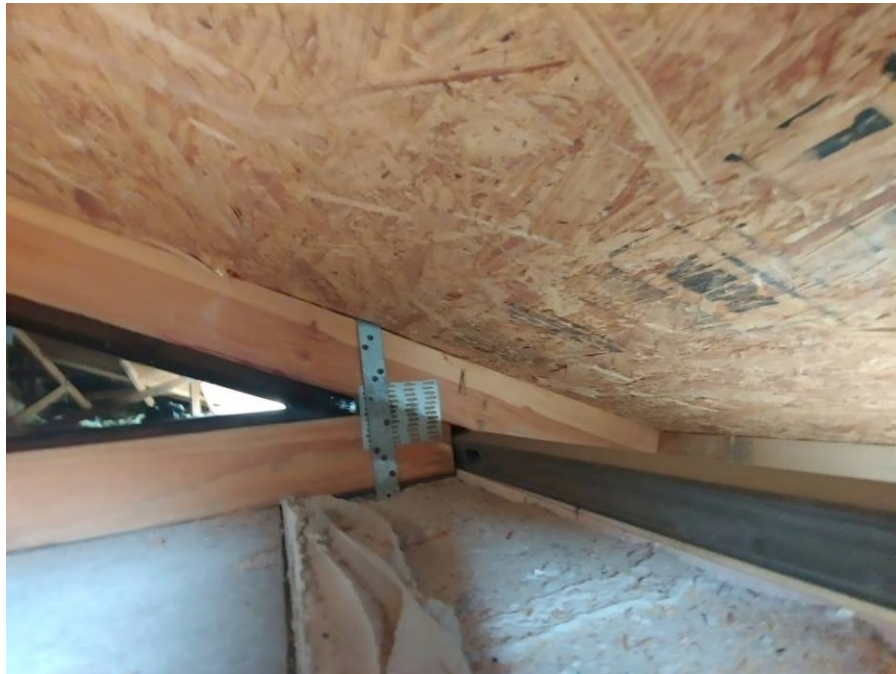
**Photograph #22: Existing strap clips on trusses have the required minimum quantity of nails on building 21731. Installation of new hurricane truss anchor straps (HGAM10) is not required.**

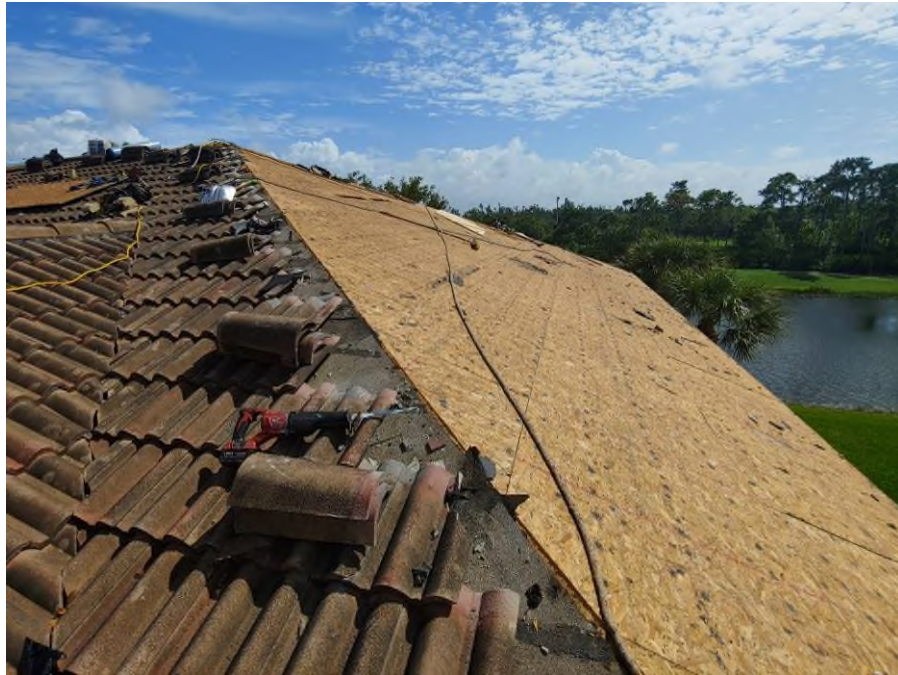
**Photograph #1: Roof tile removal was in progress on building 7860.**

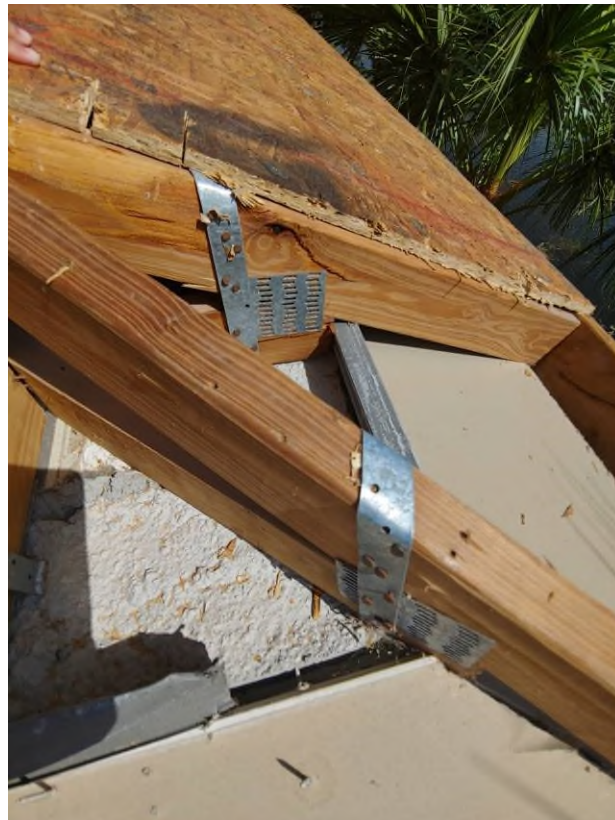
**Photograph #2: Existing strap clips on trusses have the required minimum quantity of nails on building 7860.**

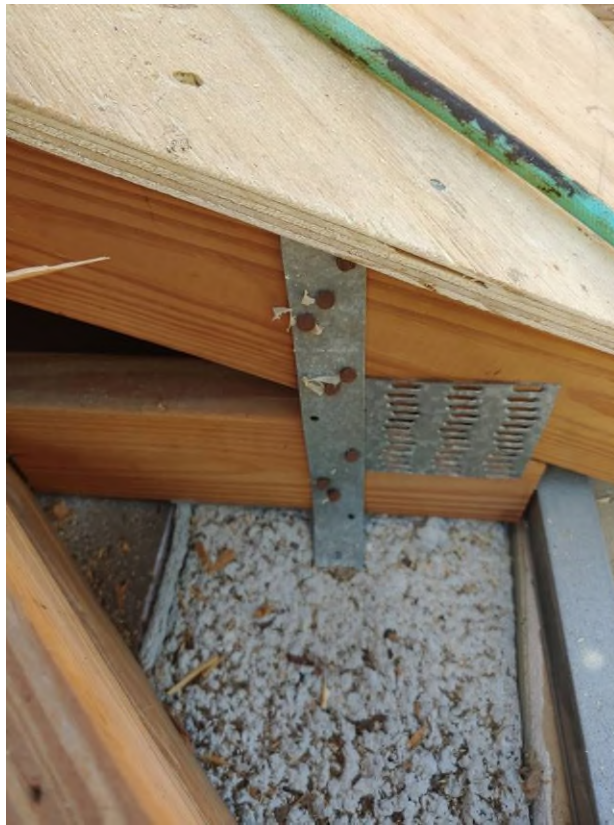
**Photograph #3: Existing strap clips on trusses have the required minimum quantity of nails on building 7860.**

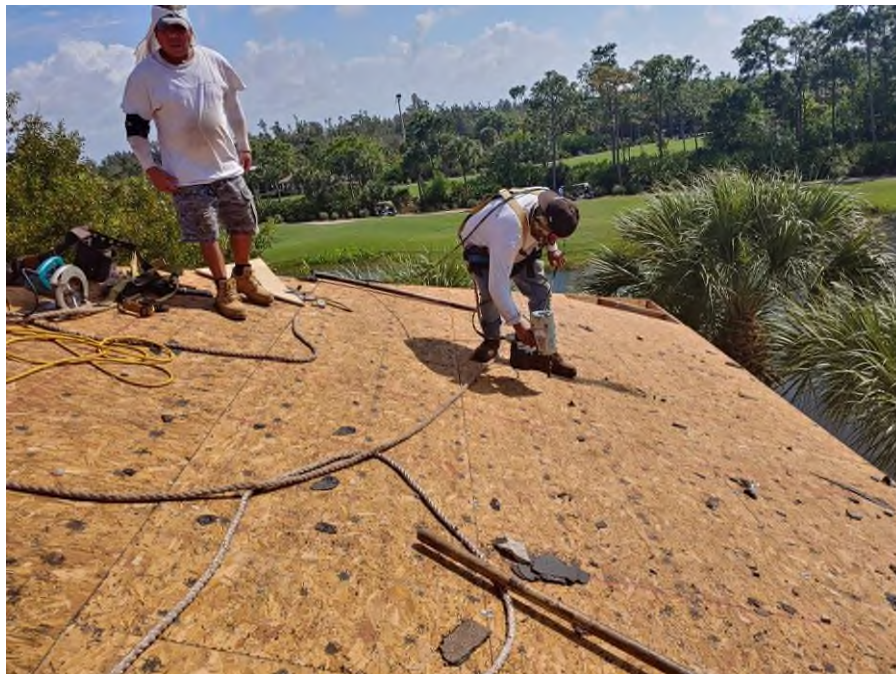
**Photograph #4: Re-nail pattern at plywood sheathing was in progress on building 7860.**

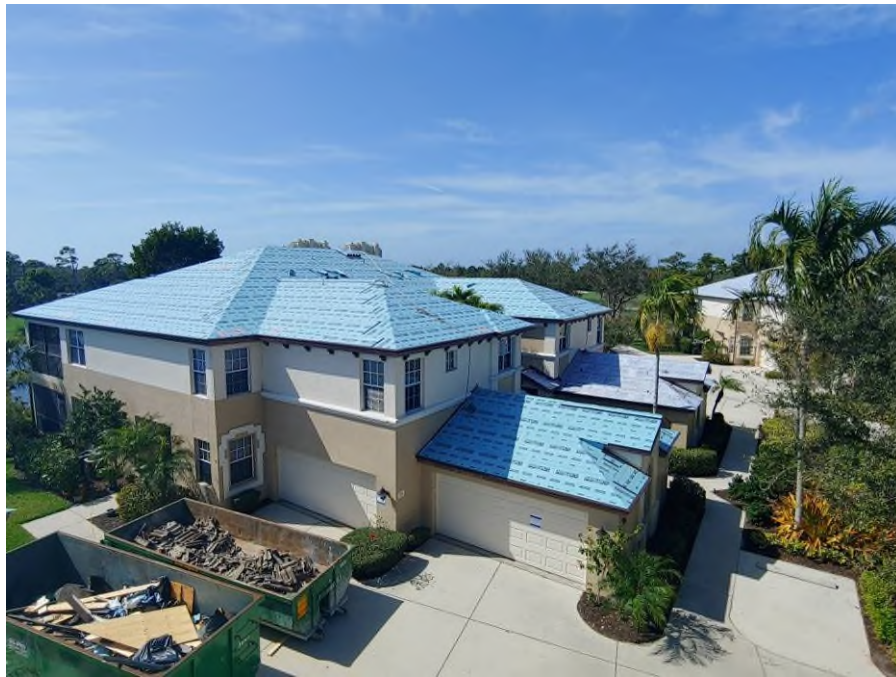
**Photograph #5: Polystick MTS Plus underlayment installation was completed on building 21710.**

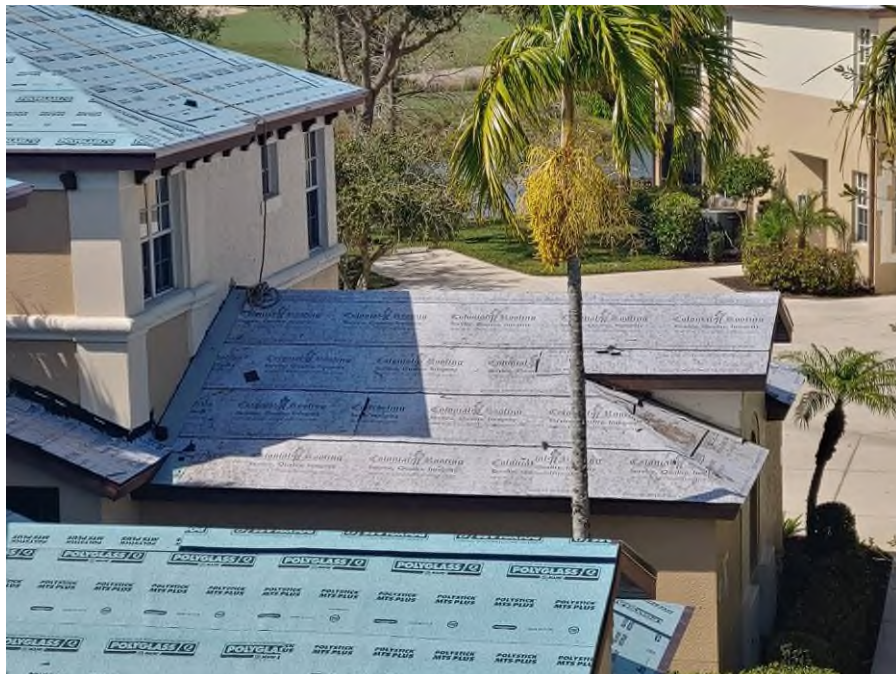
**Photograph #6: Second layer of underlayment installation was in progress on building 21710.**

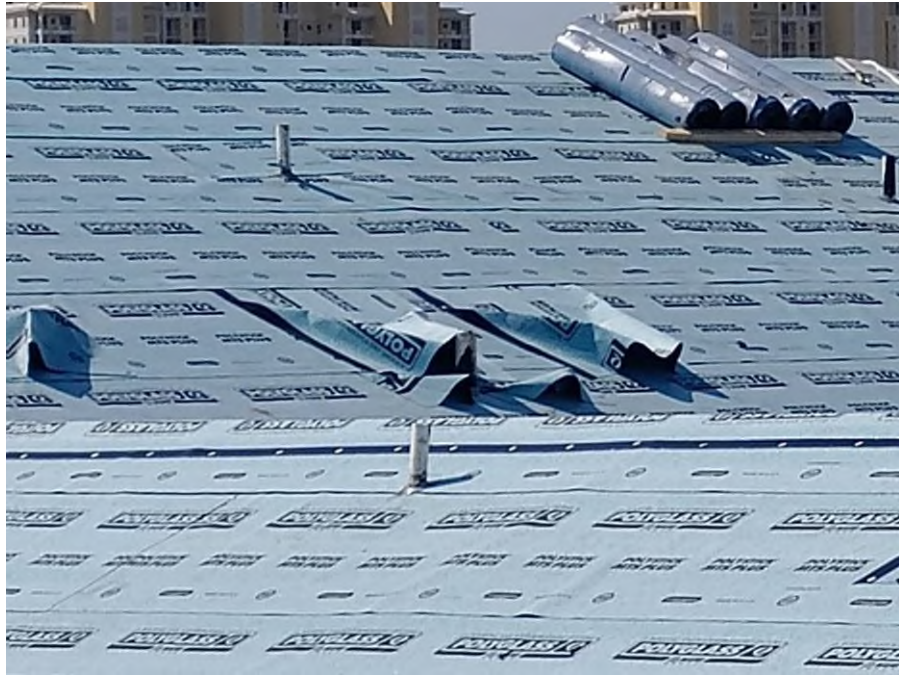
**Photograph #7: Polystick MTS Plus underlayment installation was completed on building 21710.**

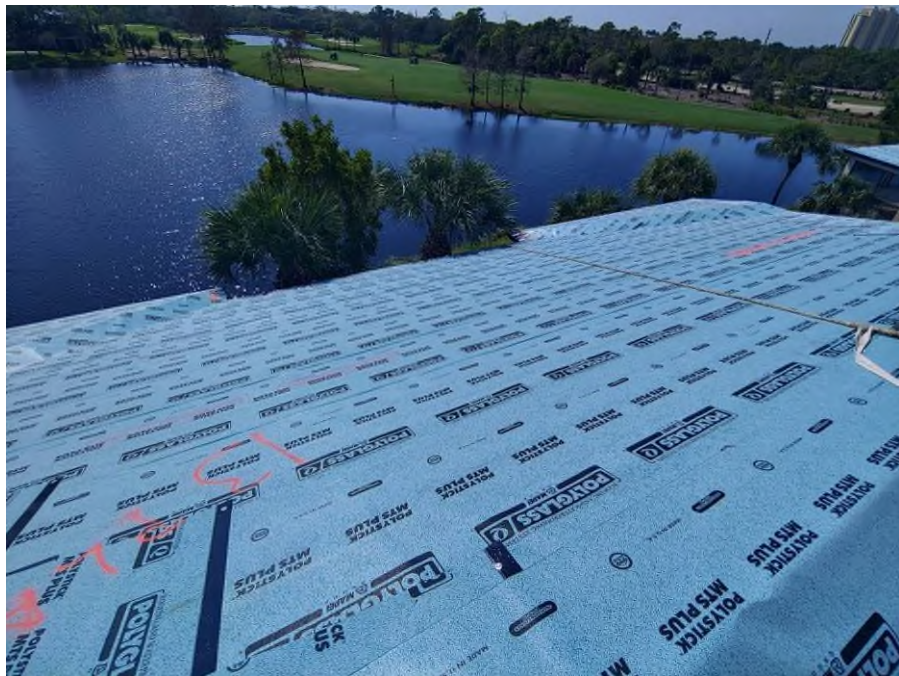
**Photograph #8: Polystick MTS Plus underlayment installation was completed on building 21720.**

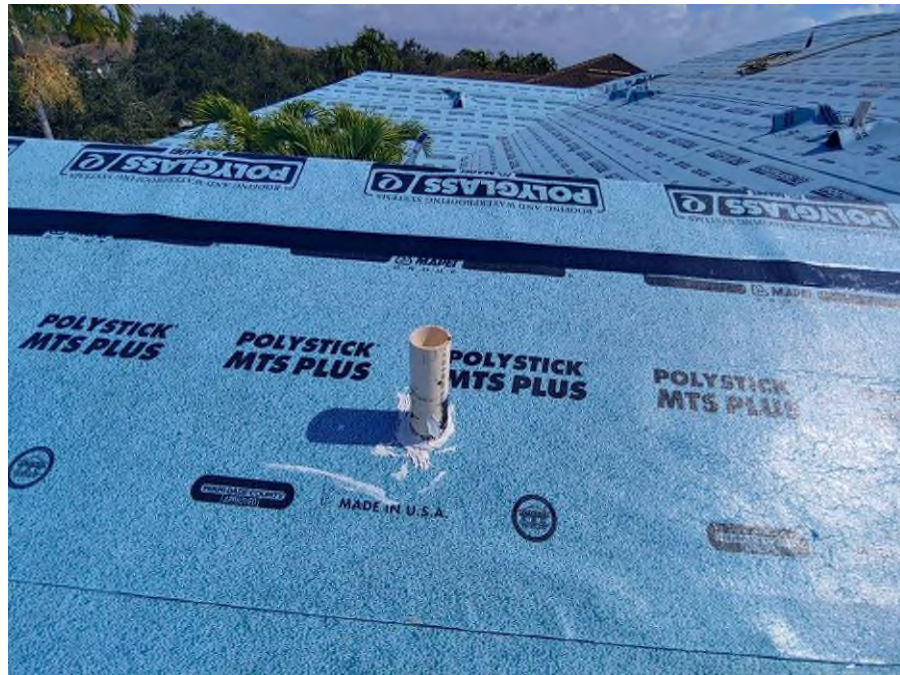
**Photograph #9: Sealant application on Vent-pipe was in progress on building 21720.**

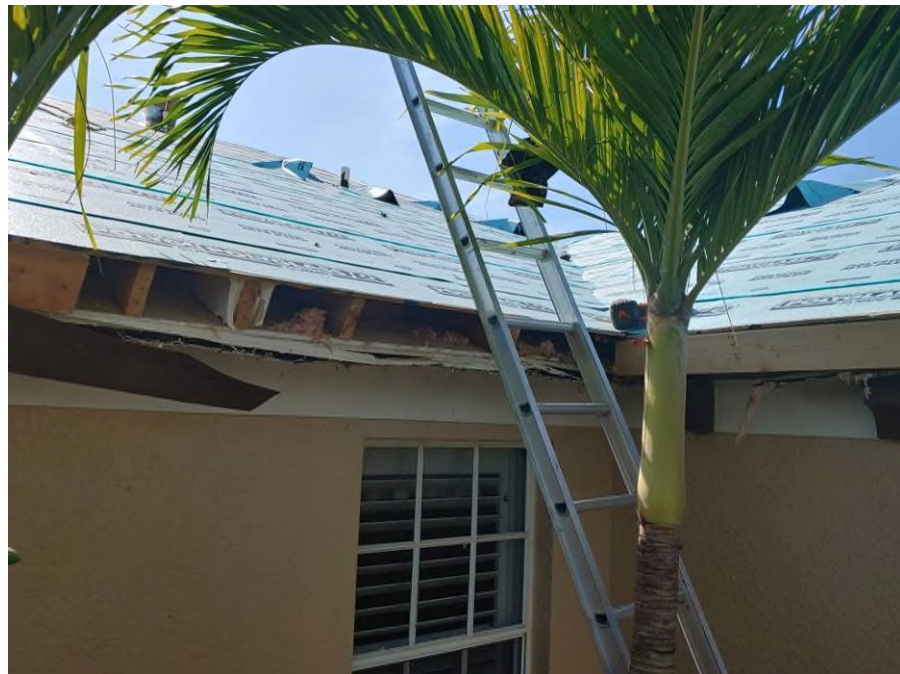
**Photograph #10: Fascia repair was in progress on building 21720.**

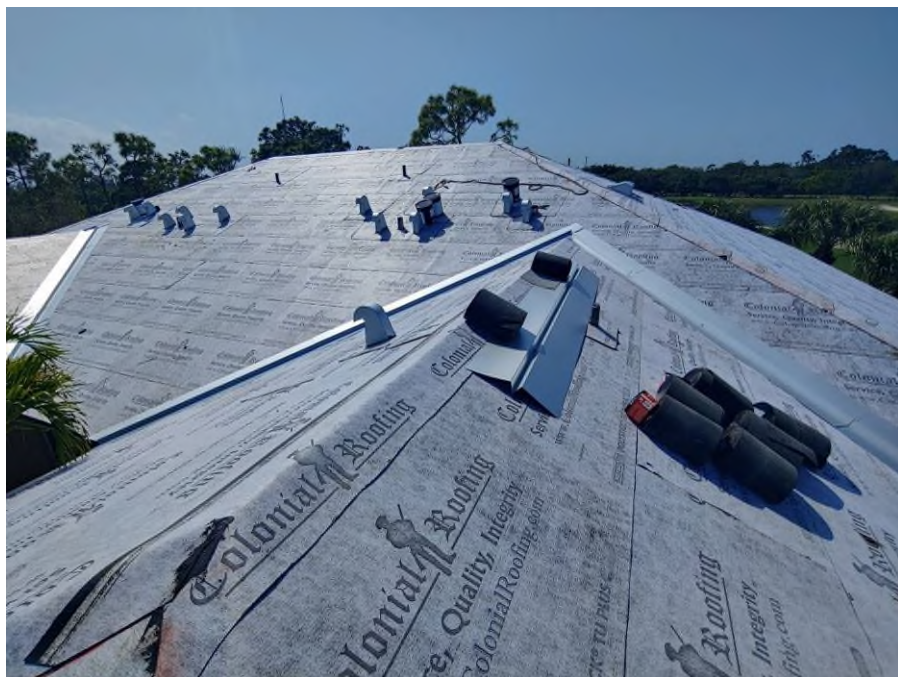
**Photograph #2: Exhaust vent installations were in progress on building 7840.**

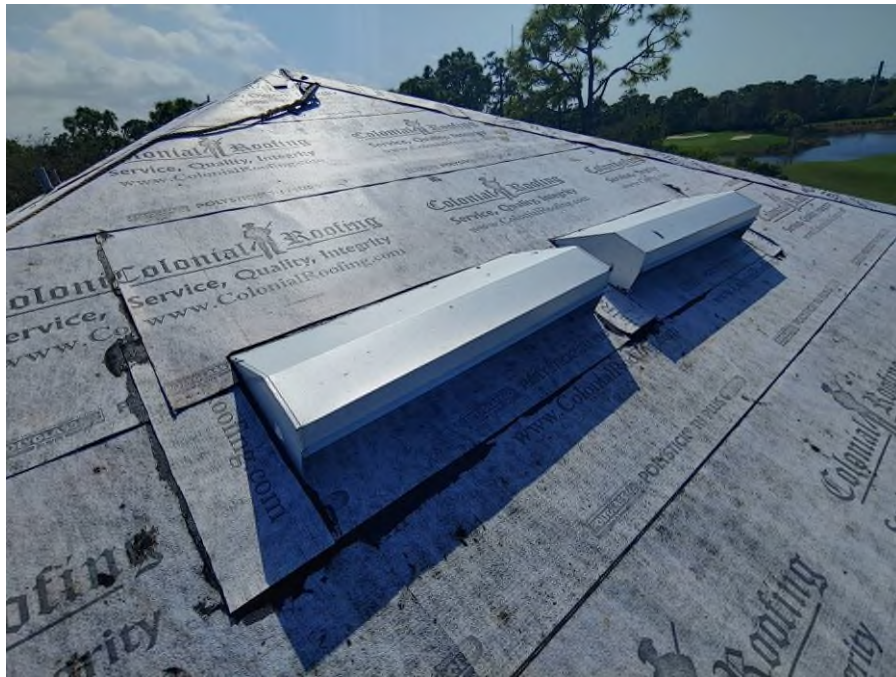
**Photograph #3: Exhaust vent installations were in progress on building 7840.**

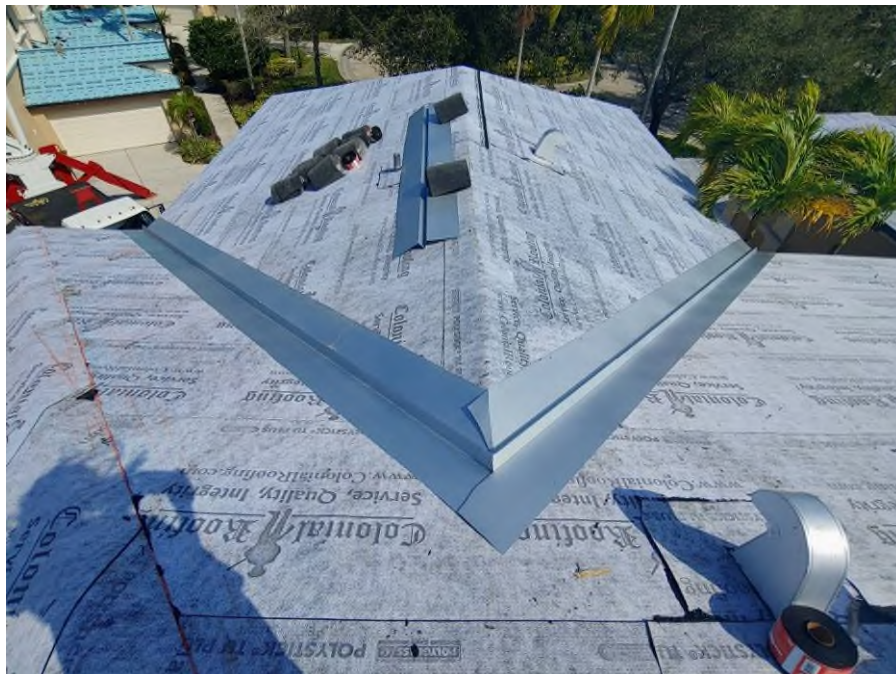
**Photograph 4: V-crimp metal Valley flashing installation was in progress on building 7840.**

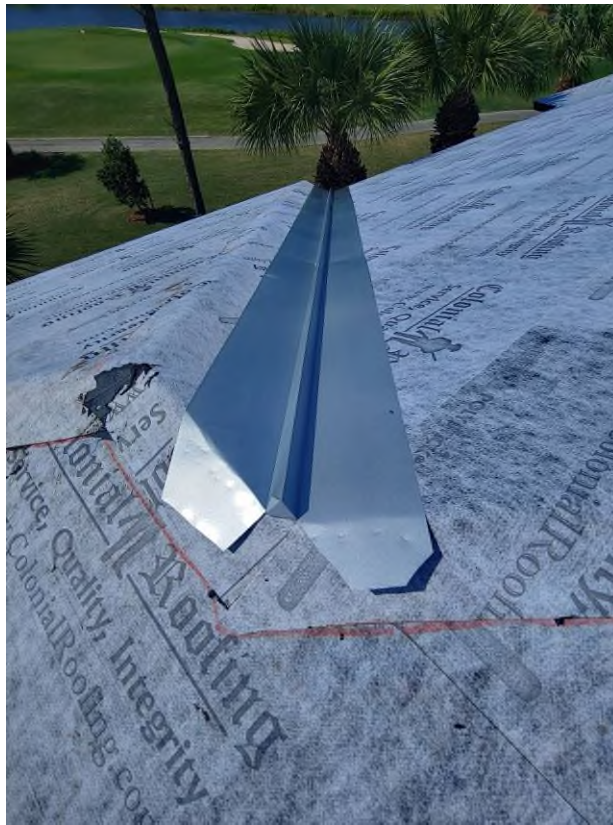
**Photograph #5: V-crimp metal Valley flashing installation was in progress on building 7840.**

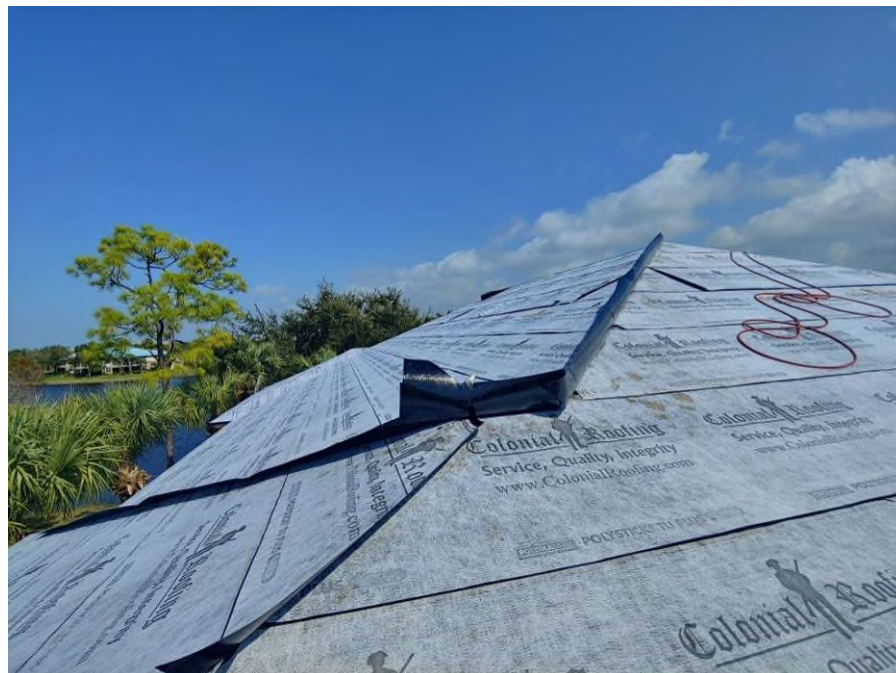
**Photograph #6: Second layer of underlayment installation was in progress on building 7841.**

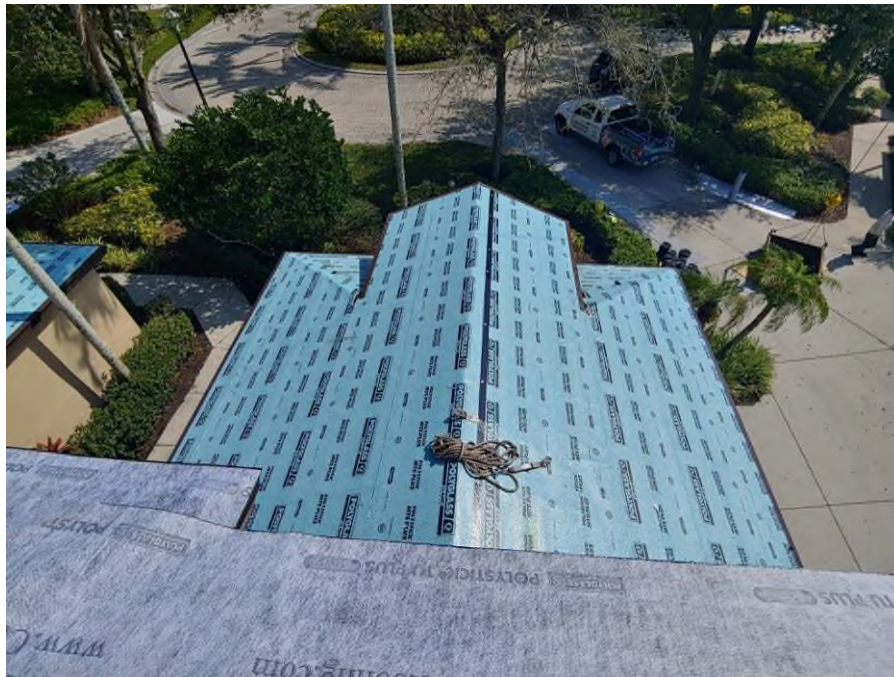
**Photograph #7: Polystick MTS Plus underlayment installation was completed on building 7841.**

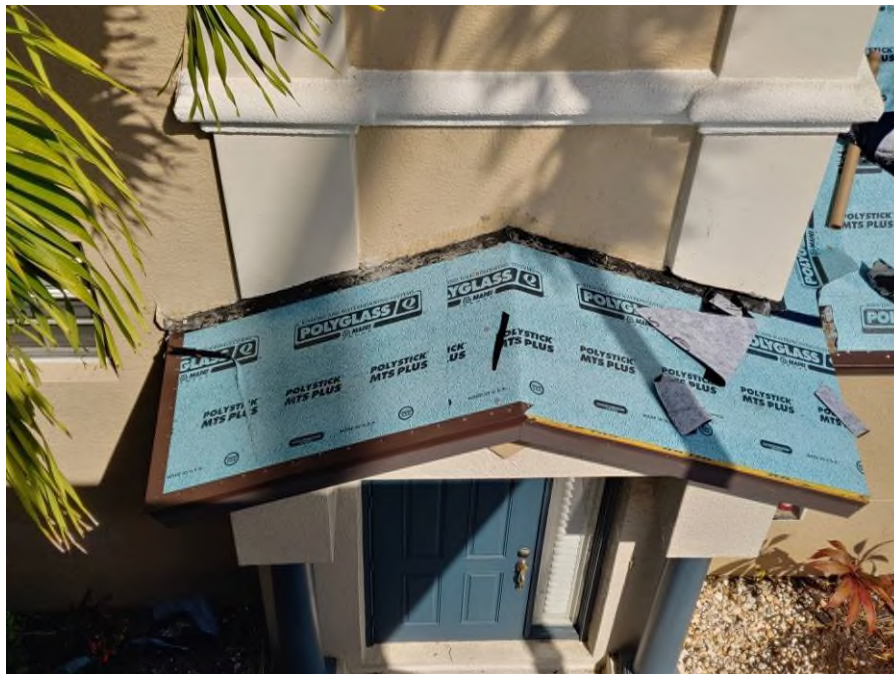
**Photograph #8: Drip-edge flashing installation was in progress on building 7841.**
