# Uniform Mitigation Verification Inspection Form

**RE: Palmetto Dunes Condominium**  
**21720 Palmetto Dunes Drive**  
**Estero, FL 33928**  
**Roofing Restoration**  
**KEG File #20RN-0085**  
**Wind Mitigation**  
**Permit # 1721301-0**

DATE	February 21, 2020	JOB NO.	20RN-0085
Palmetto Dunes CAI – Roofing Project			
LOCATION	Palmetto Dunes Drive		
CONTRACTOR	EnviroStruct, LLC	Palmetto Dunes CAI	
WEATHER	Cloudy	TEMP.	Time
		65° F	12:00PM
PRESENT AT SITE	Rahmin Bahar, EnviroStruct (ES) Teresita Nazario-Acosta, Karins Engineering Group (KEG)

REPORT: FR # 7

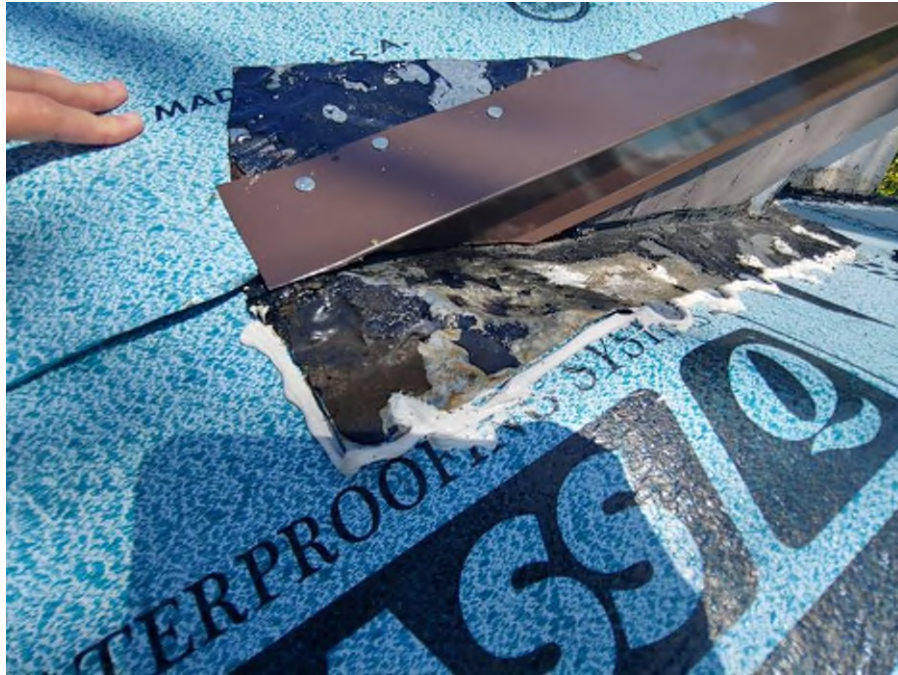
- Exhaust vent installations were in progress on buildings 7840 and 7850.
  - Contractor must address sealant application on the metal flashing on building 7841.

**Photograph #9: Contractor must address sealant application on the metal flashing on building 7841.**

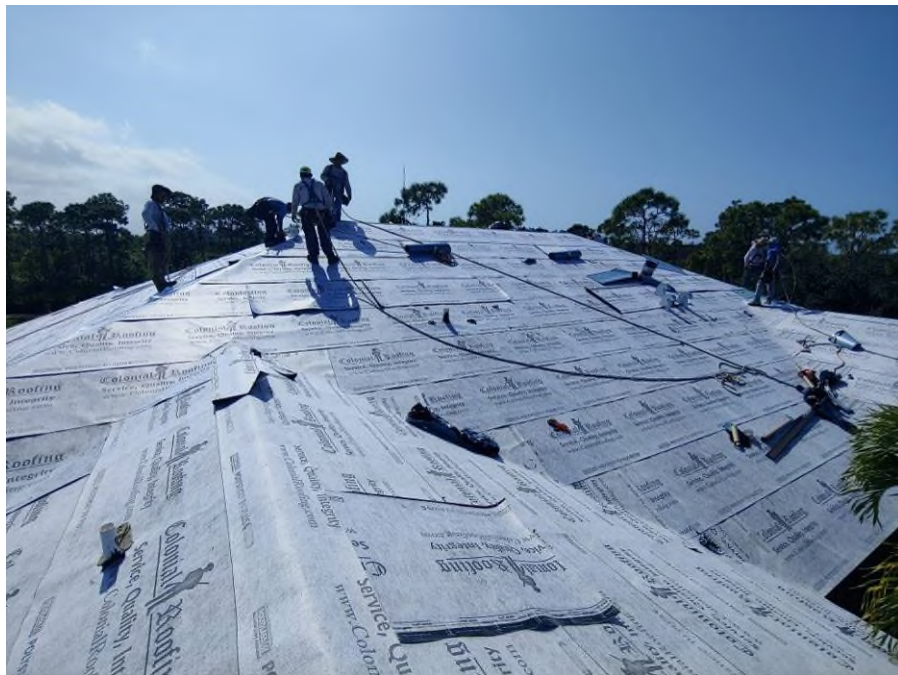
**Photograph #10: Second layer of underlayment installation was in progress on building 7850.**

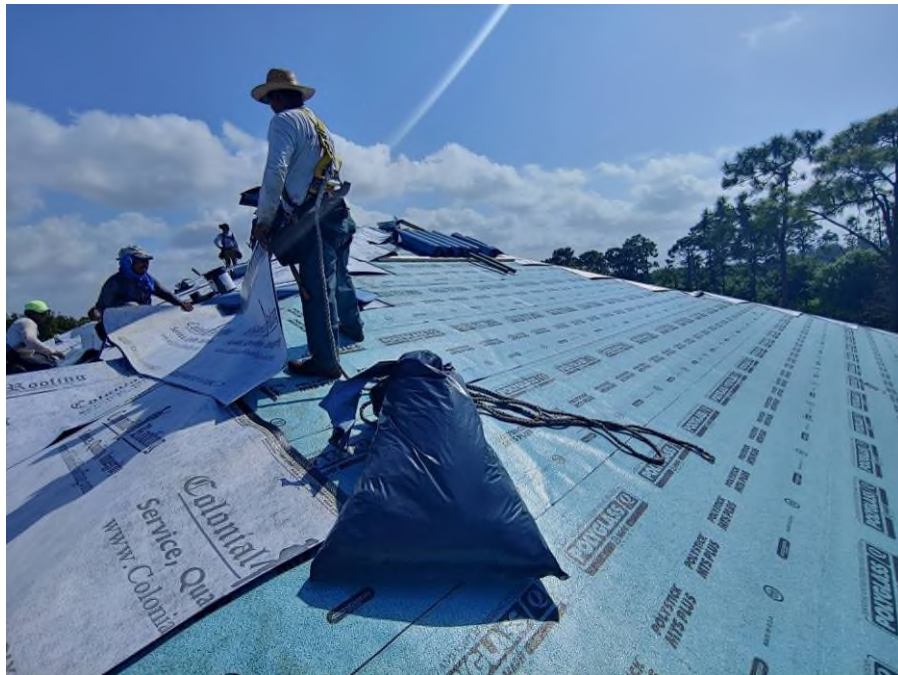
**Photograph #11: Polystick MTS Plus underlayment installation was completed on building 7850.**

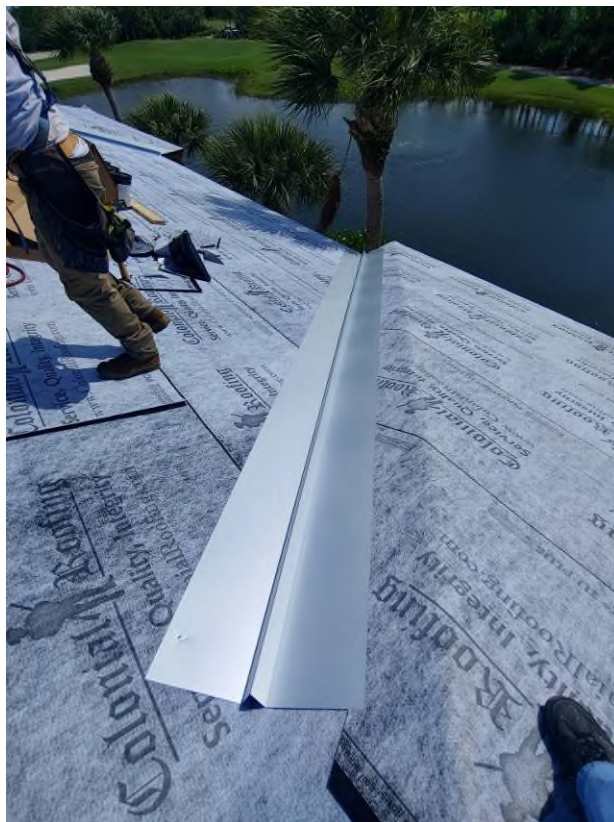
**Photograph #12: V-crimp metal Valley flashing installation was in progress on building 7850.**

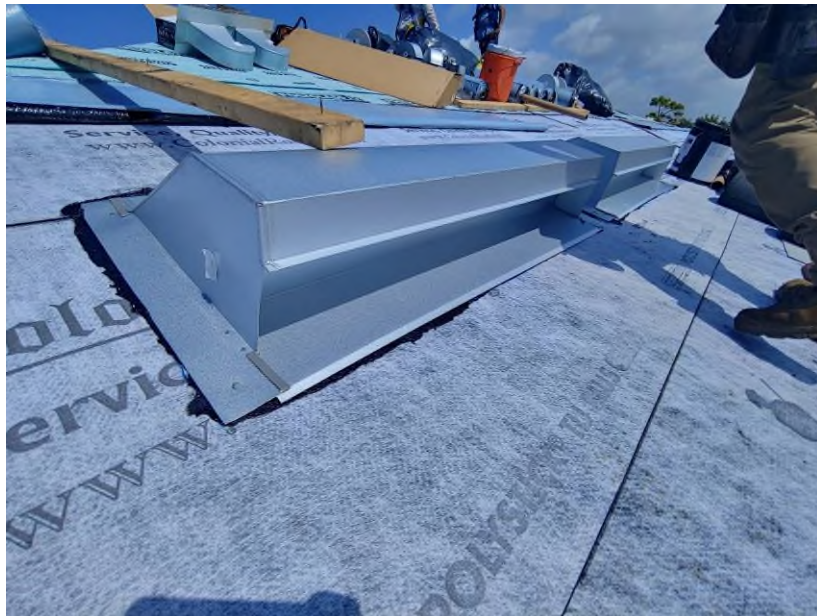
**Photograph #13: Exhaust vent installations were in progress on building 7850.**

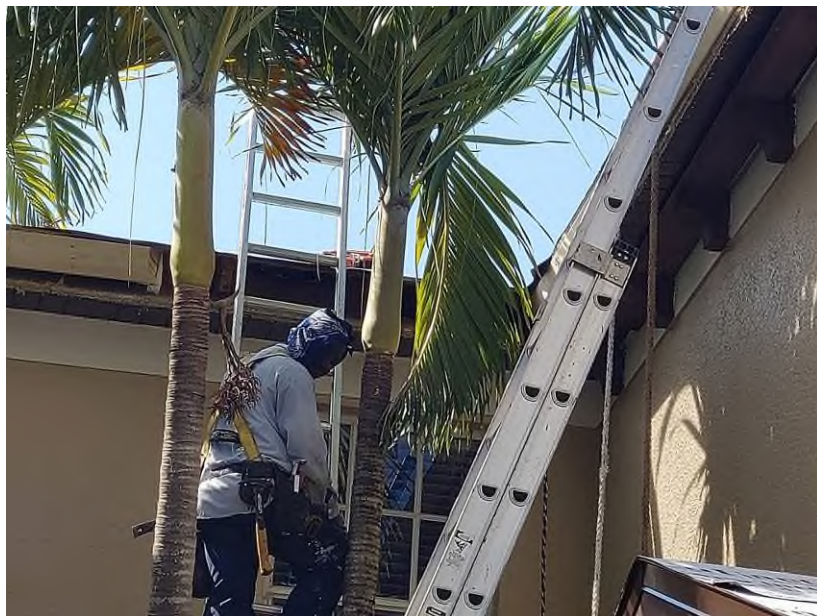
**Photograph #14: Fascia repair was in progress on building 21710.**

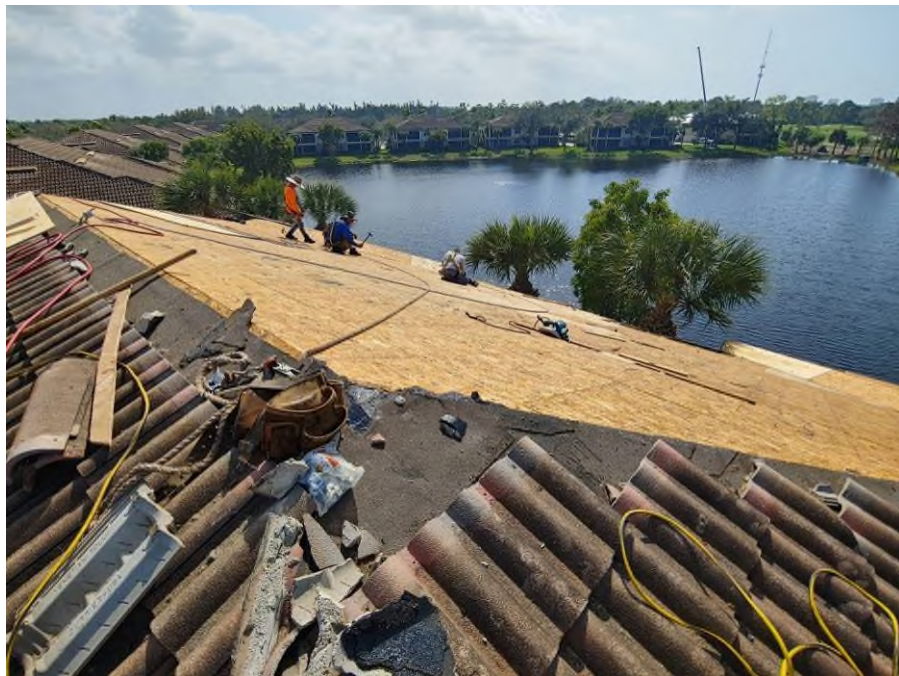
**Photograph #16: Roof tile removal was in progress on building 21720.**

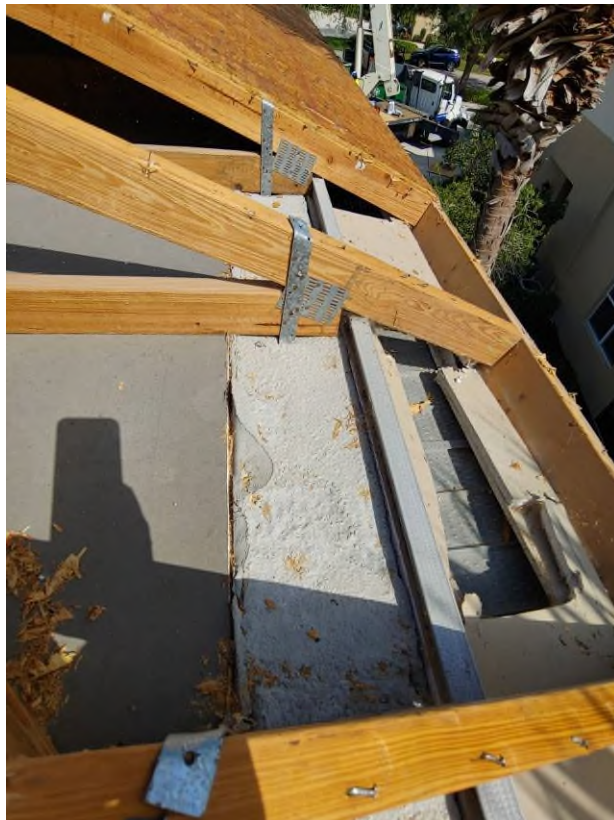
**Photograph #18: Existing strap clips on trusses have the required minimum quantity of nails on building 21720.**

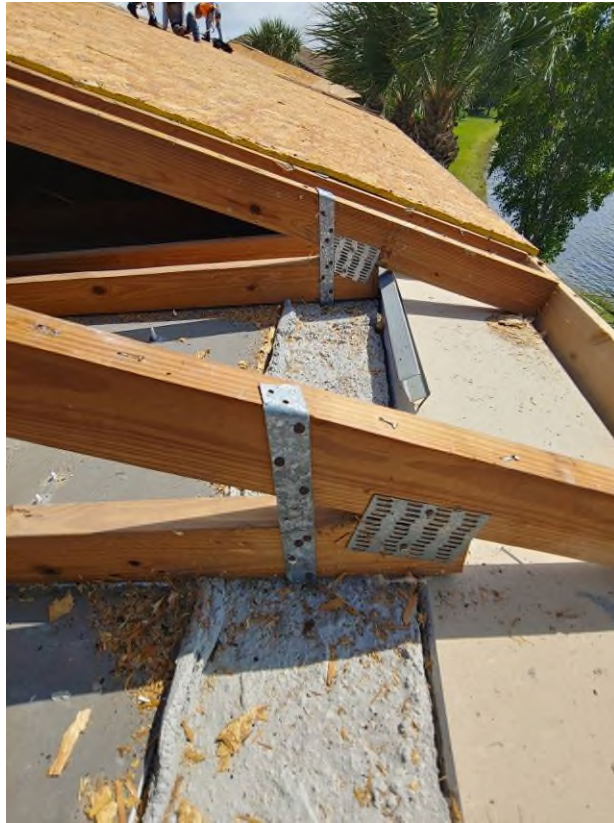
**Photograph #19: Existing strap clips on trusses have the required minimum quantity of nails on building 21720.**

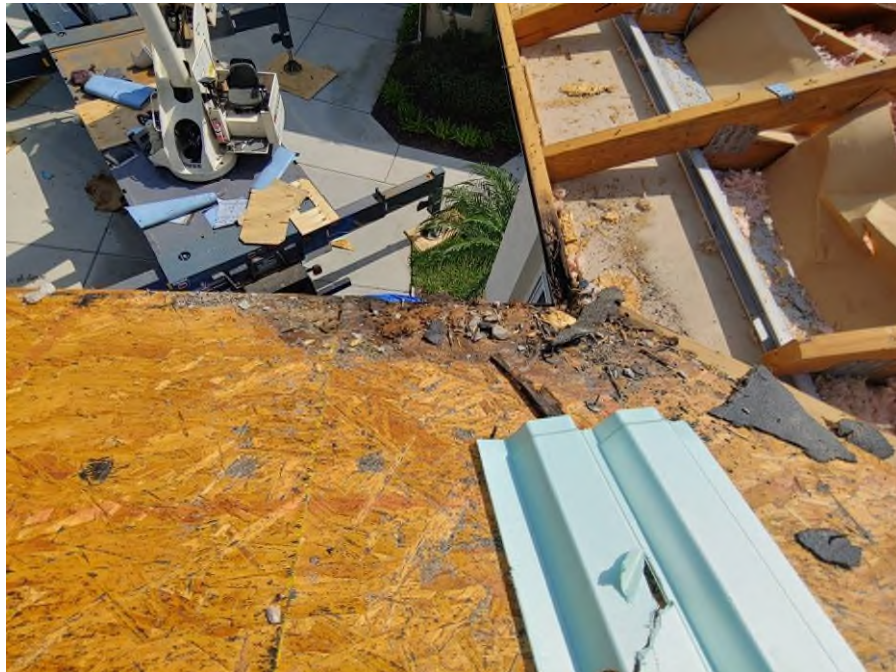
- Rotten plywood sheathing was observed.

**Photograph #20: Rotten plywood sheathing was observed on building 21720.**
