Uniform Mitigation Verification Inspection Form

Inspection Date: 5-6-2020		
Owner Information		
Owner Name: Palmetto Dunes Pelican Sound Condominium Association Inc.		Contact Person:
Address: 21740 Palmetto Dunes Drive Units 101,102,201,202		Home Phone:
City: Estero	Zip: 33928	Work Phone:
County: Lee		Cell Phone:
Insurance Company:		Policy #:
Year of Home: 2001	# of Stories: 2	Email:

RE: Palmetto Dunes Condominium
21740 Palmetto Dunes Drive
Estero, FL 33928
Roofing Restoration
KEG File #20RN-0085
Wind Mitigation
Permit # 1721236-0

DATE	March 30, 2020	JOB NO.	20RN-0085
Palmetto Dunes CAI – Roofing Project			
LOCATION	Palmetto Dunes Drive		
CONTRACTOR	EnviroStruct, LLC	Palmetto Dunes CAI	
WEATHER	Sunny	TEMP. 88° F	Time 2:30PM
PRESENT AT SITE	Rahmin Bahar, EnviroStruct (ES) Teresita Nazario-Acosta, Karins Engineering Group (KEG)

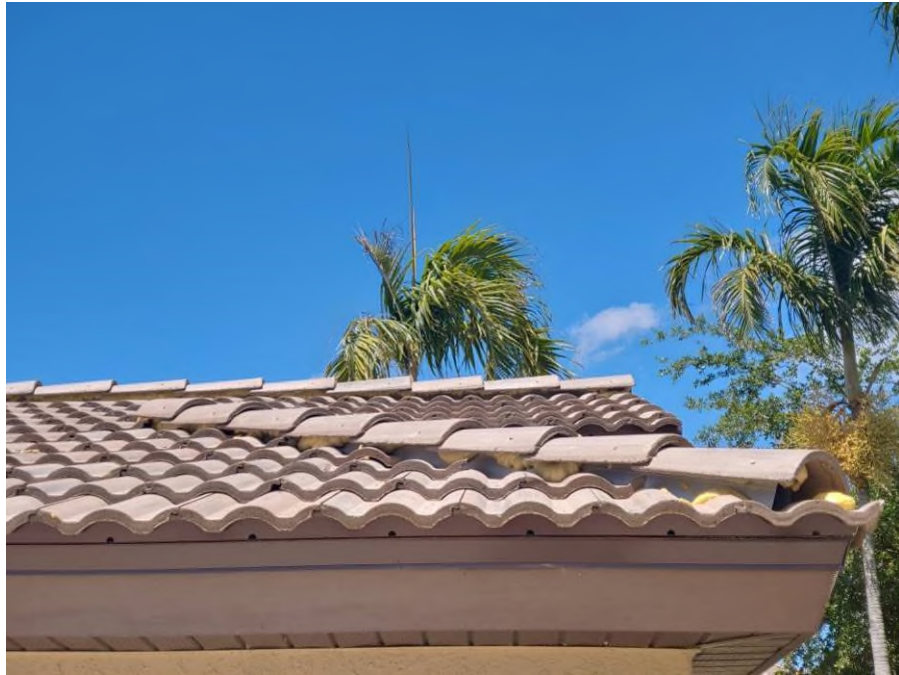
Photograph #1: Roof field, ridge and hip tile installations with polyurethane foam adhesive were in progress on building 21710.

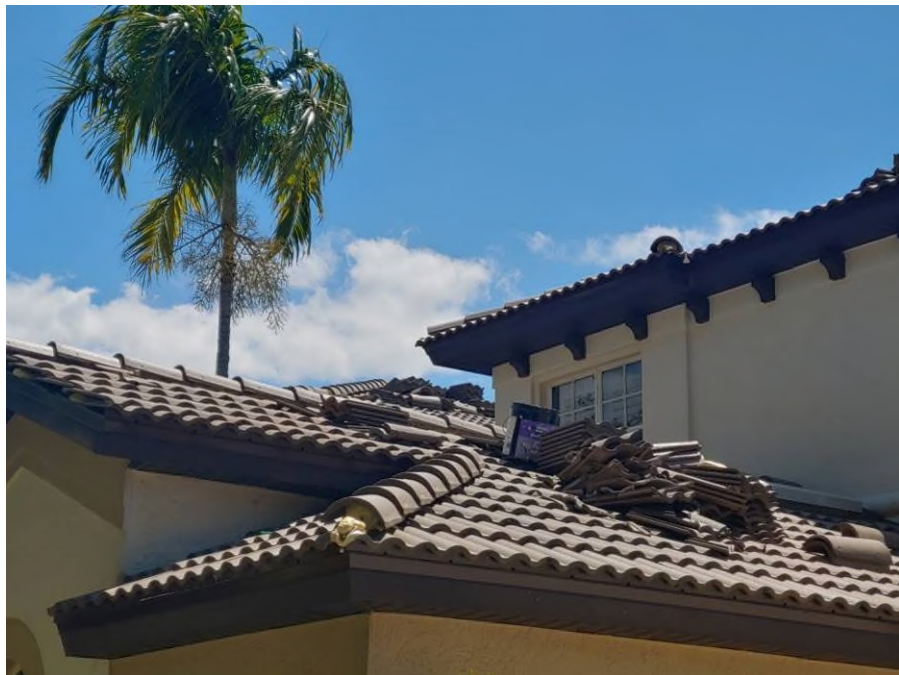
Photograph #2: Roof field, ridge and hip tile installations with polyurethane foam adhesive were in progress on building 21710.

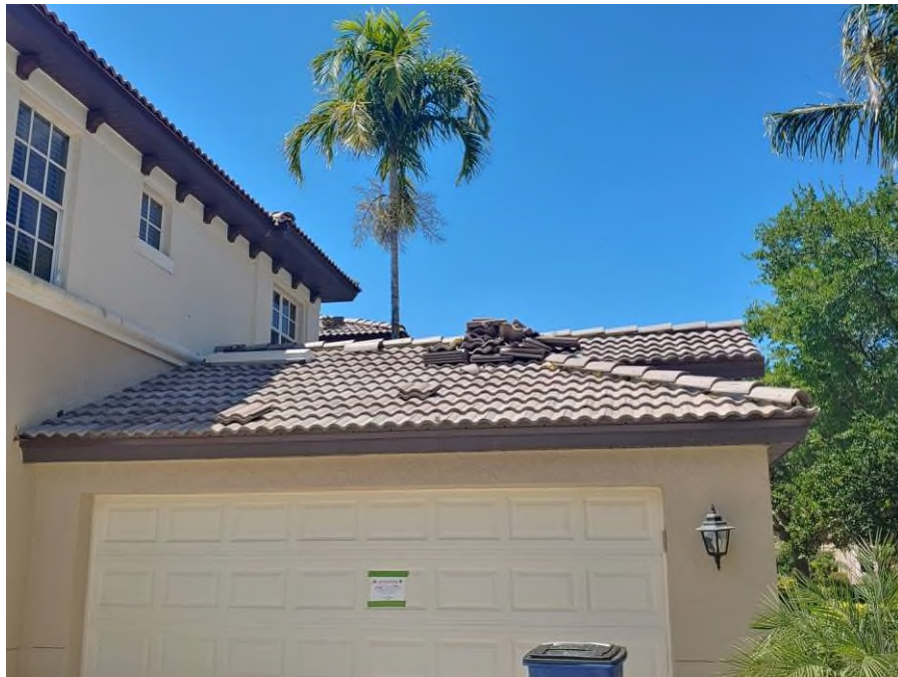
Photograph #3: Roof field, ridge and hip tile installations with polyurethane foam adhesive were in progress on building 21710.

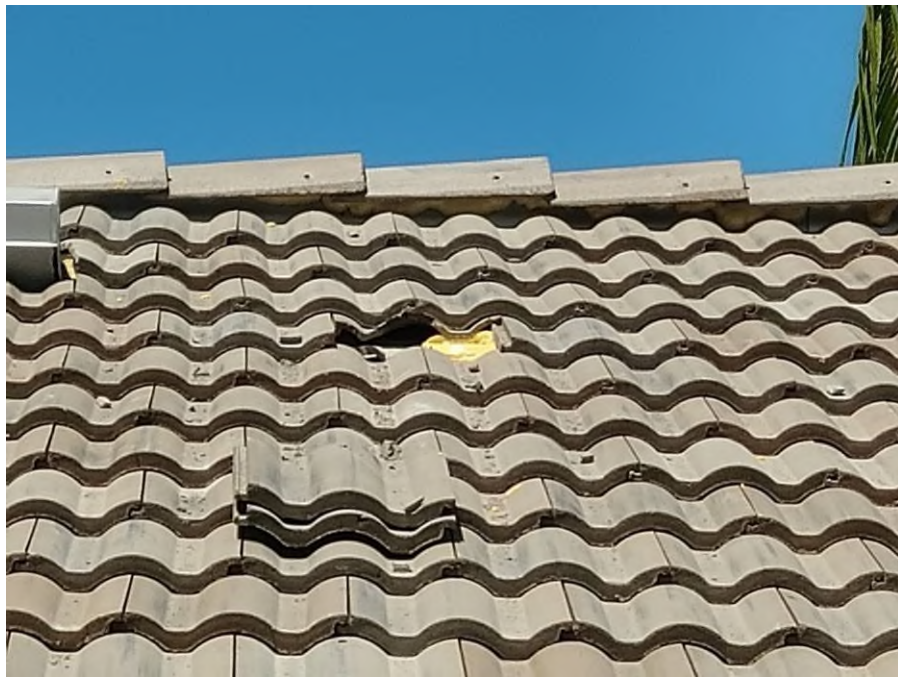
Photograph #4: Broken field tile replacement must be addressed on building 21710.

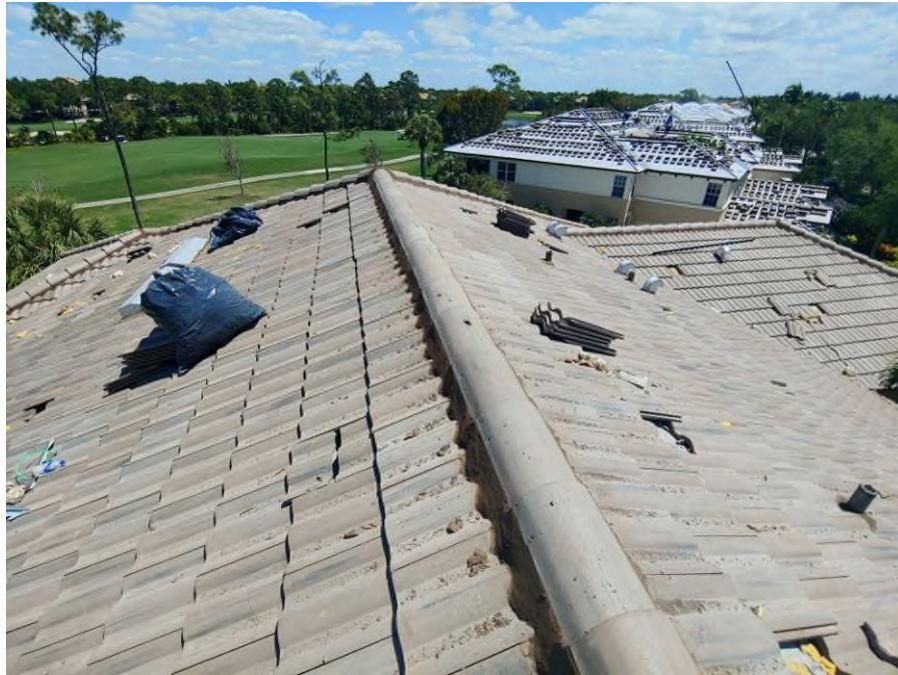
Photograph #5: Roof field, ridge and hip tile installations with polyurethane foam adhesive were in progress on building 21711.

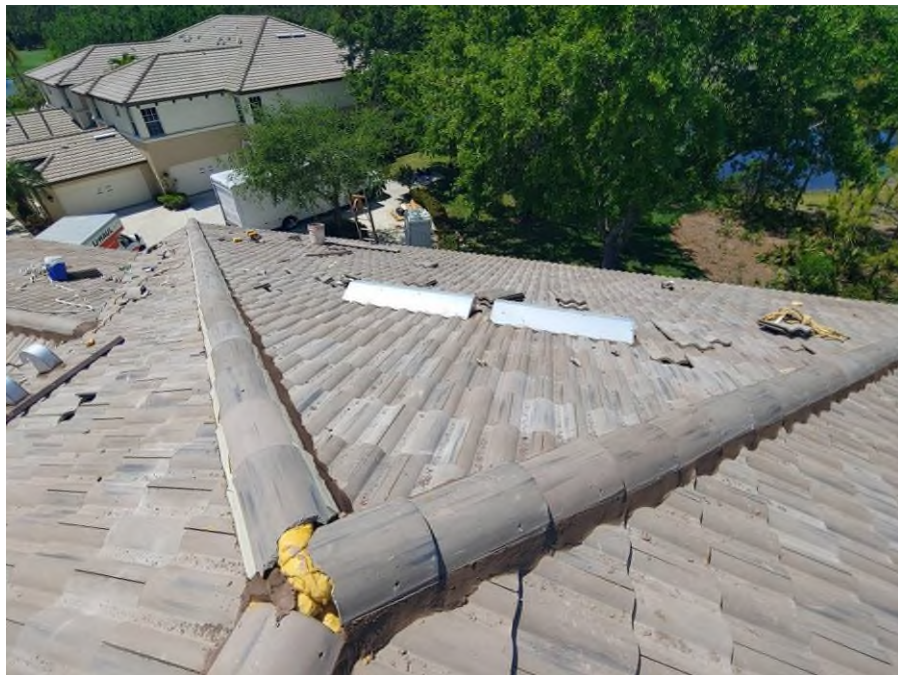
Photograph #6: Roof field, ridge and hip tile installations with polyurethane foam adhesive were in progress on building 21711.

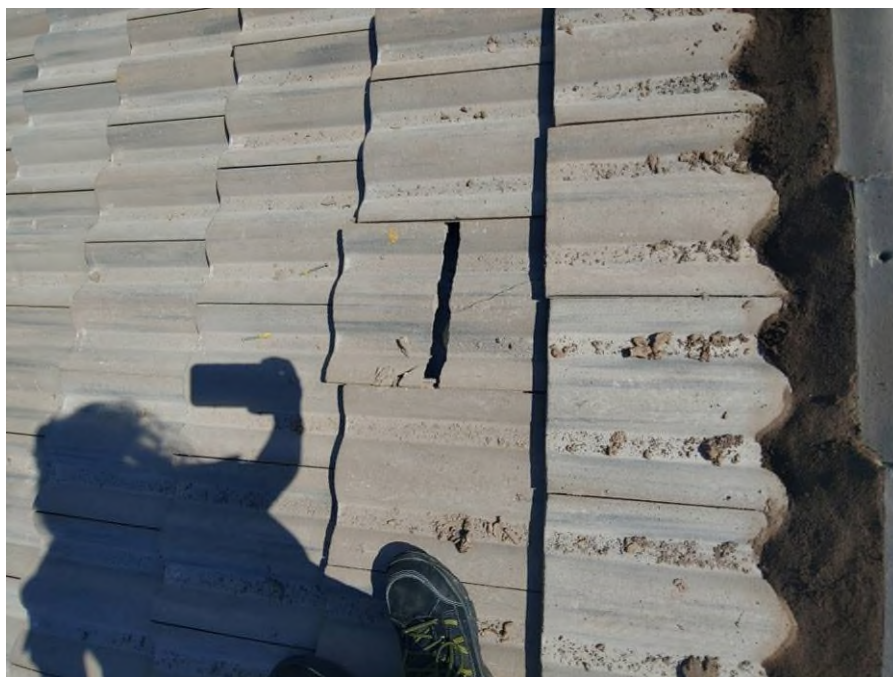
Photograph #7: Broken field tile replacement must be addressed on building 21711.

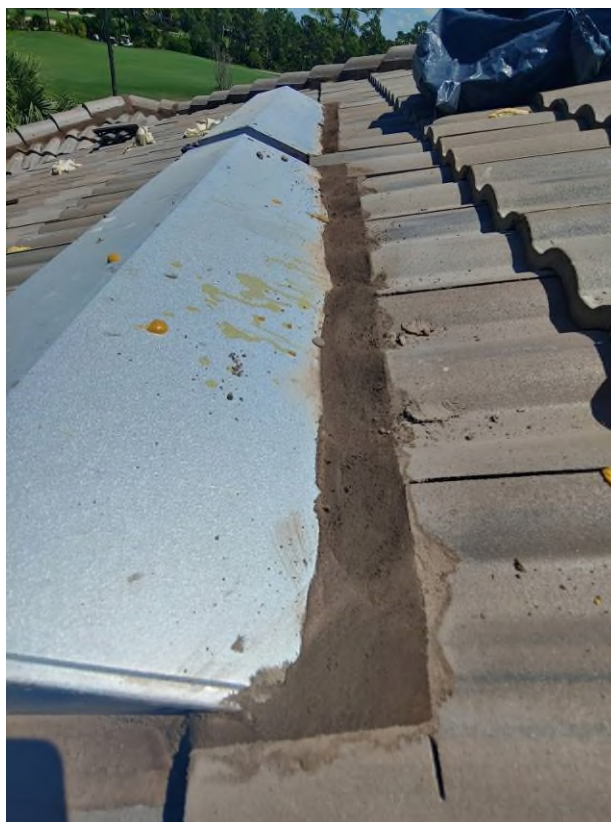
Photograph #8: Mortar adhesive application was in progress on building 21711.

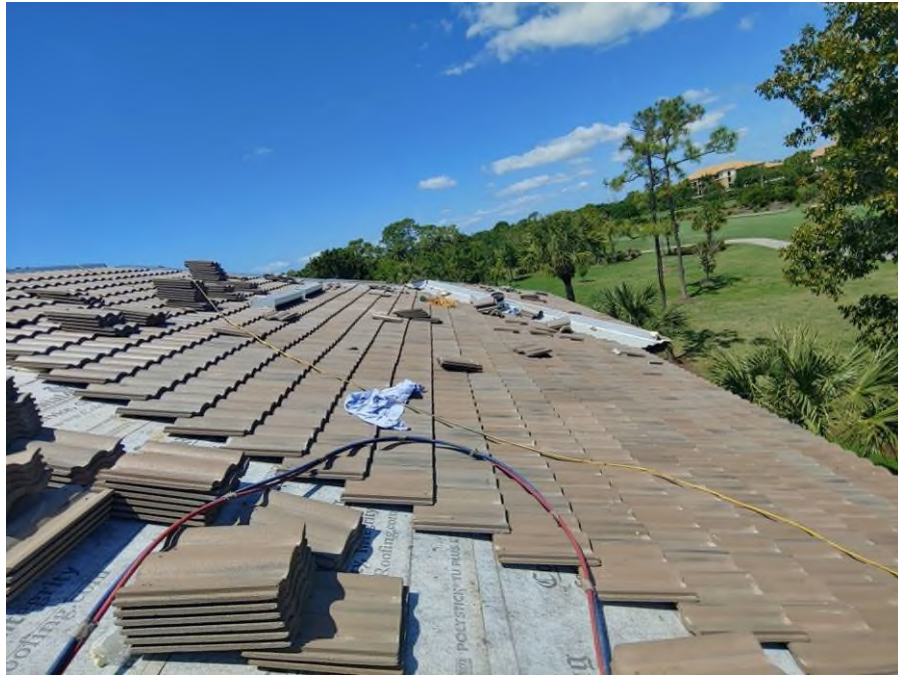
Photograph #11: Roof field, ridge and hip tile installations with polyurethane foam adhesive were in progress on building 21721.

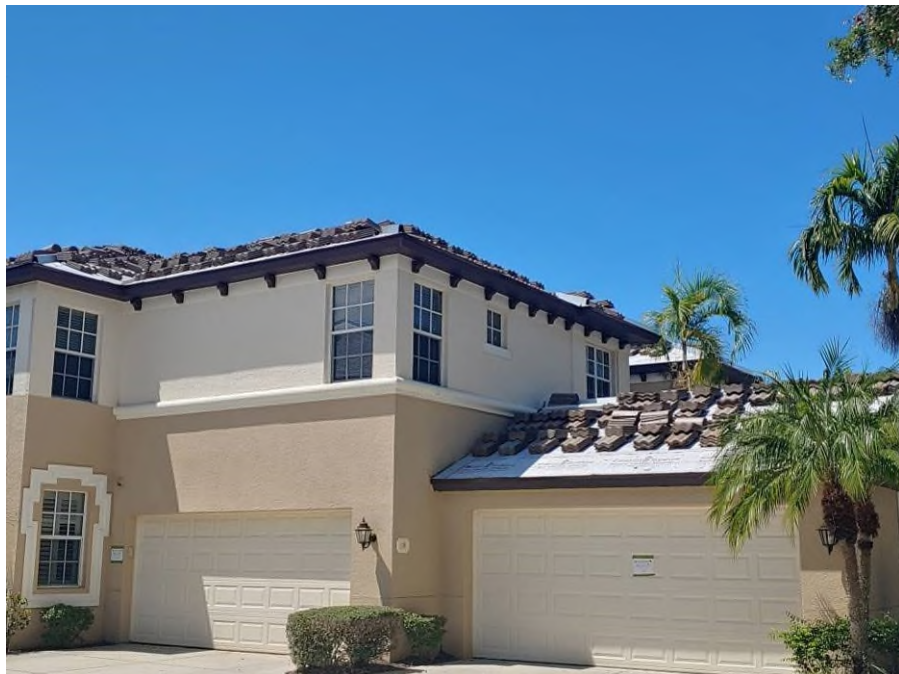
Photograph #14: Roof tiles were set into place for installation on building 21740.

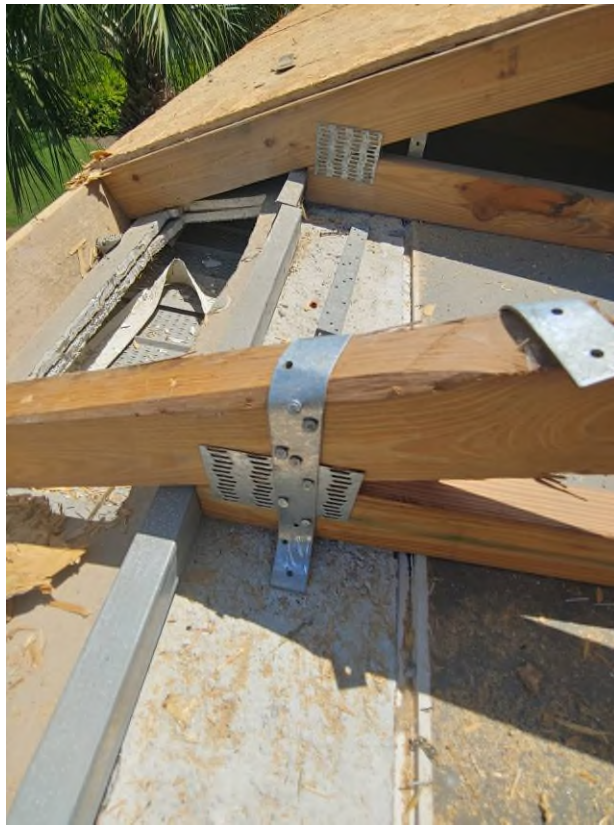
Photograph #17: Existing strap clips on the trusses have the required minimum of nails on building 21781.

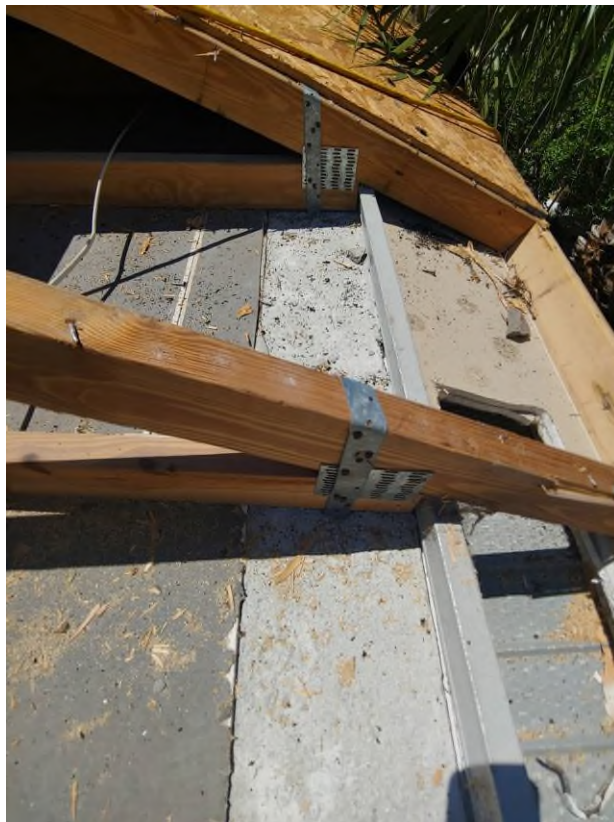
Photograph #18: Existing strap clips on the trusses have the required minimum of nails on building 21781.

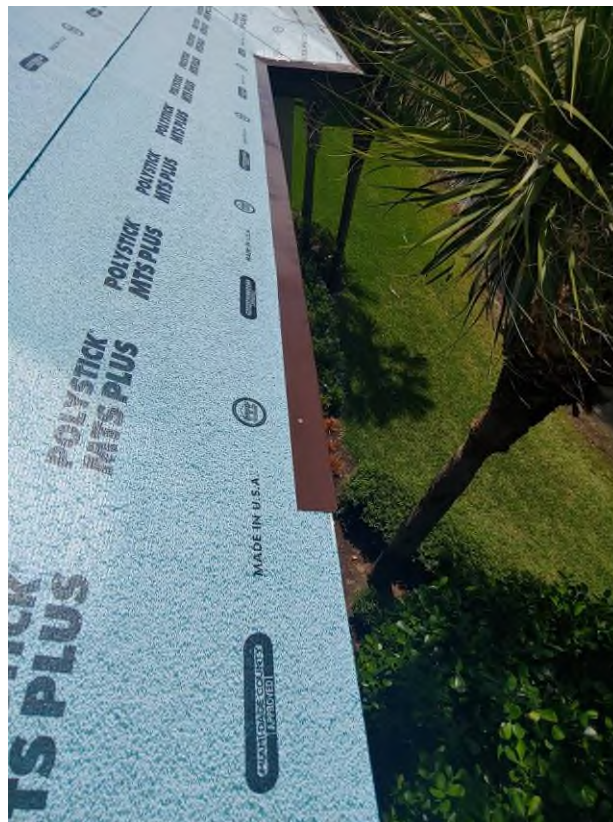
Photograph #22: Drip-edge installation was in progress on building 21810.

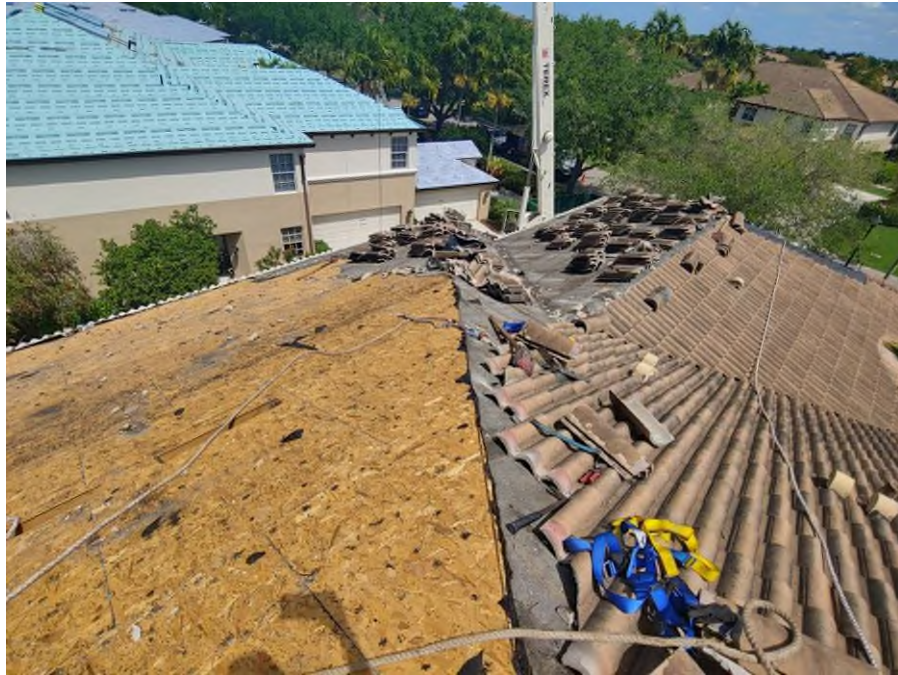
Photograph #25: Roof tile removal was in progress on building 21820.

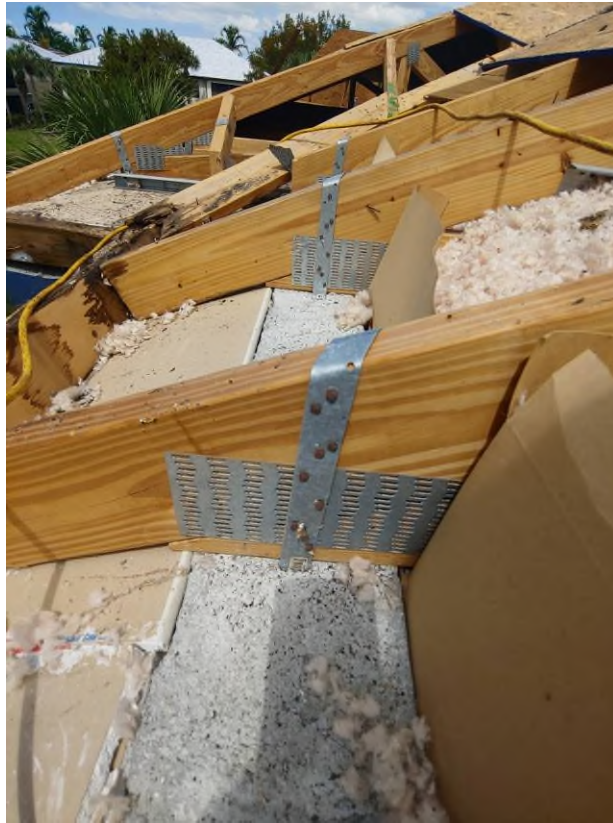
Photograph #27: Existing strap clips on the trusses have the required minimum of nails on building 21820.

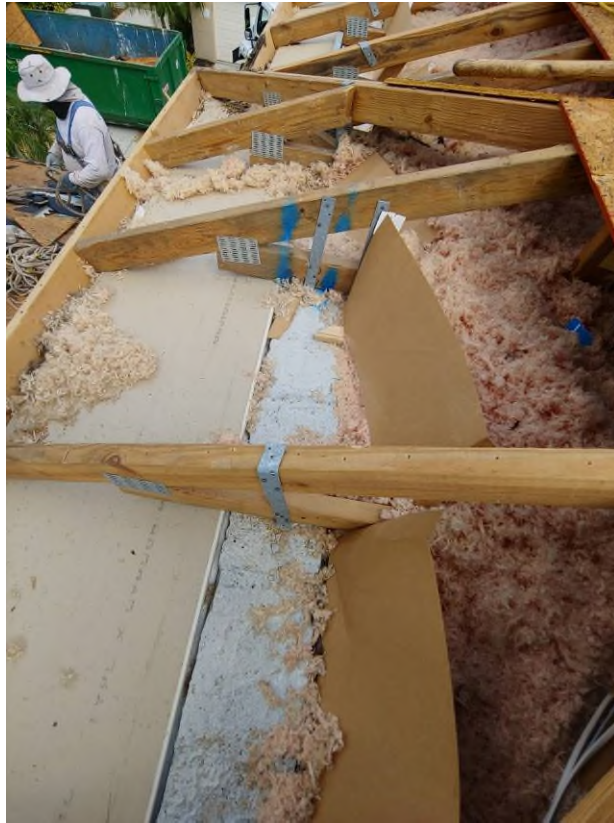
Photograph #1: Existing strap clips on the trusses have the required minimum quantity of nails on building 7870.

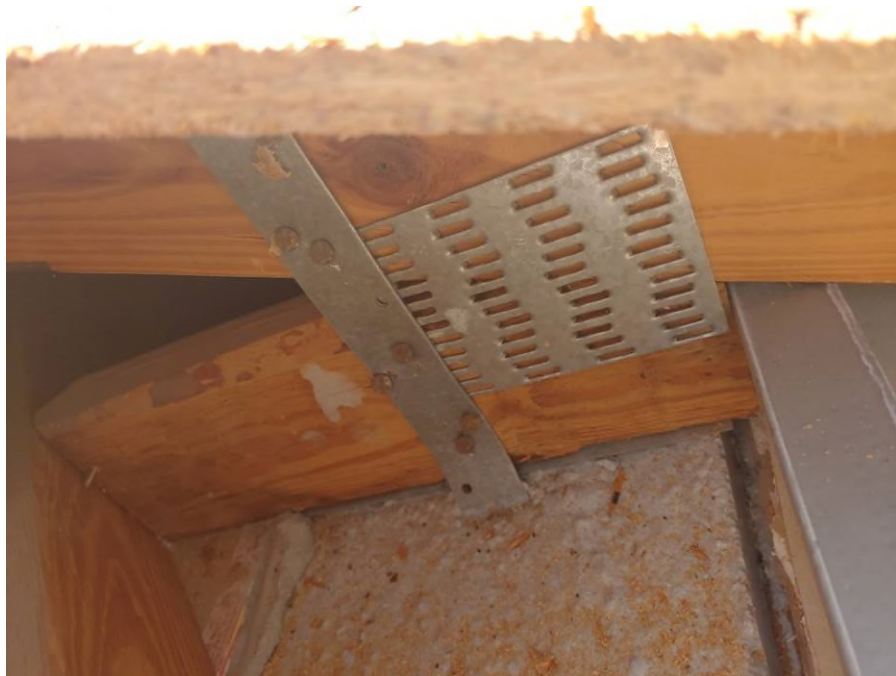
Photograph #2: Existing strap clips on the trusses have the required minimum quantity of nails on building 7870.

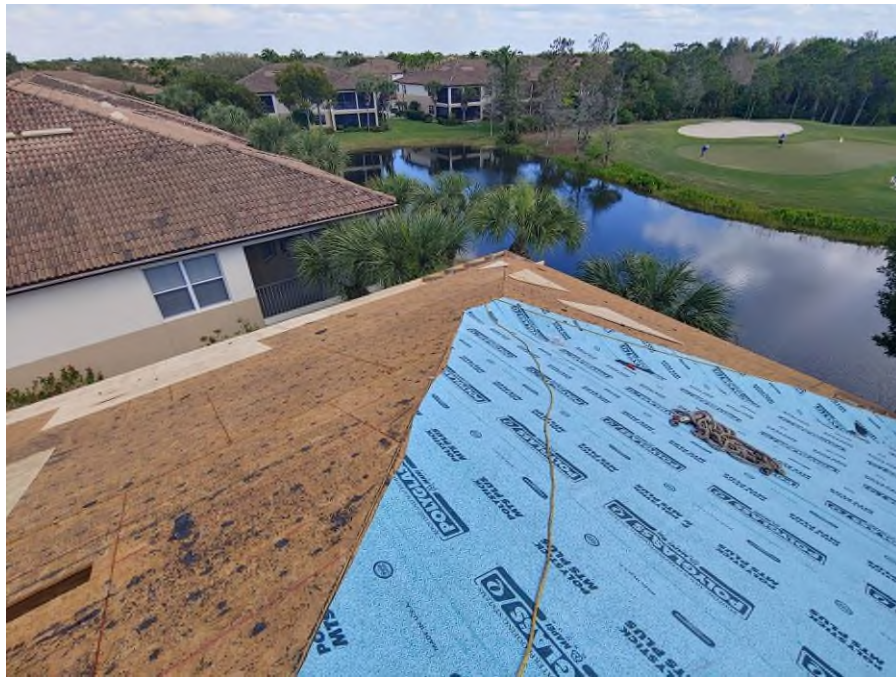
Photograph #3: Polystick MTS Plus underlayment installation was in progress on building 7870.

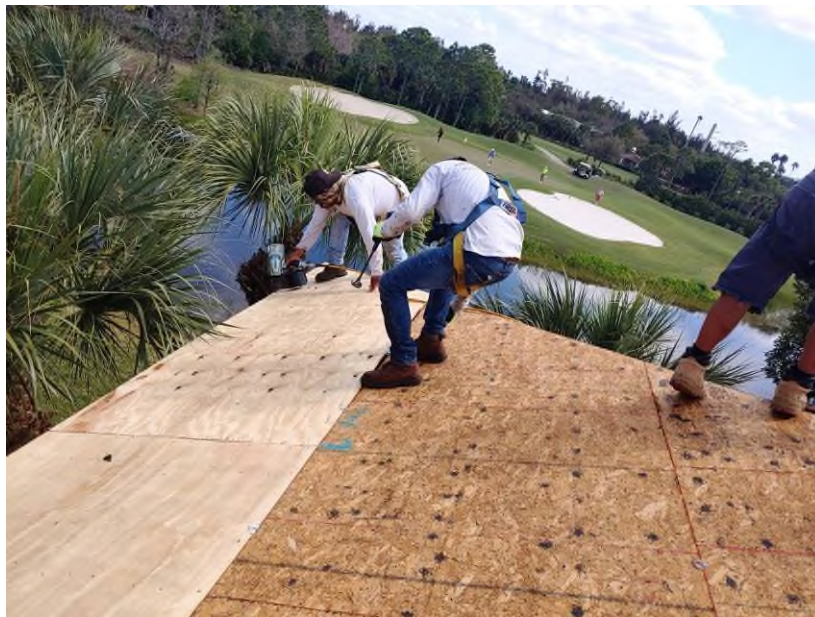
Photograph #4: Re-nail pattern at the plywood sheathing was in progress on buildings 7870.

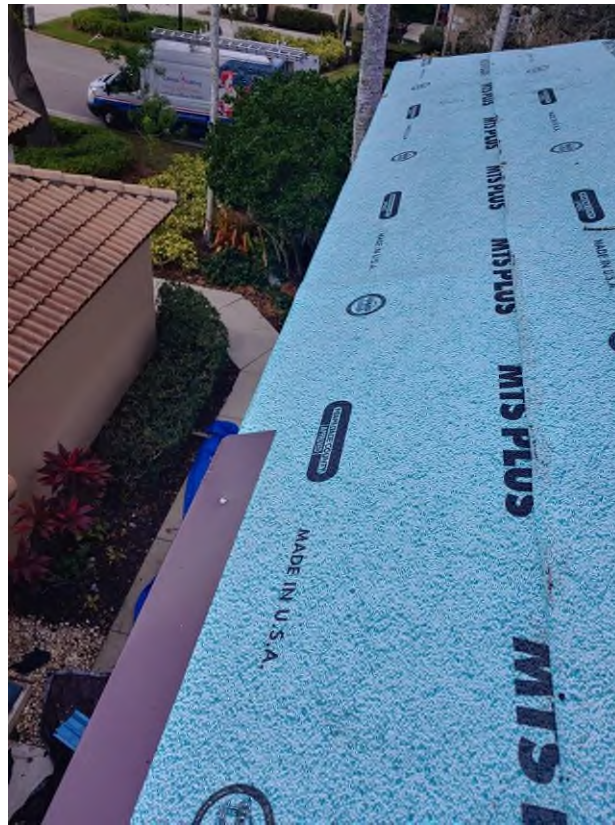
Photograph #5: Drip edge installation was in progress on building 7870.

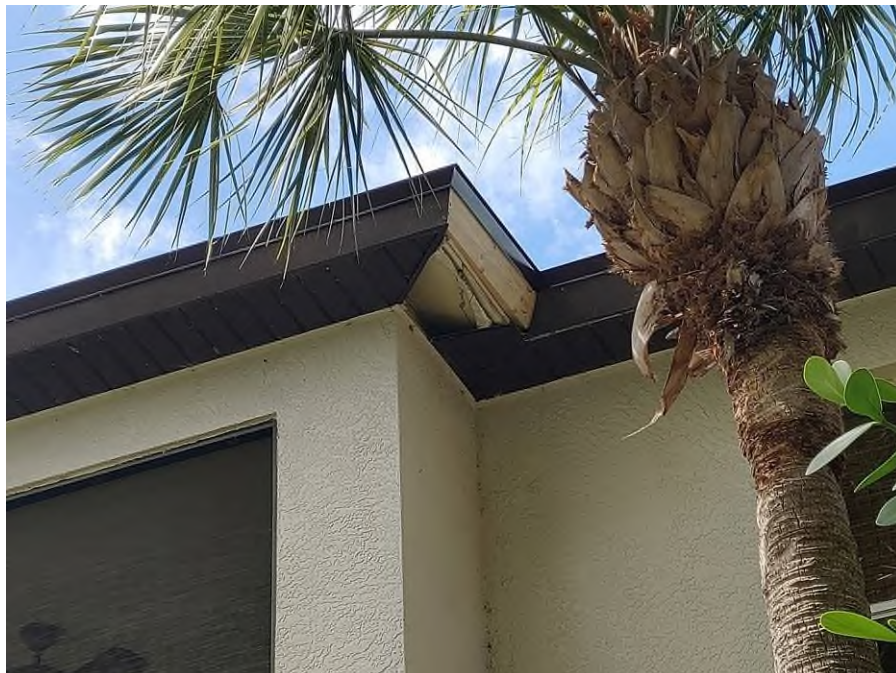
Photograph #6: Fascia repair was in progress on building 7870.

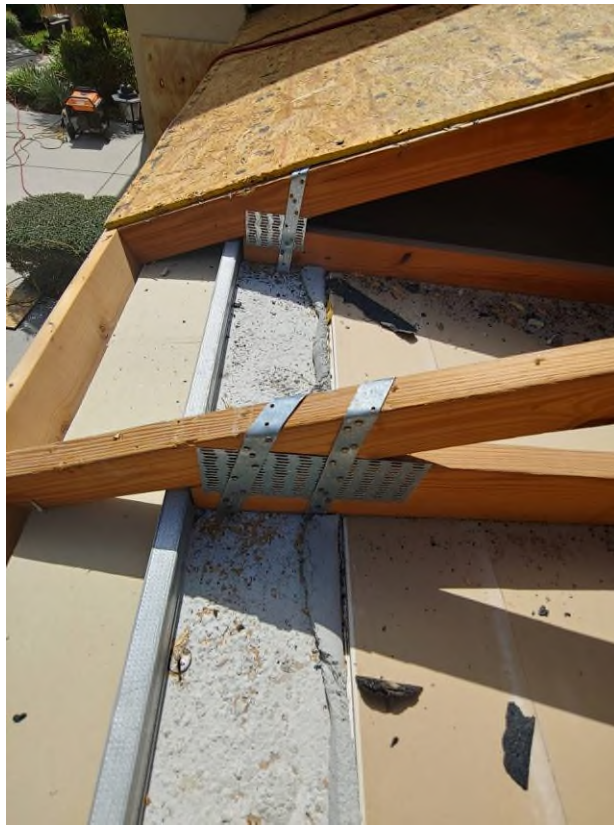
Photograph #7: Existing strap clips on the trusses have the required minimum quantity of nails on building 21740.

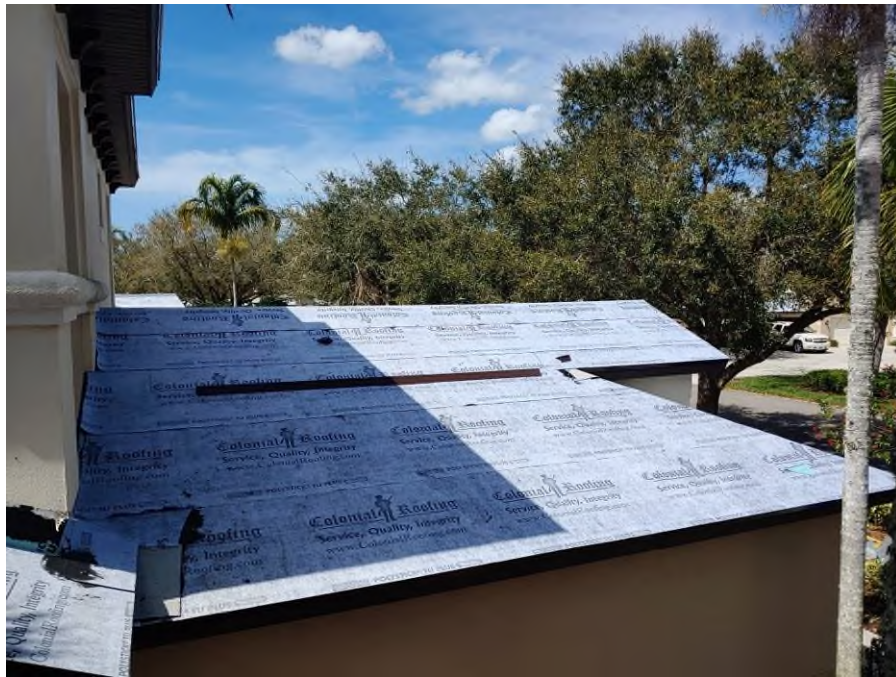
Photograph #9: Second layer of underlayment was in progress on building 21740.

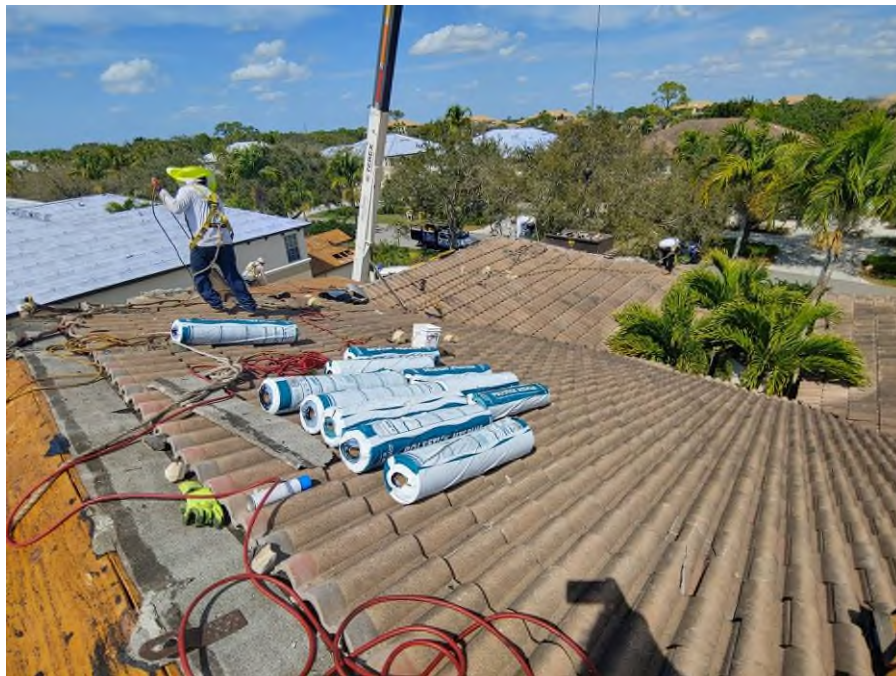
Photograph #10: Observed work-in-progress was completed on building 21750.

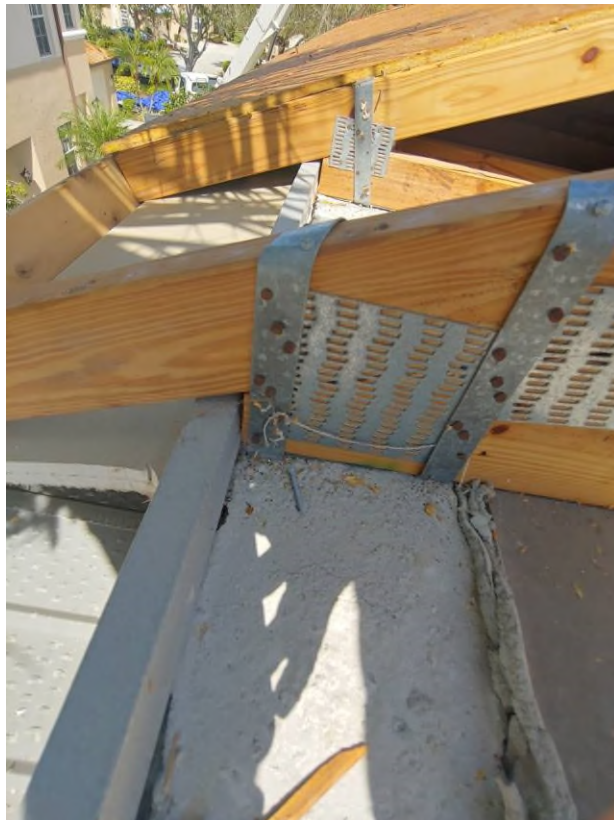
Photograph #12: Existing strap clips on the trusses have the required minimum quantity of nails on building 21750.

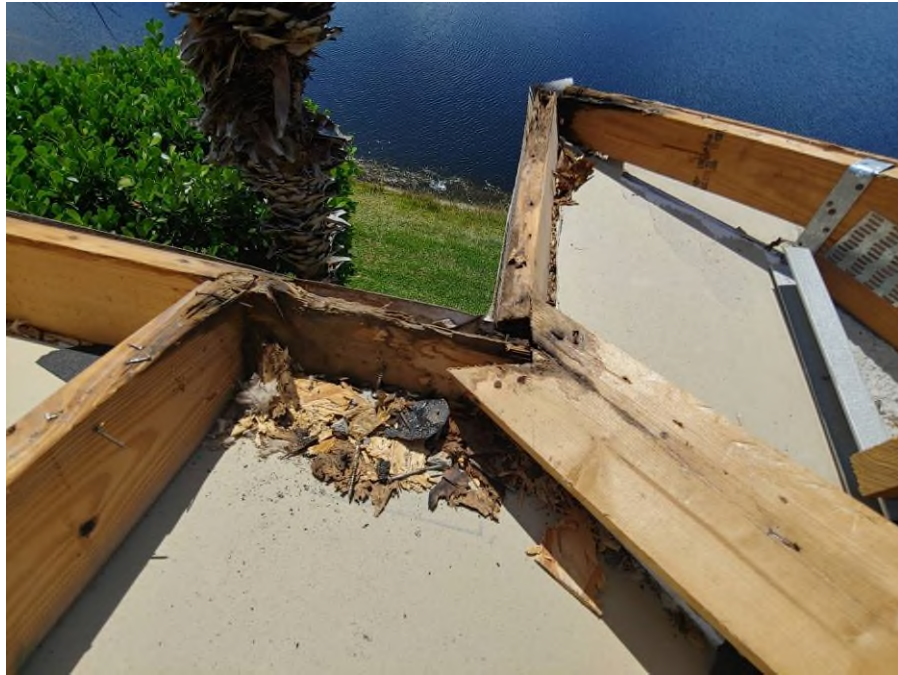
Photograph #13: Rotten fascia and truss were observed on building 21750.

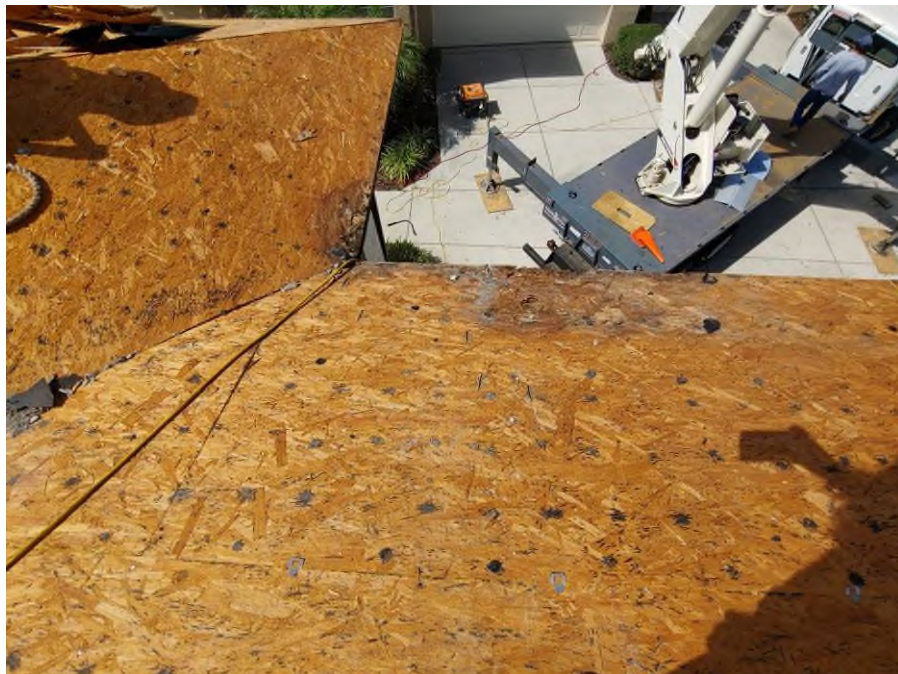
Photograph #14: Rotten plywood sheathing was observed on building 21750.

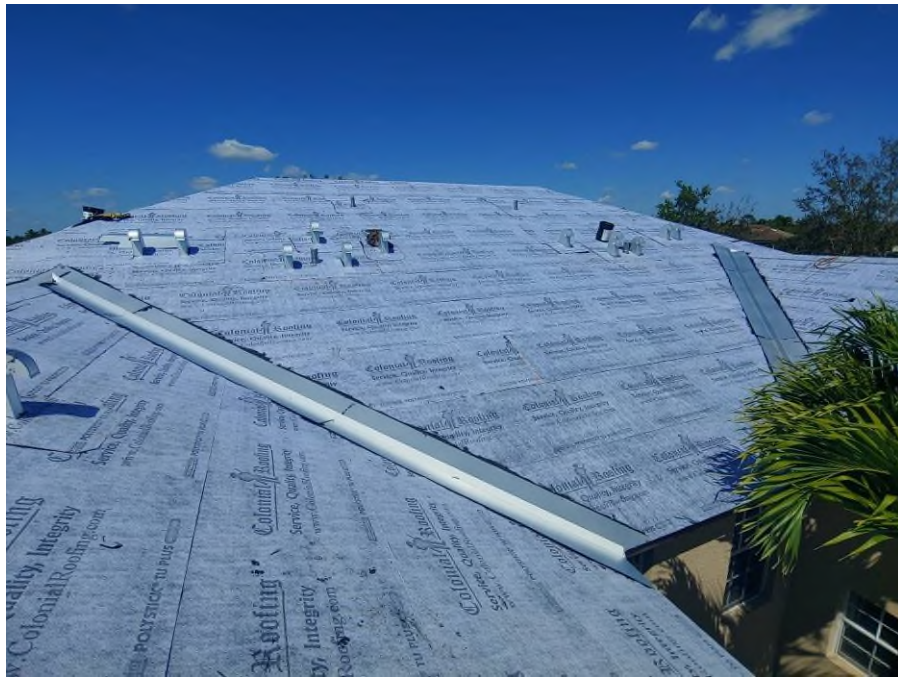
Photograph #1: Second layer of underlayment installation was completed on building 7851.

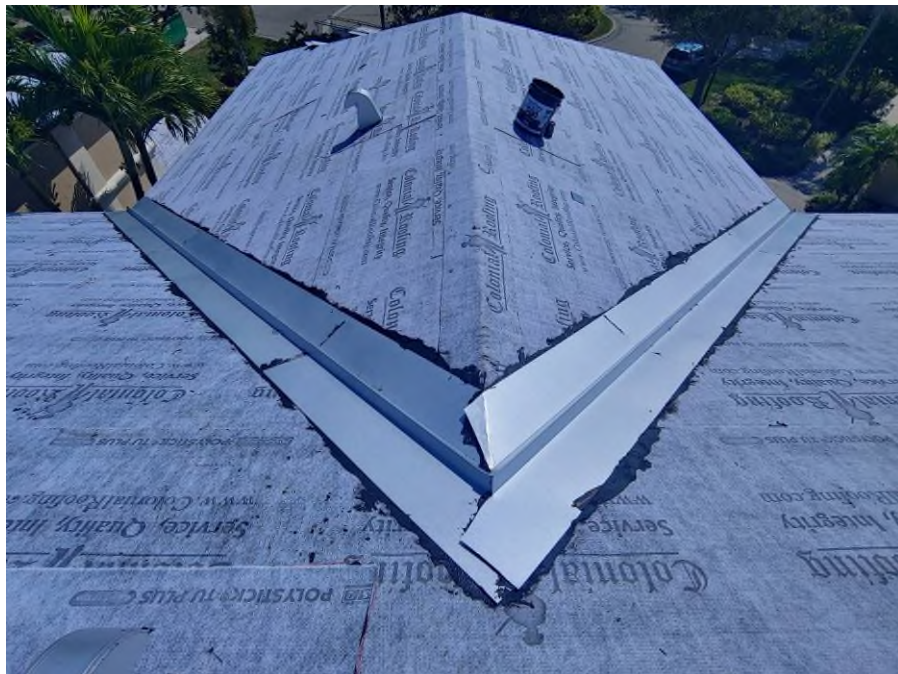
Photograph #2: V-crimp metal valley flashing installation was in progress on building 7851.

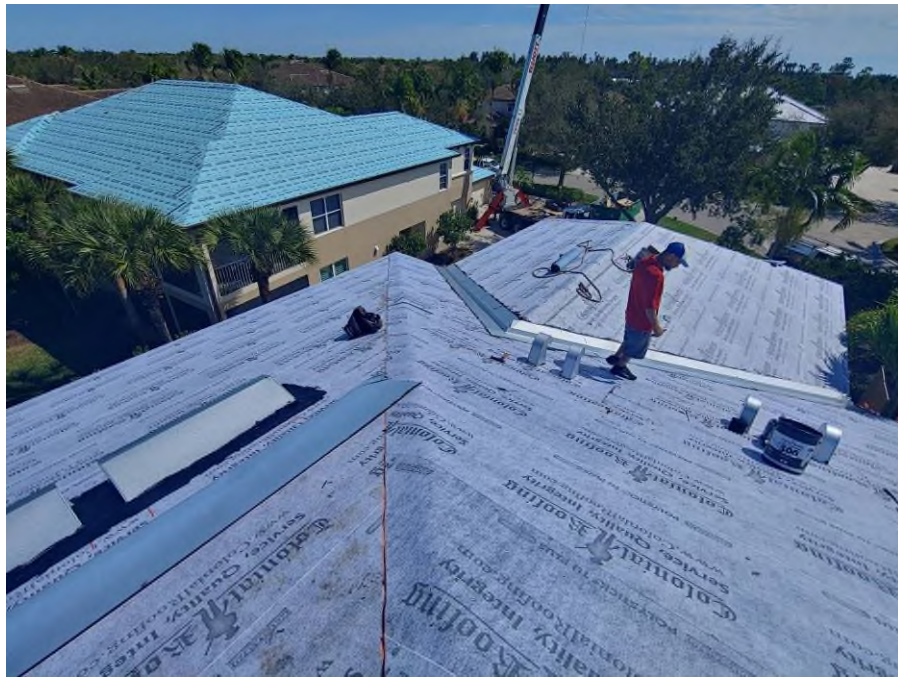
Photograph #3: Exhaust vent installation was in progress on building 7851.

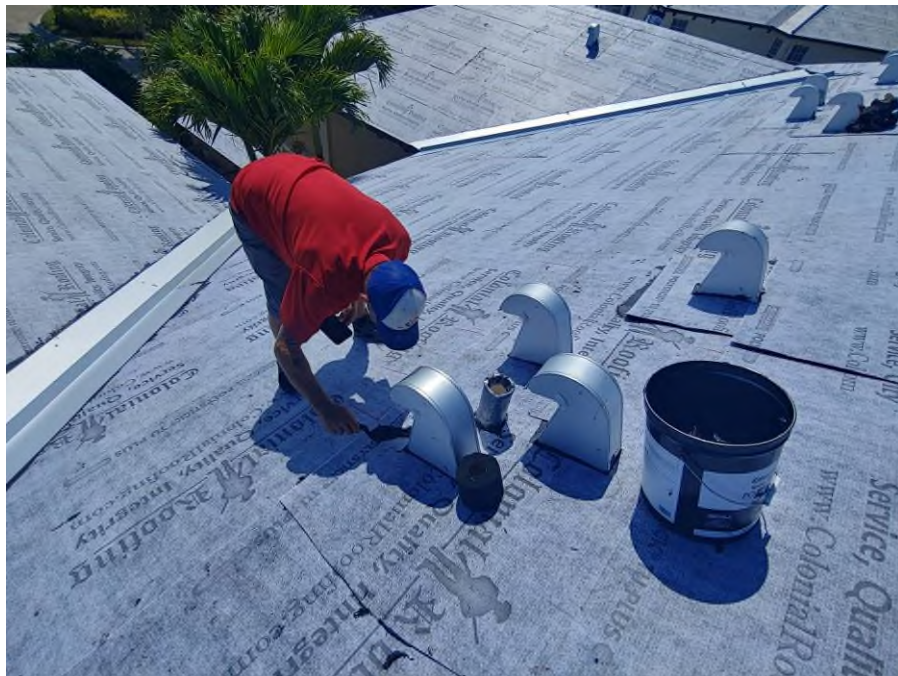
Photograph #4: Exhaust vent installation was in progress on building 7851.

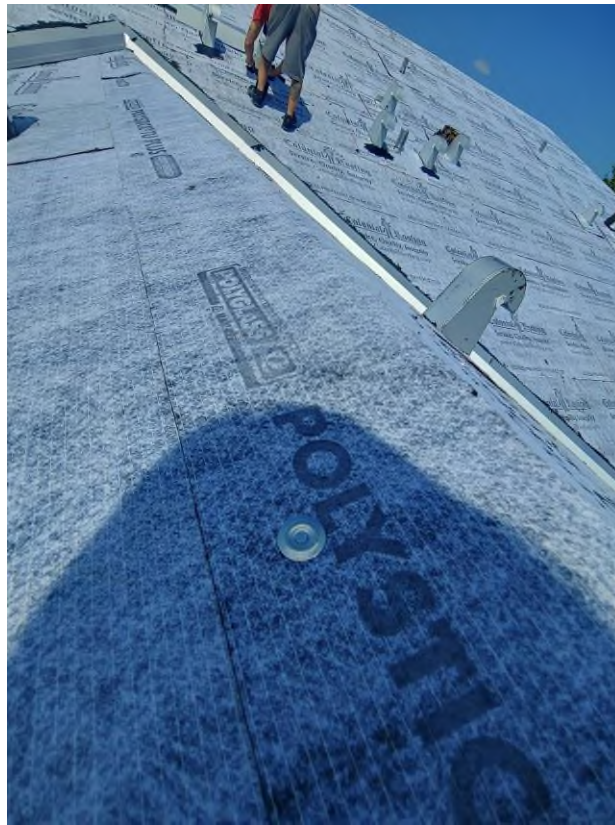
Photograph #5: Contractor must cover all exposed nails with asphalt plastic roofing cement on building 7851.

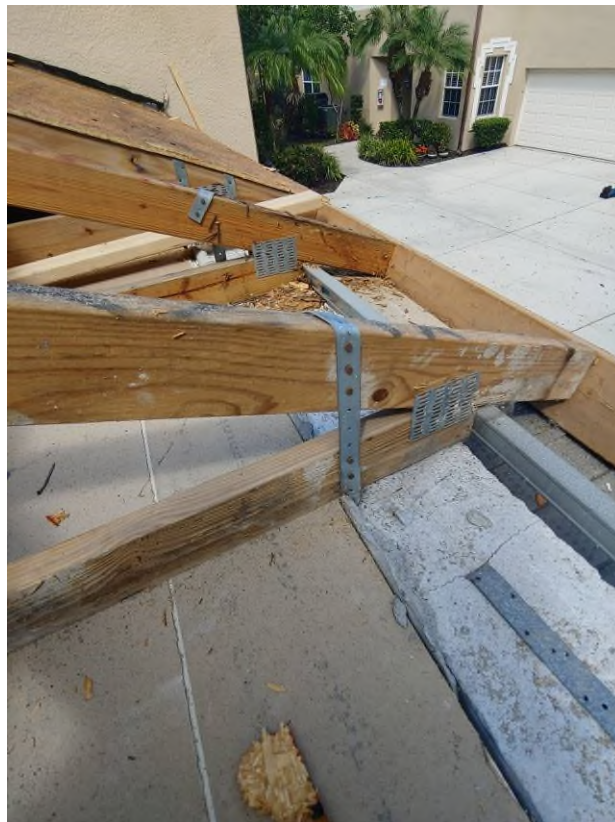
Photograph #6: Existing strap clips on the trusses have the required minimum quantity of nails on building 7861.

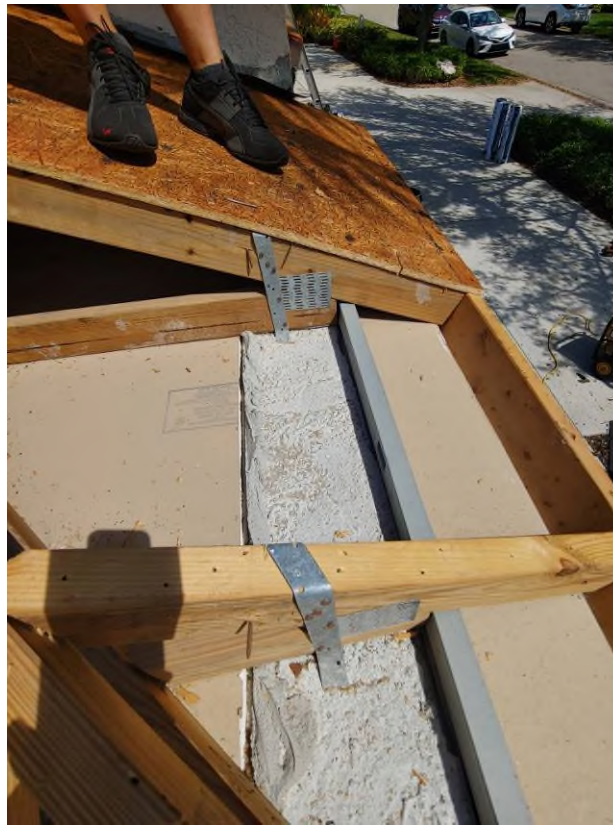
Photograph #7: Existing strap clips on the trusses have the required minimum quantity of nails on building 7861.

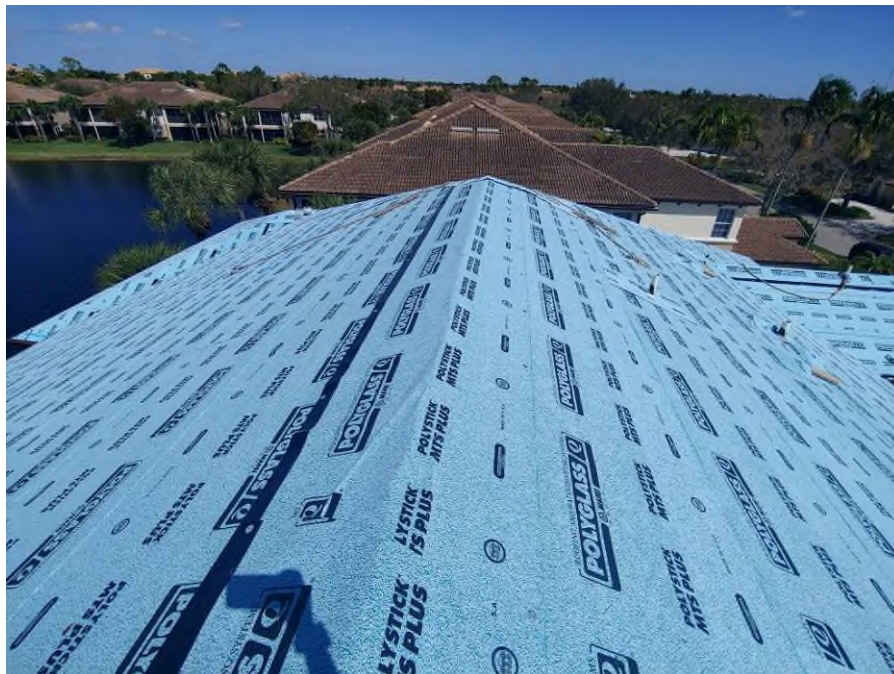
Photograph #8: Polystick MTS Plus underlayment installation was in progress on building 7861.

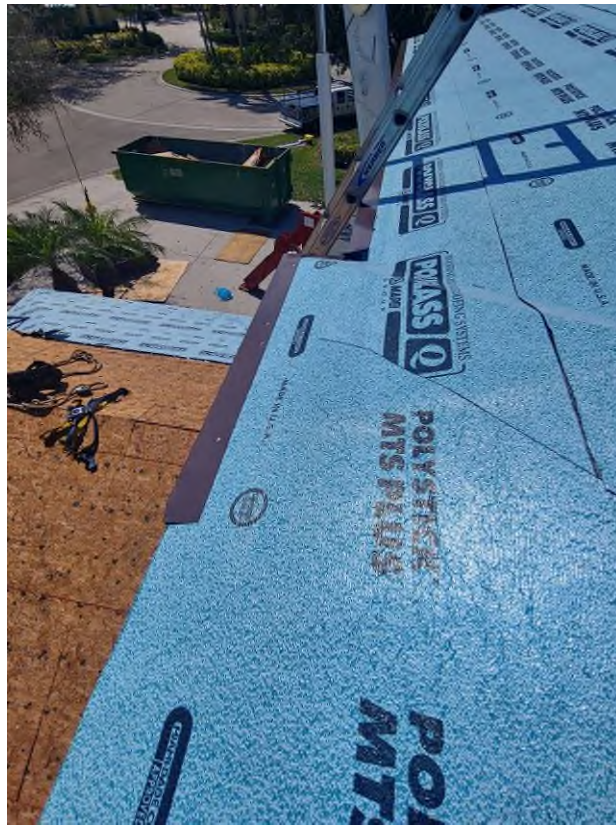
Photograph #9: Drip edge installation was in progress on building 7861.

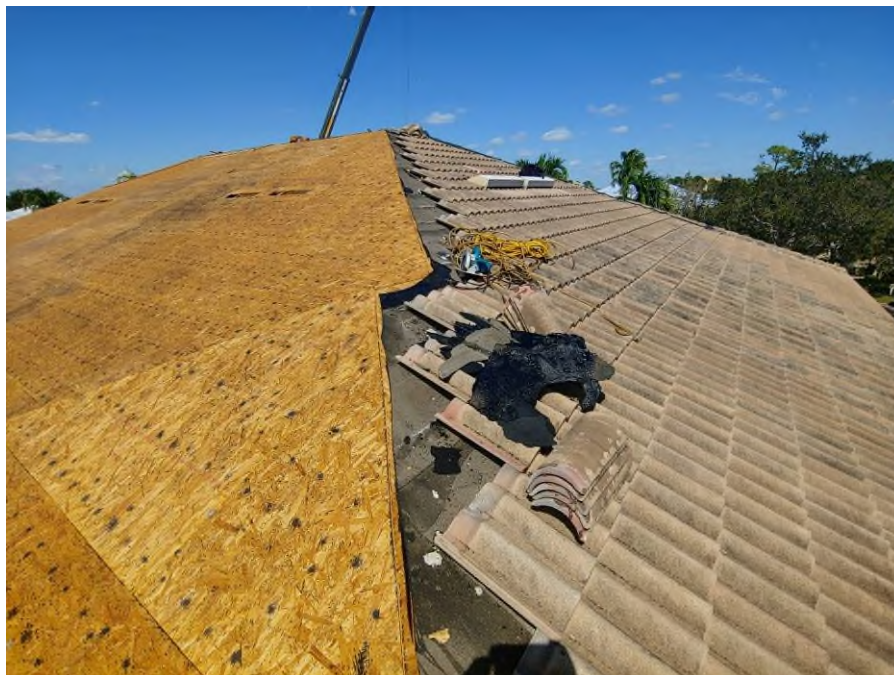
Photograph #10: Roof tile removal was in progress on building 21740.

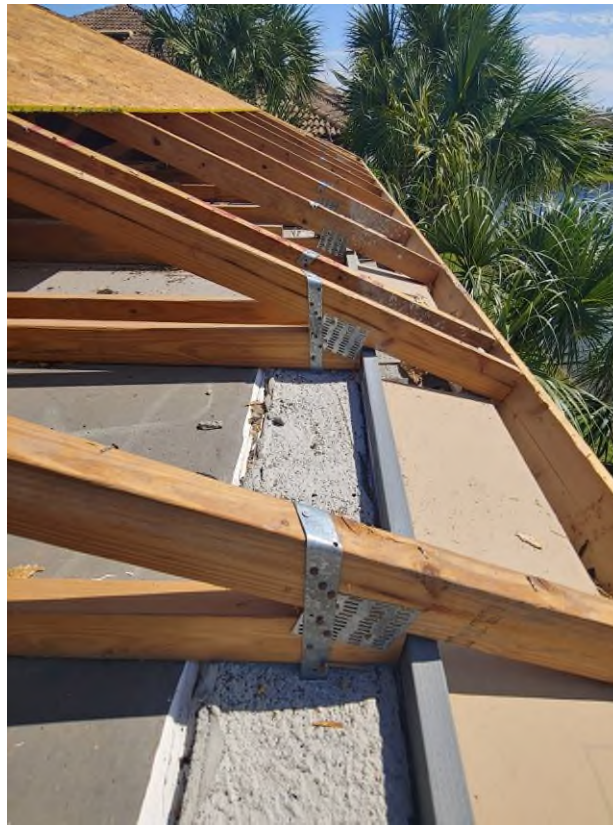
Photograph #11: Existing strap clips on the trusses have the required minimum quantity of nails on building 21740.

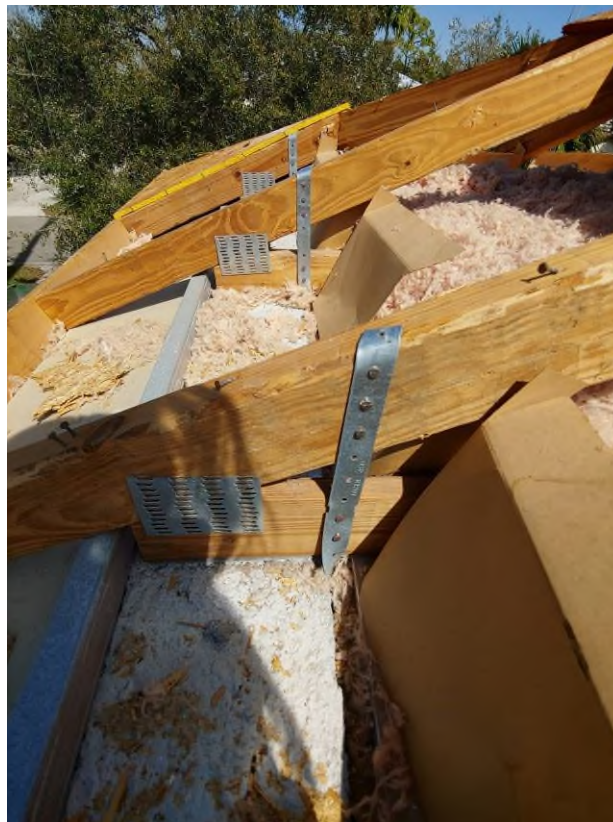
Photograph #12: Existing strap clips on the trusses have the required minimum quantity of nails on building 21740.
