Uniform Mitigation Verification Inspection Form

Inspection Date: 5-6-2020		
Owner Information		
Owner Name: Palmetto Dunes Pelical Sound Condominium Association Inc.		Contact Person:
Address: 21731 Palmetto Dunes Drive Units 101,102,201,202		Home Phone:
City: Estero	Zip: 33928	Work Phone:
County: Lee		Cell Phone:
Insurance Company:		Policy #:
Year of Home: 2001	# of Stories: 2	Email:

DATE	March 30, 2020	JOB NO.	20RN-0085
Palmetto Dunes CAI – Roofing Project			
LOCATION	Palmetto Dunes Drive		
CONTRACTOR	EnviroStruct, LLC	Palmetto Dunes CAI	
WEATHER	Sunny	TEMP. 88° F	Time 2:30PM
PRESENT AT SITE	Rahmin Bahar, EnviroStruct (ES) Teresita Nazario-Acosta, Karins Engineering Group (KEG)

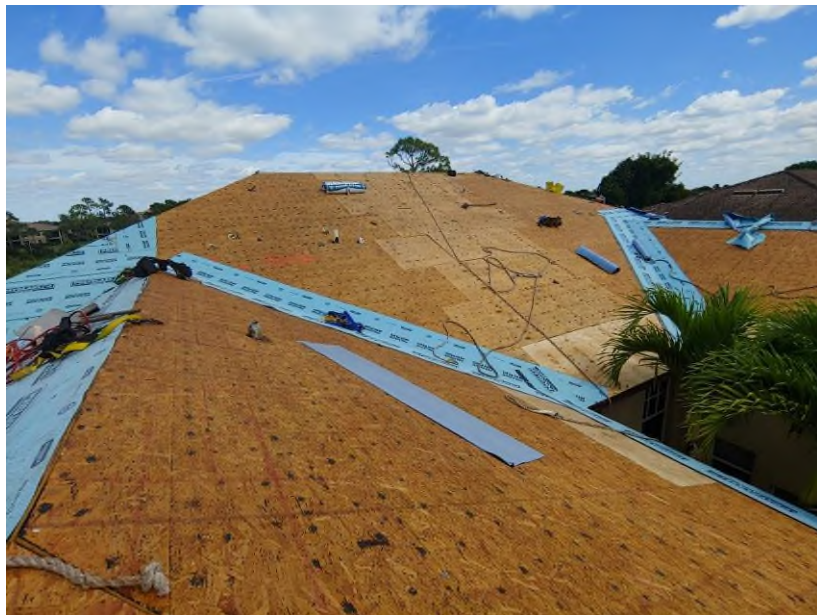
Photograph #8: Polystick MTS Plus underlayment installation was in progress on building 21731.
